SWALE CREEK WATER TEMPERATURE STUDY

Klickitat County Planning Unit

Watershed Professionals Network, LLC

September 30, 2004

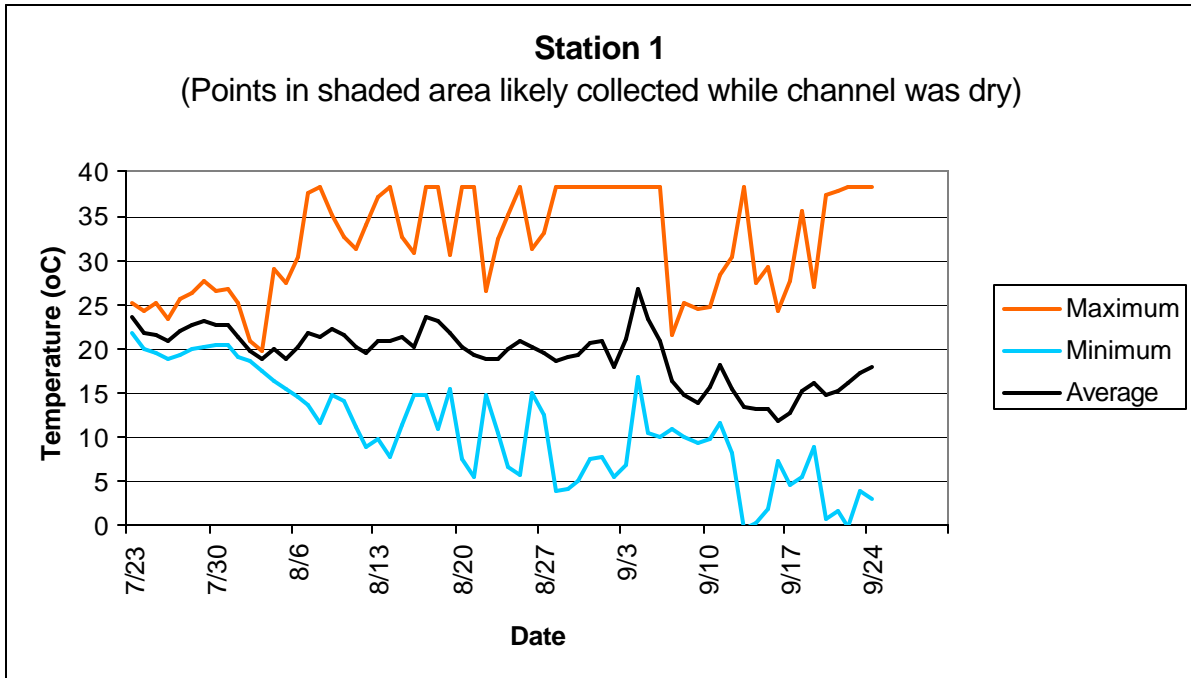
Figure 6. Water temperature recorded at Station 1 (just downstream of Warwick). Station was dry when the recording device was retrieved. Shaded area indicates period when site was likely dry.

Eleven continuous water temperature recorders were deployed in Swale Creek in the summer of 2003 (Figures 6 through 14). One of these was lost. The recorder at station 8 (near the bend in the creek where it turns to the west, roughly 4 stream miles from the mouth) quit working after 3 days of recording. Data from this site were disregarded. Stations 1, 2, and 10 were all dry when the temperature monitors were retrieved. These sites include the two near Warwick and a third roughly 1.8 stream miles downstream of Warwick. The patterns observed in the data suggest that Station 1 went dry on August 2nd, Station 2 went dry on September 12th, and Station 10 went dry on August 20th (Figures 6, 7, and 13). In mid-season, stream temperatures at Station 4 also suggest that the creek was dry at that location from August 15th through September 8th (Figure 9). The station was wetted when the monitoring device was retrieved; therefore, we cannot confirm that the station was dry at any time.

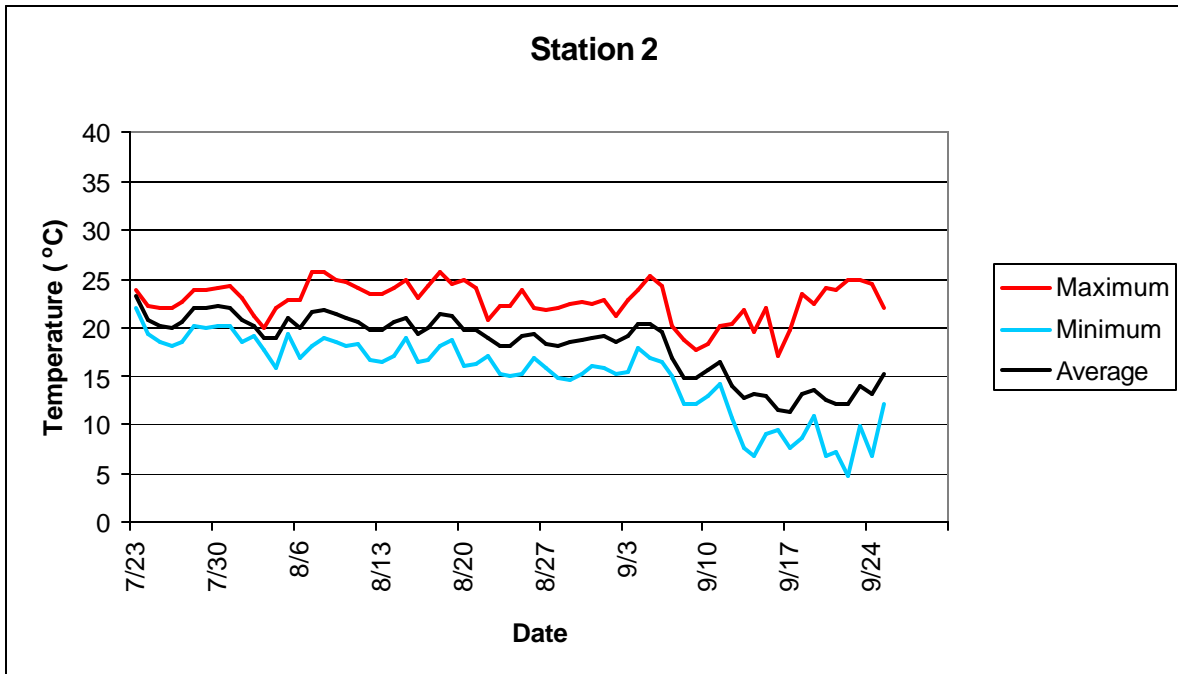
Figure 7. Water temperature recorded at Station 2 (approximately 1.8 miles downstream from Warwick). The site was dry when the device was retrieved. The shaded area on the plot indicates the likely period during which the site was dry.

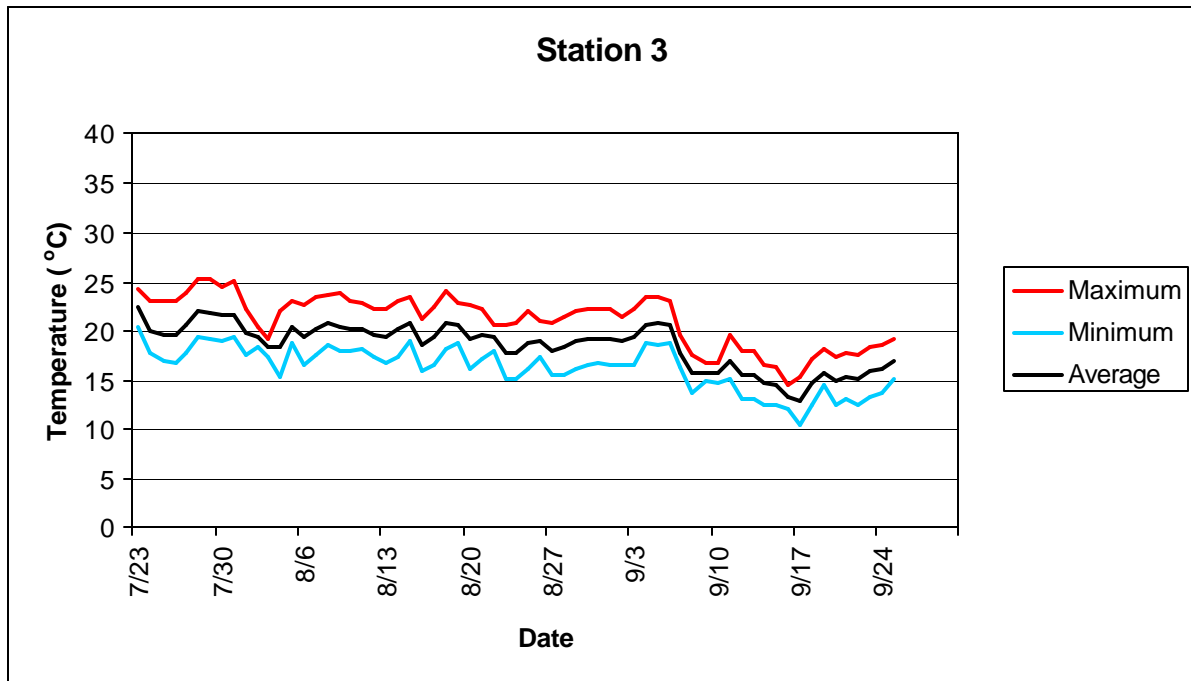
Figure 8. Water Temperature recorded at Station 3 (approximately ½ mile downstream of Stacker Canyon).

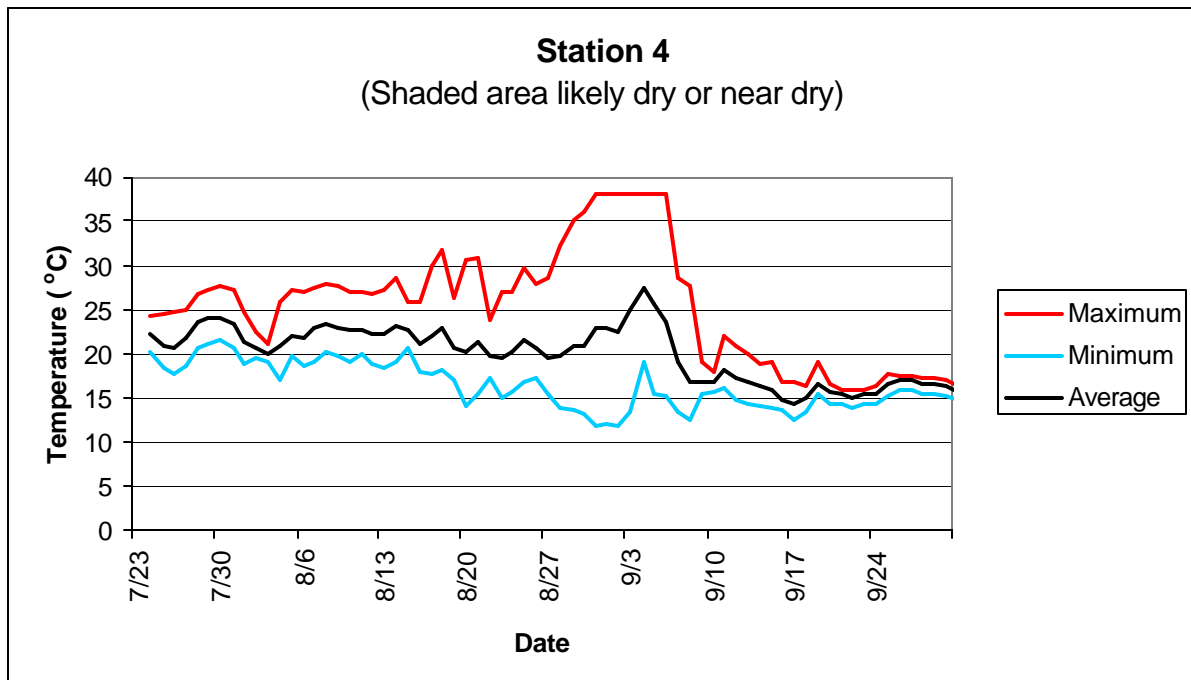
Figure 9. Water temperature recorded at Station 4 (approximately 3 miles downstream of Stack Canyon). Site was wetted when device was retrieved, however data suggest the site may have been dry for a period in late August (shaded area).

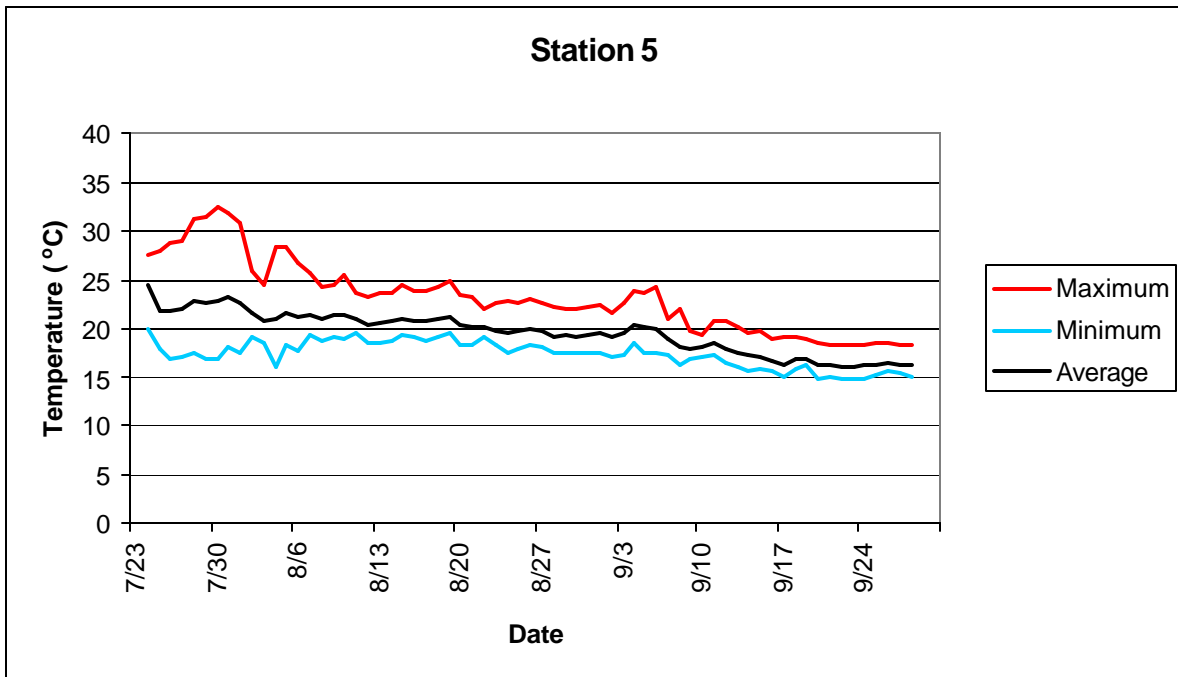
Figure 10. Water temperature recorded at Station 5 (near mouth of Swale Creek). The wide fluctuation in temperature during the first 2 weeks of deployment is unexplained.

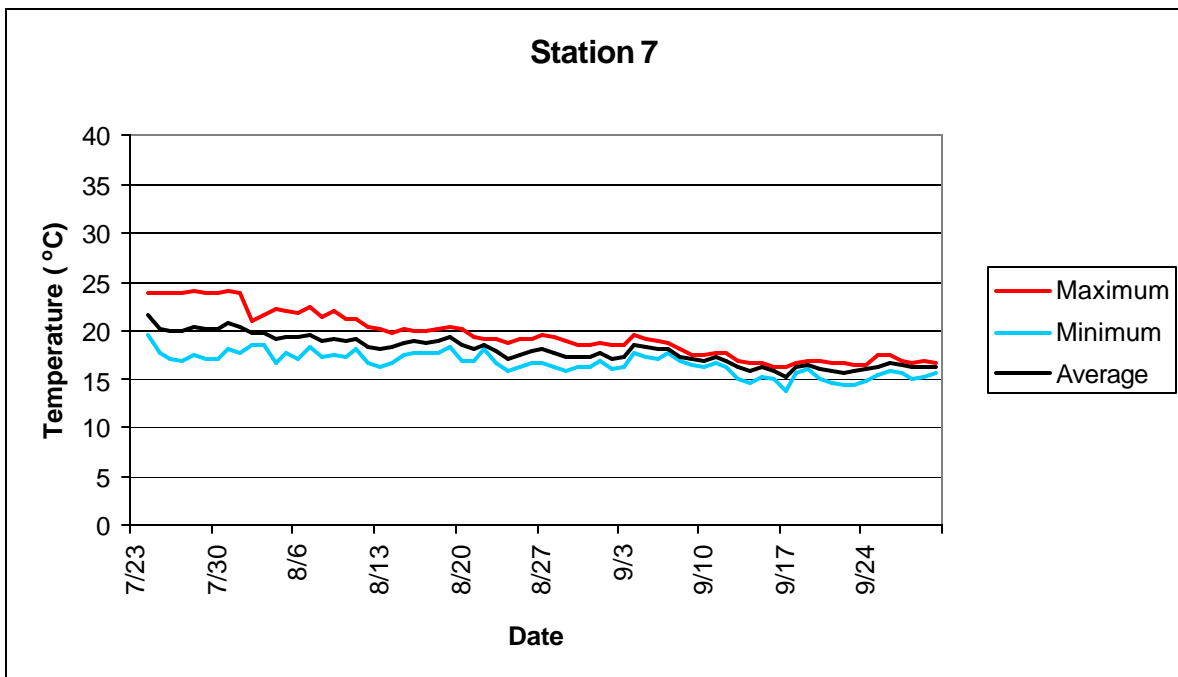
Figure 11. Water temperature recorded at Station 7 (roughly 1.5 stream miles upstream of mouth).

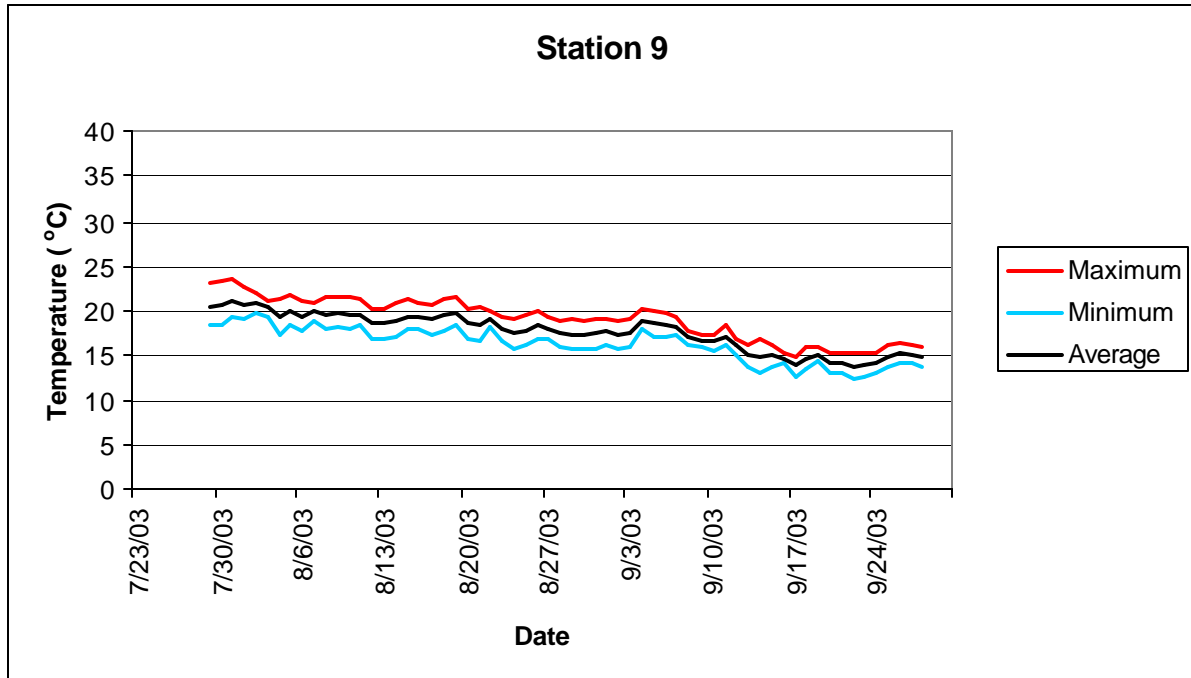
Figure 12. Water temperature recorded at Station 9 (approximately ½ mile downstream of bend in creek where creek turns west and runs toward the confluence with the Klickitat River).

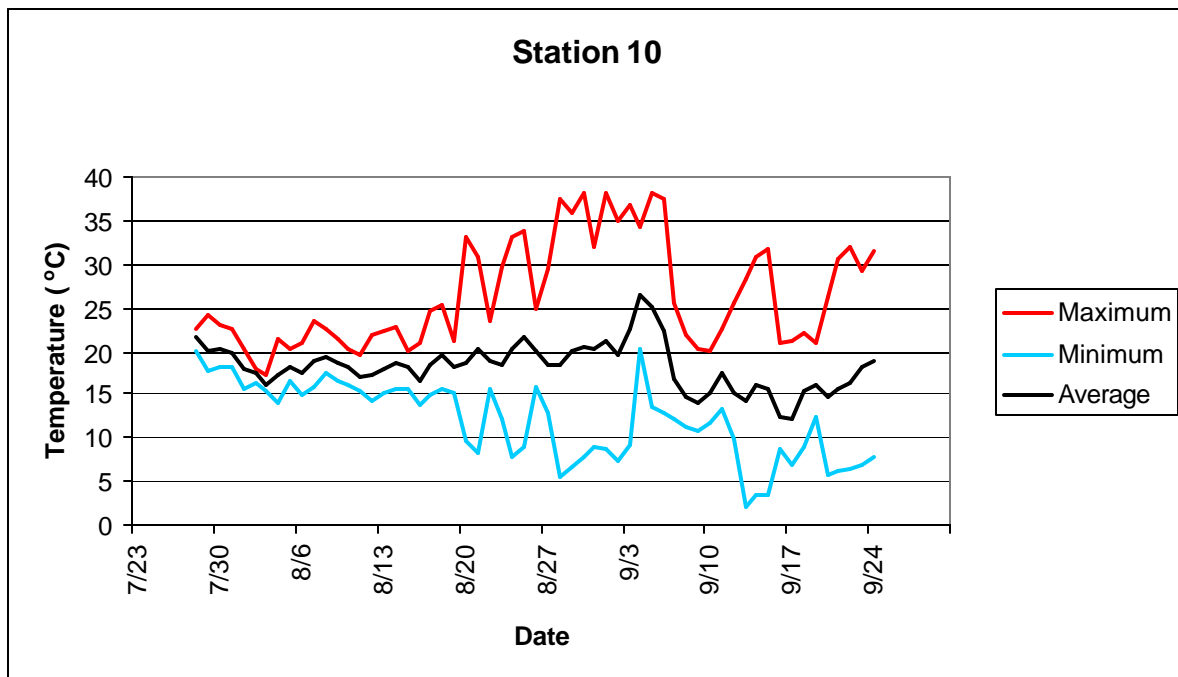
Figure 13. Water temperature recorded at Station 10 (just upstream of Warwick). Stream was dry when monitoring device was retrieved. Shaded area indicates duration of time during which the stream was likely dry.

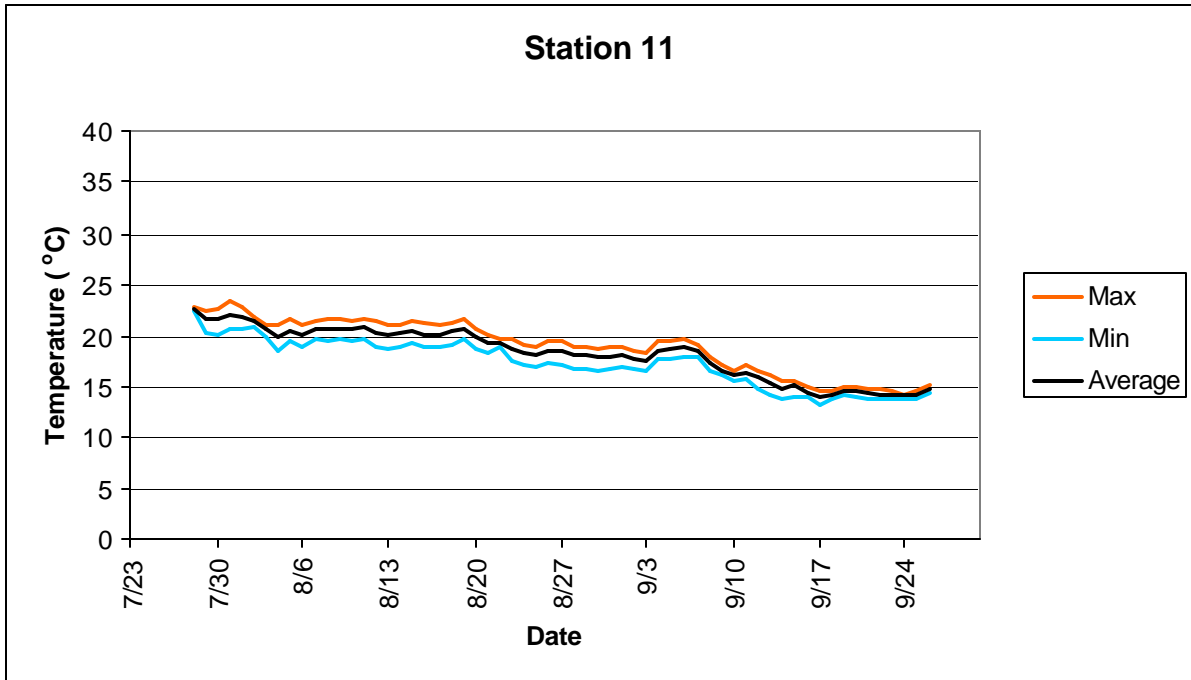
Figure 14. Water temperature recorded at Station 11 (just upstream of Highway 97 Bridge).

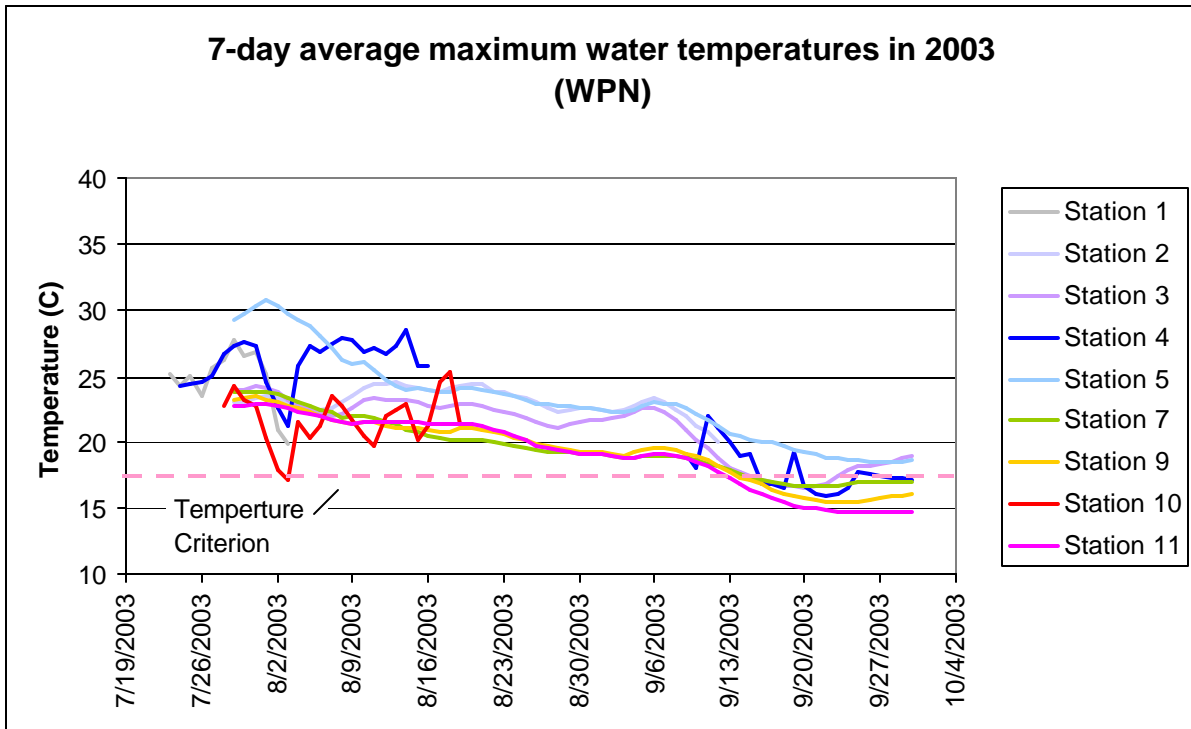
Figure 15. Seven day average maximum water temperature at locations on Swale Creek monitored by this project in 2003.

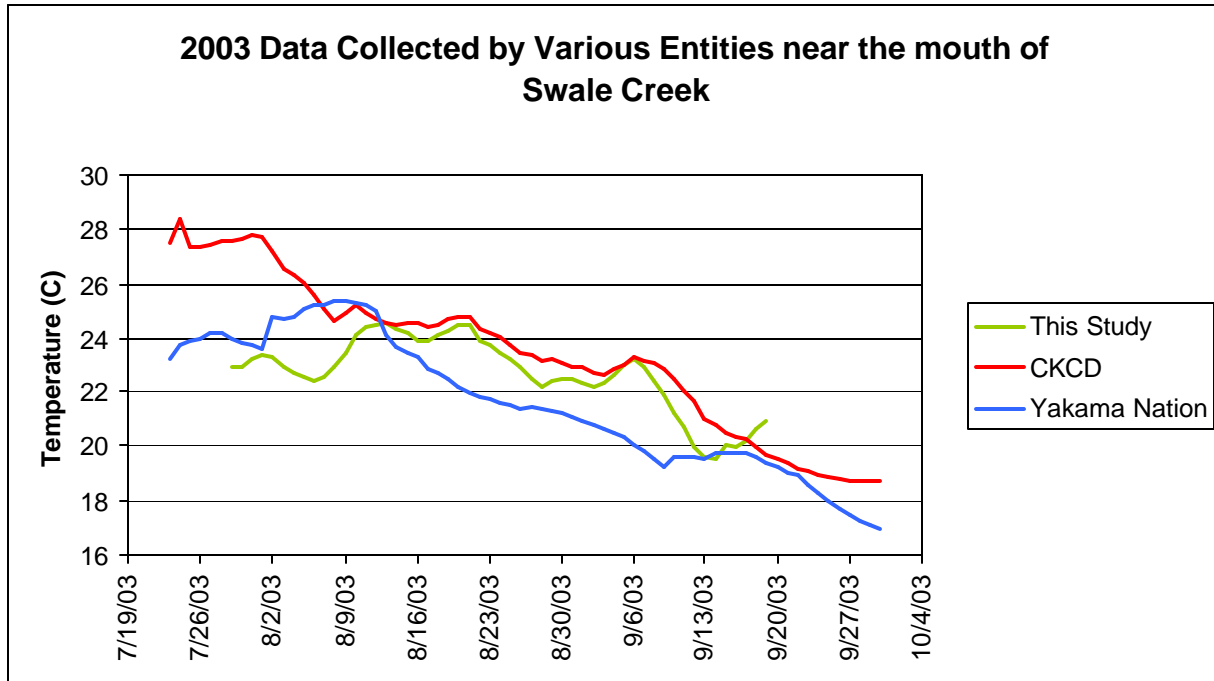
Figure 16. Comparison of data collected in 2003 near the mouth of Swale Creek by this study, the Yakama Nation, and CKCD.

It should be noted that the three sets of data collected at Harms Road, near the mouth of Swale Creek and at Highway 97 (2 sets) were not all collected at precisely the same point. Hence, there are differences in the datasets for similar locations (e.g. Figure 16). These differences likely reflect differences in site characteristics such as water depth, wind speed, and shade. The CKCD site and the plot for this study plotted in Figure 16 were roughly 0.75 miles apart. The Yakama Nation site was further downstream than the other two sites.

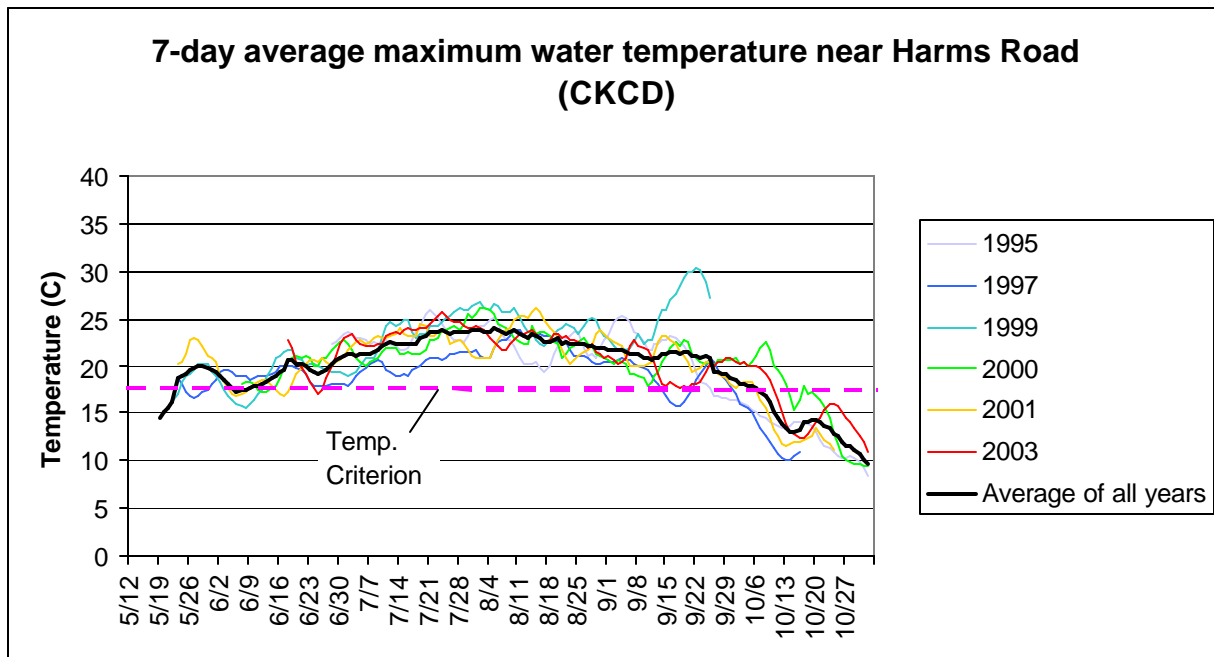
Figure 17. Six years of 7-day averages of the daily maximum temperatures recorded by CKCD at Site 2 (Harms Road).

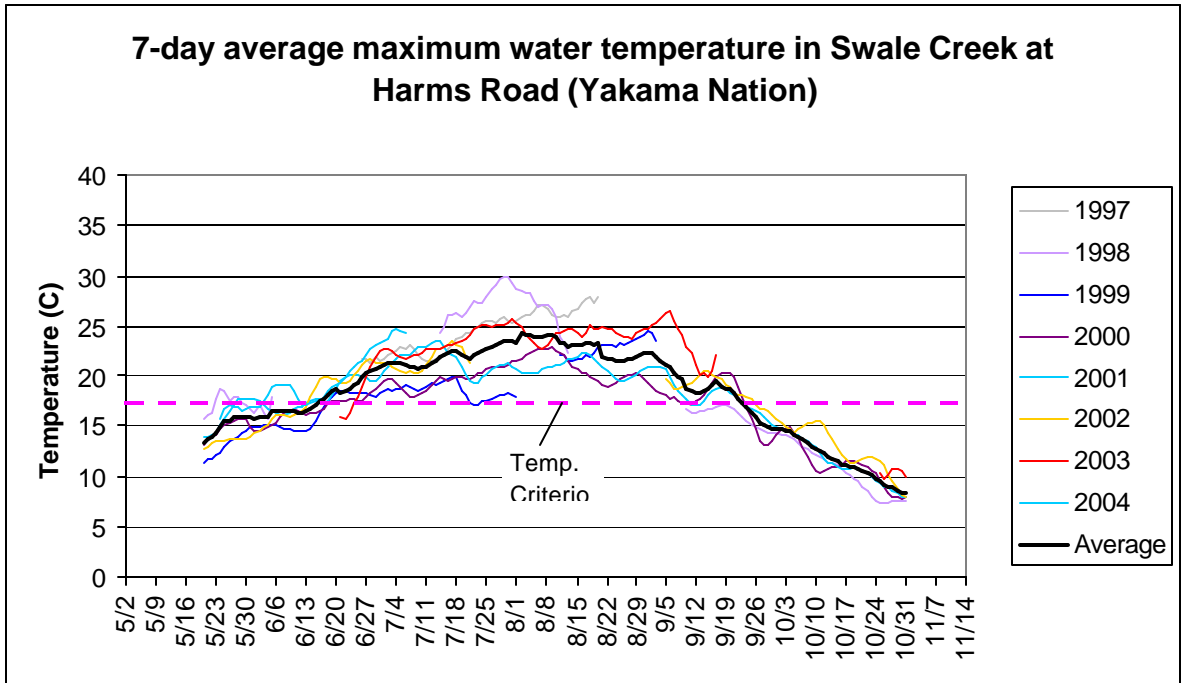
Figure 18. Eight years of 7-day averages of the daily maximum temperatures recorded by the Yakama Nation at Harms Road

The temperature criterion of 17.5 °C was clearly exceeded at all stations monitored in 2003 (Figure 55). From this stand point, 2003 was not unusual. The criterion has been exceeded in all years of monitoring from 1995 to present (Figures 18 and 19). Inter-annual variability was not as high as expected. The differences between years were smaller than the differences within years (Figures 18 and 19).

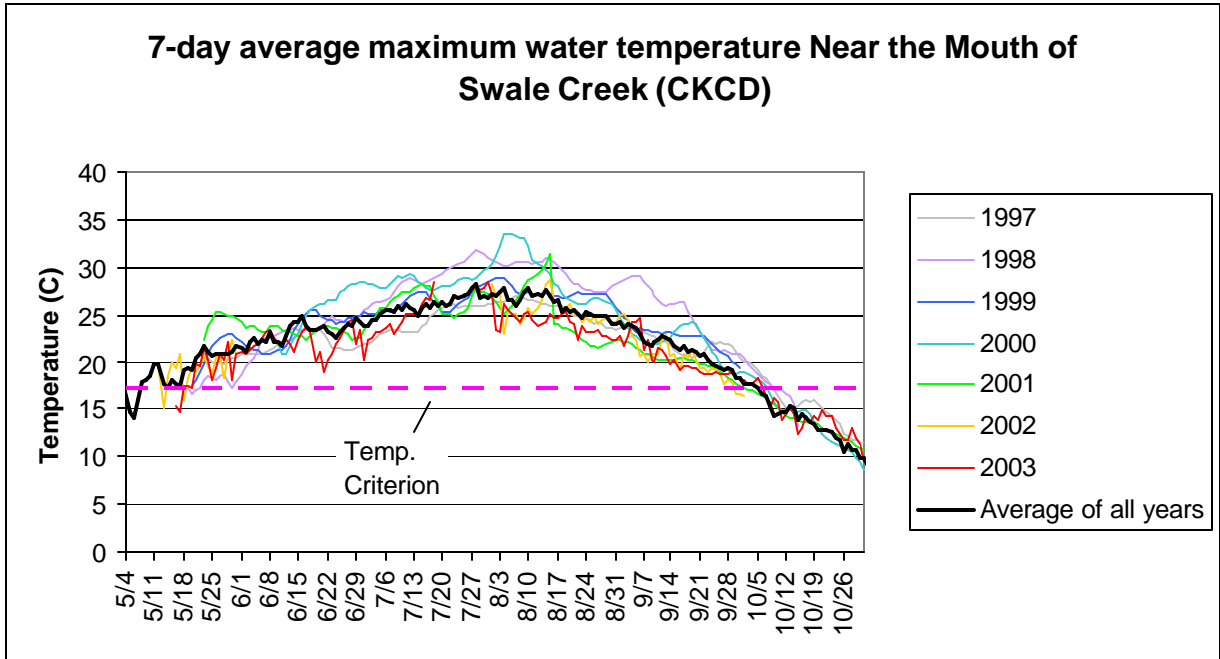
Figure 19. Seven years of 7-day averages of the daily maximum temperatures recorded by CKCD at Site 3.

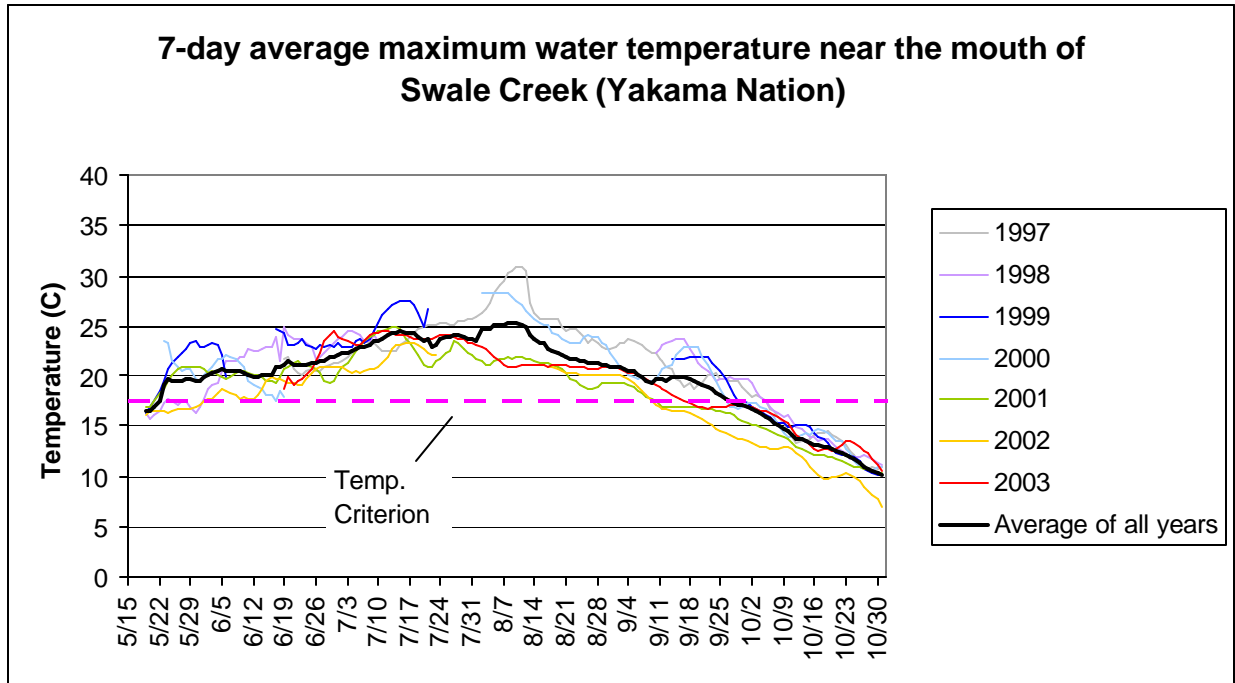
Figure 20. Seven years of 7-day averages of the daily maximum temperatures recorded by the Yakama Nation at the mouth of Swale Creek.

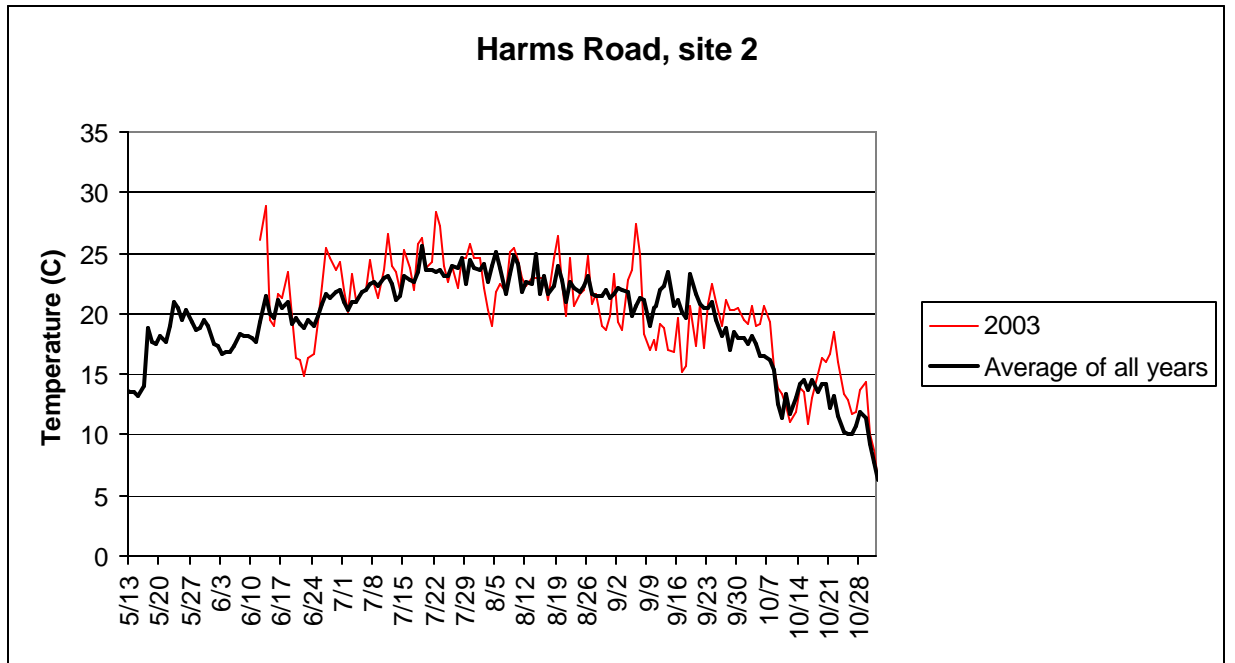
Figure 21. Comparison of 2003 daily maximum water temperature with the average daily maximum temperature from 1995 through 2003 at CKCD's Site 2 (Harms Road).

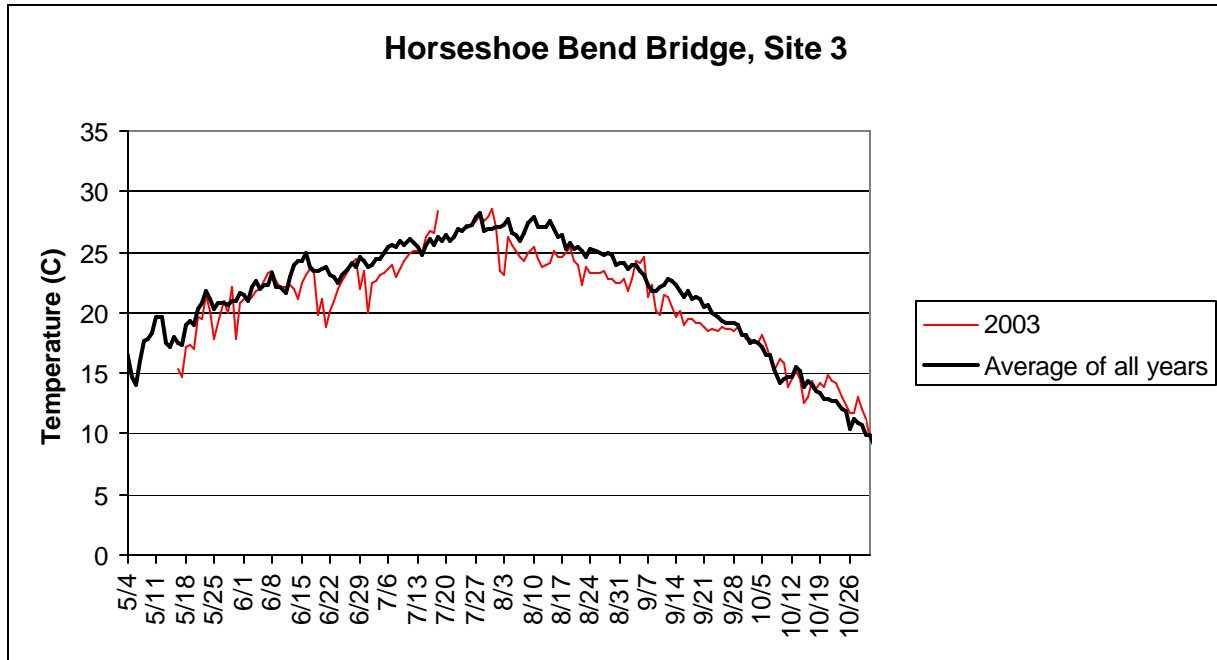
Figure 22. Comparison of 2003 daily maximum water temperature with the average daily maximum temperature from 1995 through 2003 at CKCD's Site 3 (Horseshoe Bend Bridge).

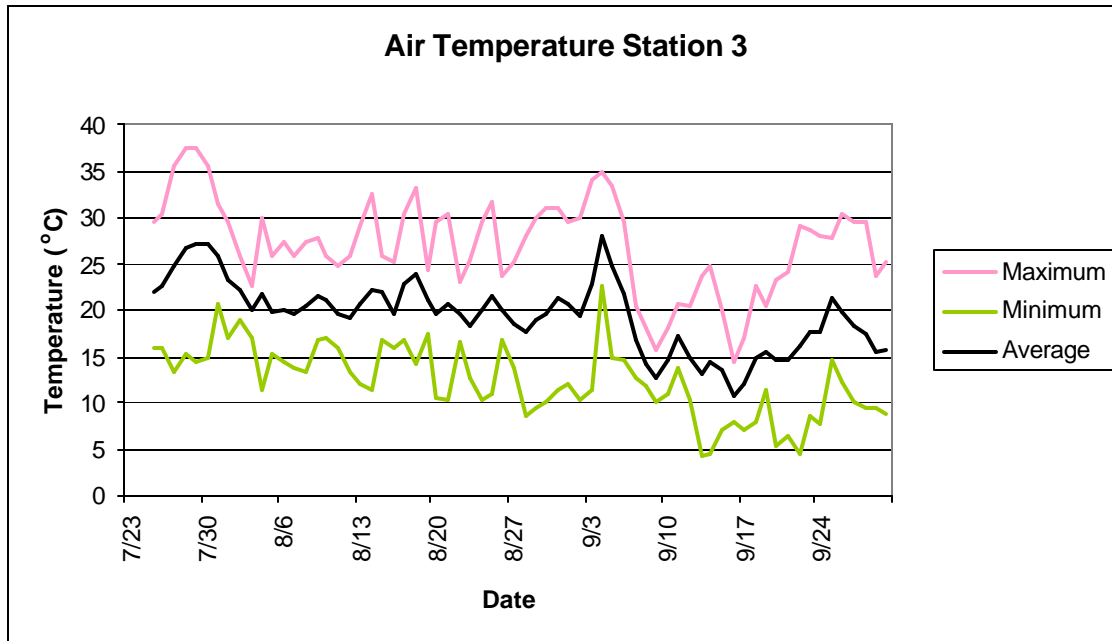
Figure 23. Air temperature recorded in 2003 at water temperature monitoring station 3.

Air temperature and humidity was monitored at Stations 3 and 4. A third monitoring device malfunctioned and no data were retrieved. Air temperatures decreased gradually throughout the summer (Figures 23 and 24) and ranged between roughly 5 and 40 °C. No seasonal pattern was apparent in the humidity data (Figures 25 and 26). Humidity varied from close to 0 to 90%.

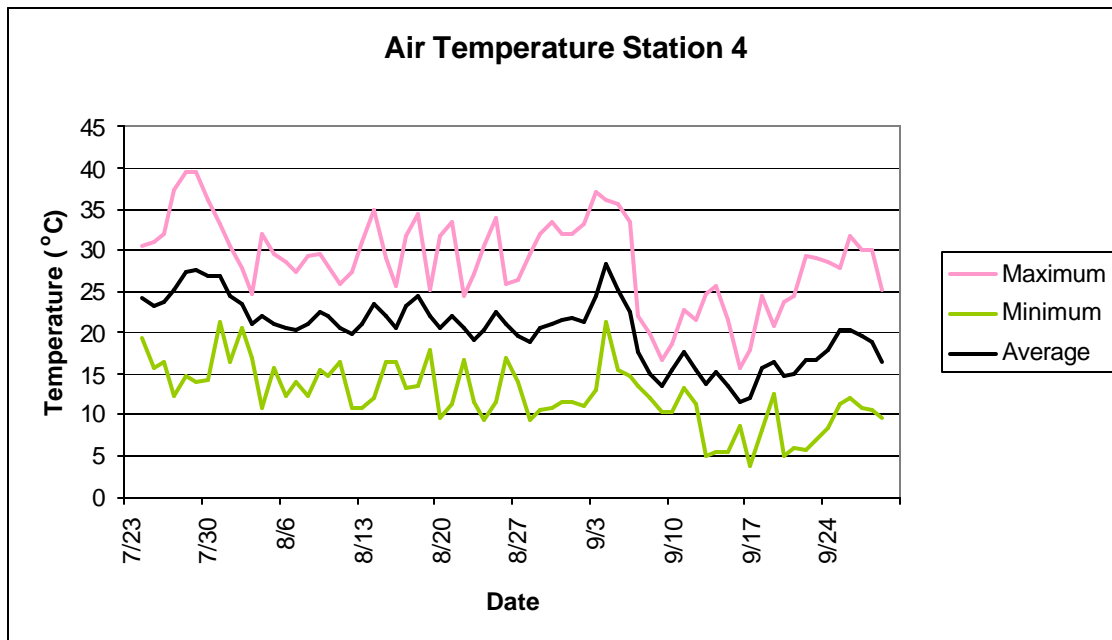
Figure 24. Air temperature recorded in 2003 at water temperature monitoring station 4.

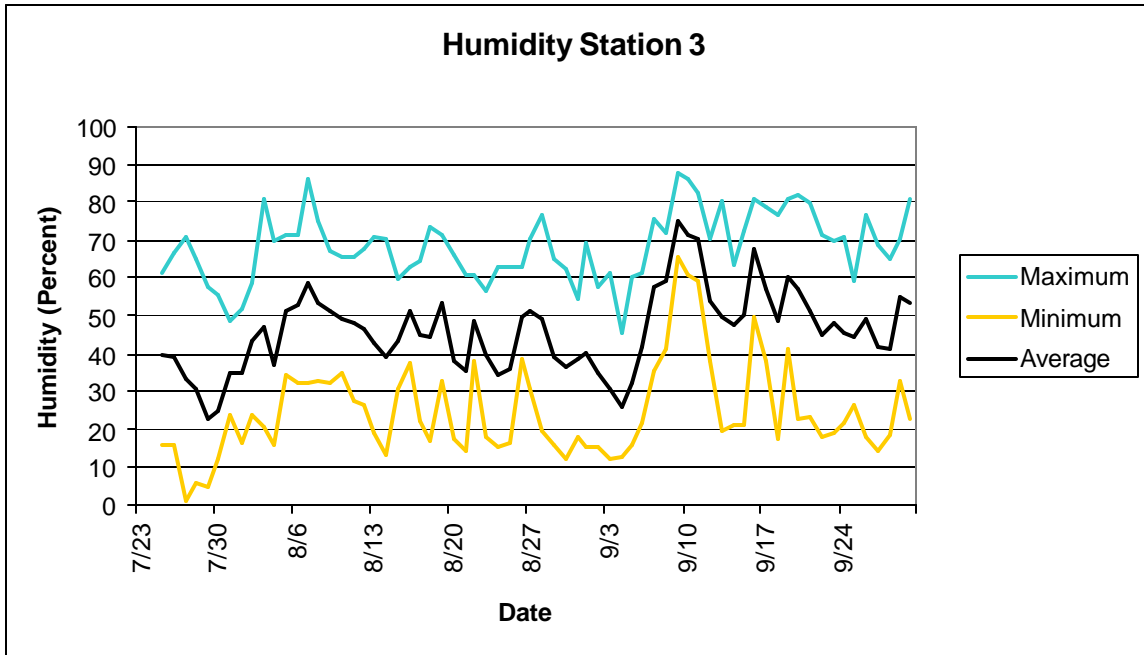
Figure 25. Humidity recorded in 2003 at water temperature monitoring station 3.

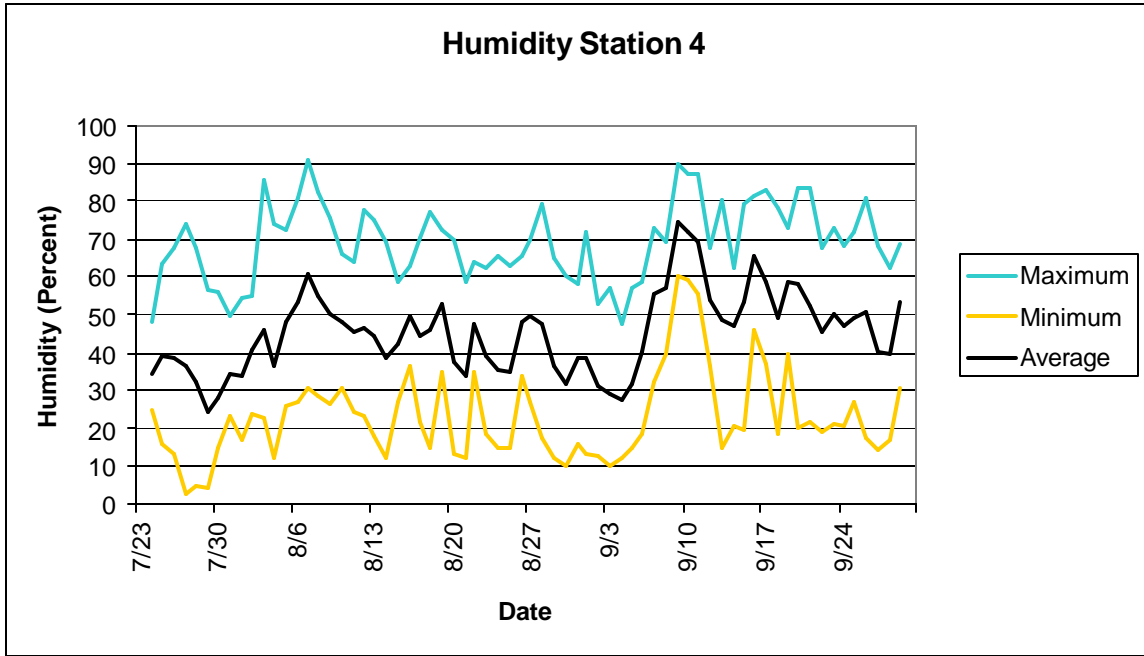
Figure 26. Humidity recorded in 2003 at water temperature monitoring station 4.

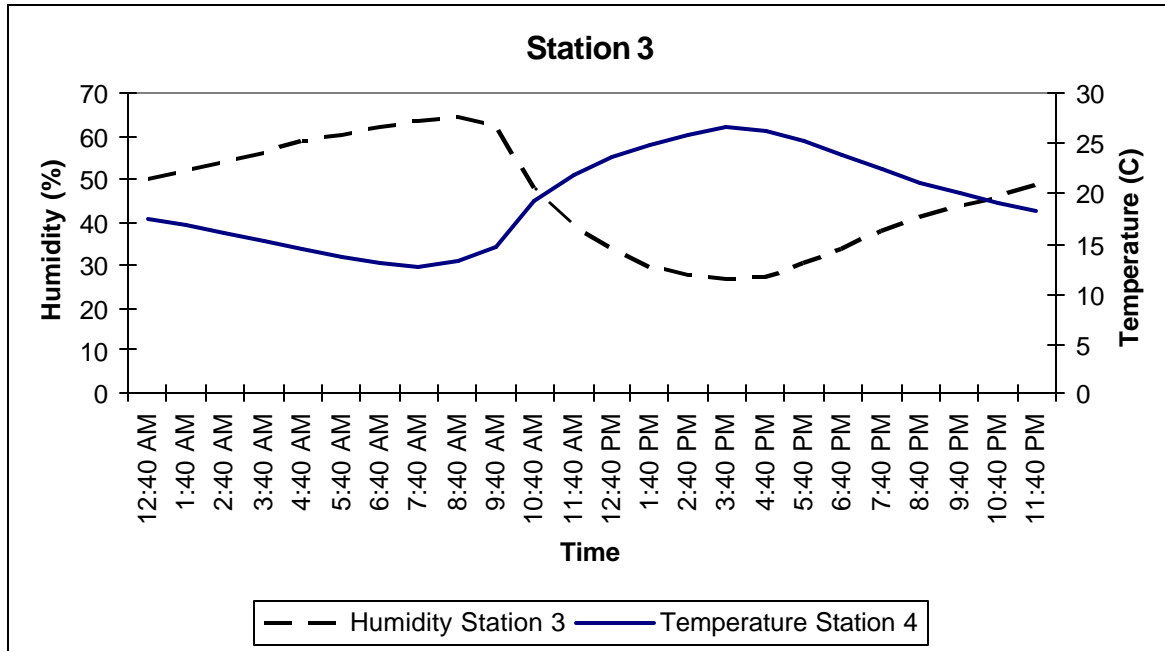
Figure 27. Average diel (day to night) air temperature and humidity patterns at Station 3.

Both air temperature and humidity vary considerably over the day. Air temperature and humidity tend to be inversely correlated. Humidity increases at night as air temperatures decrease and then decreases in day as the air warms (Figures 27 and 28).

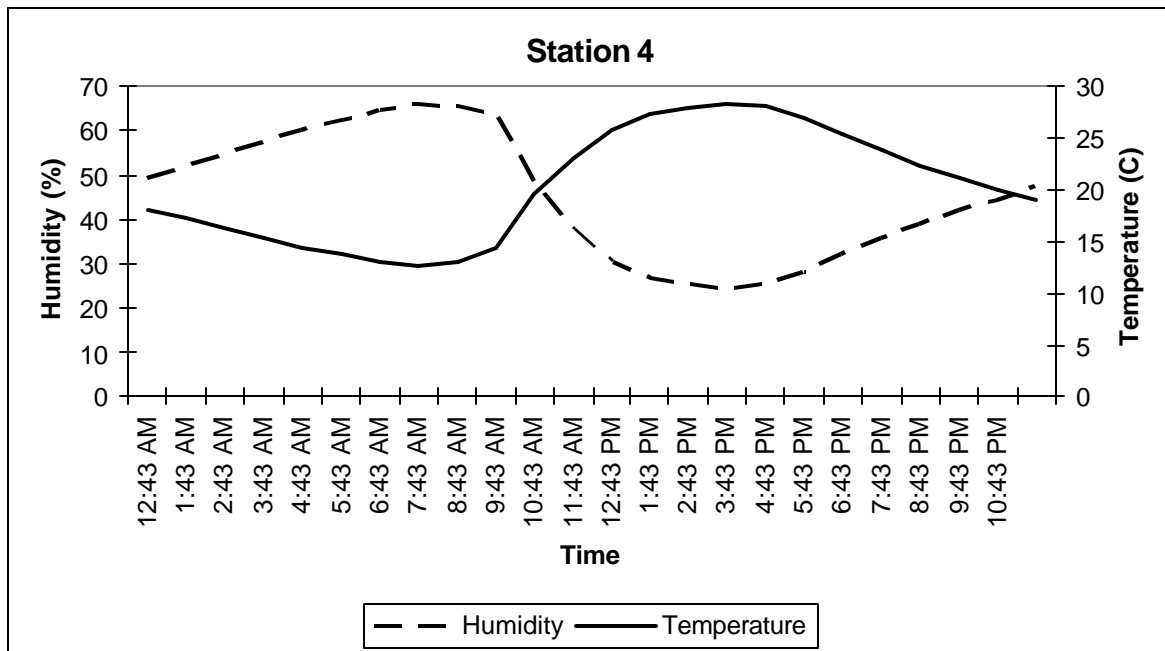
Figure 28. Average diel (day to night) air temperature and humidity patterns at Station 4.

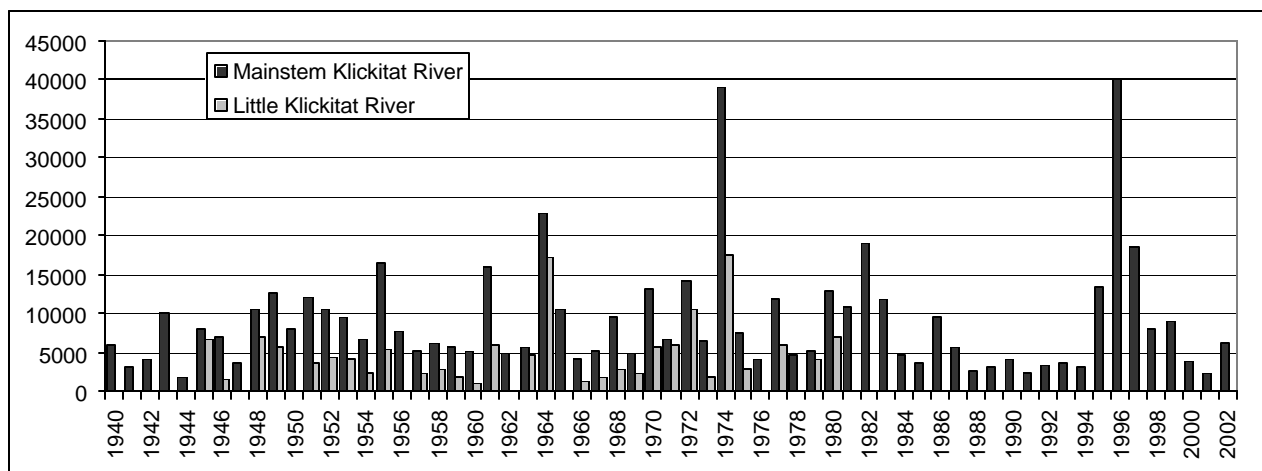
Figure 31. Annual peak flows in the mainstem Klickitat River near Pitt and the Little Klickitat River near Wahkiacus (source: USGS; <http://nwis.waterdata.usgs.gov/nwis>).

No stream gage data are available for Swale Creek. Major storm events recorded at the gage on the Little Klickitat River might be a reasonable indicator of when storm events occurred in the Swale Creek basin; however, the gaging of the Little Klickitat River ended in the 1980s. The mainstem Klickitat River near Pitt has a better period of record. The magnitude of peak flows in the Little Klickitat River is not always well correlated to the magnitude of peak flows in the mainstem (Figure 31). This likely reflects the difference in the primary source of flows between the rivers. The mainstem derives the majority of its flow from the Cascade Mountains, while the Little Klickitat flows originate in the Simcoe Mountains. Nevertheless, major events tended to occur in the same year in both drainages (Table 6). Major events likely also occurred in the same years in Swale Creek, although the relative magnitude of those events is unknown.

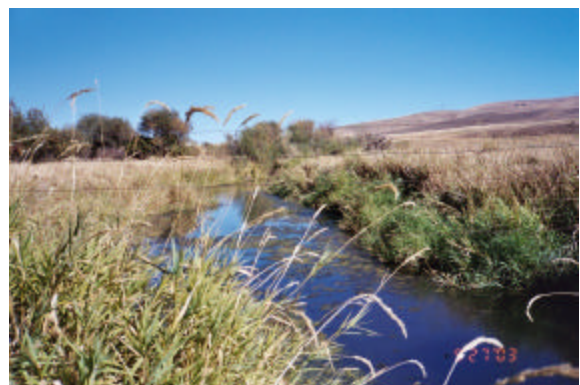
Figure 32. Upstream of Highway 97.

Grasses dominate most of the upper reaches of Swale Creek, although shrubs dominate in a few locations. The lack of water in summer limits riparian vegetation development along the creek. A small canyon-like area with alder (*Alnus sinuata*) and some aspen (*Populus tremuloides*) is located upstream of Highway 97 (Figure 32). Downstream of Highway 97, Swale Creek alternates between

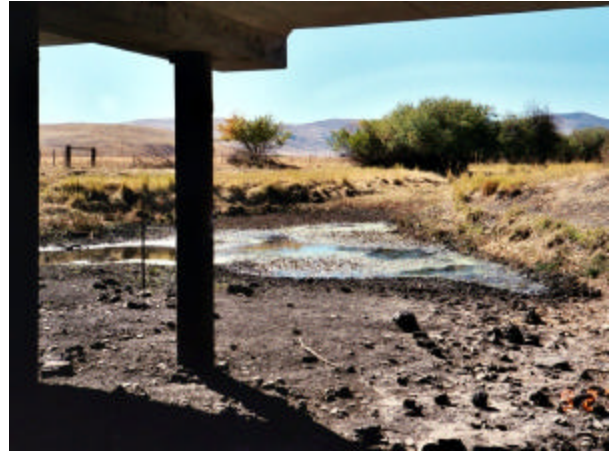
Figure 33. Reach 1 from under Uecker Bridge.

grass and sedge dominated and shrub dominated riparian areas (Figure 33). Willows (*Salix sp.*) are the primary species in the shrub dominated areas. Shade is limited to small stands of willow and alder in a few places. In the shaded places, canopy closure is 60% or less.

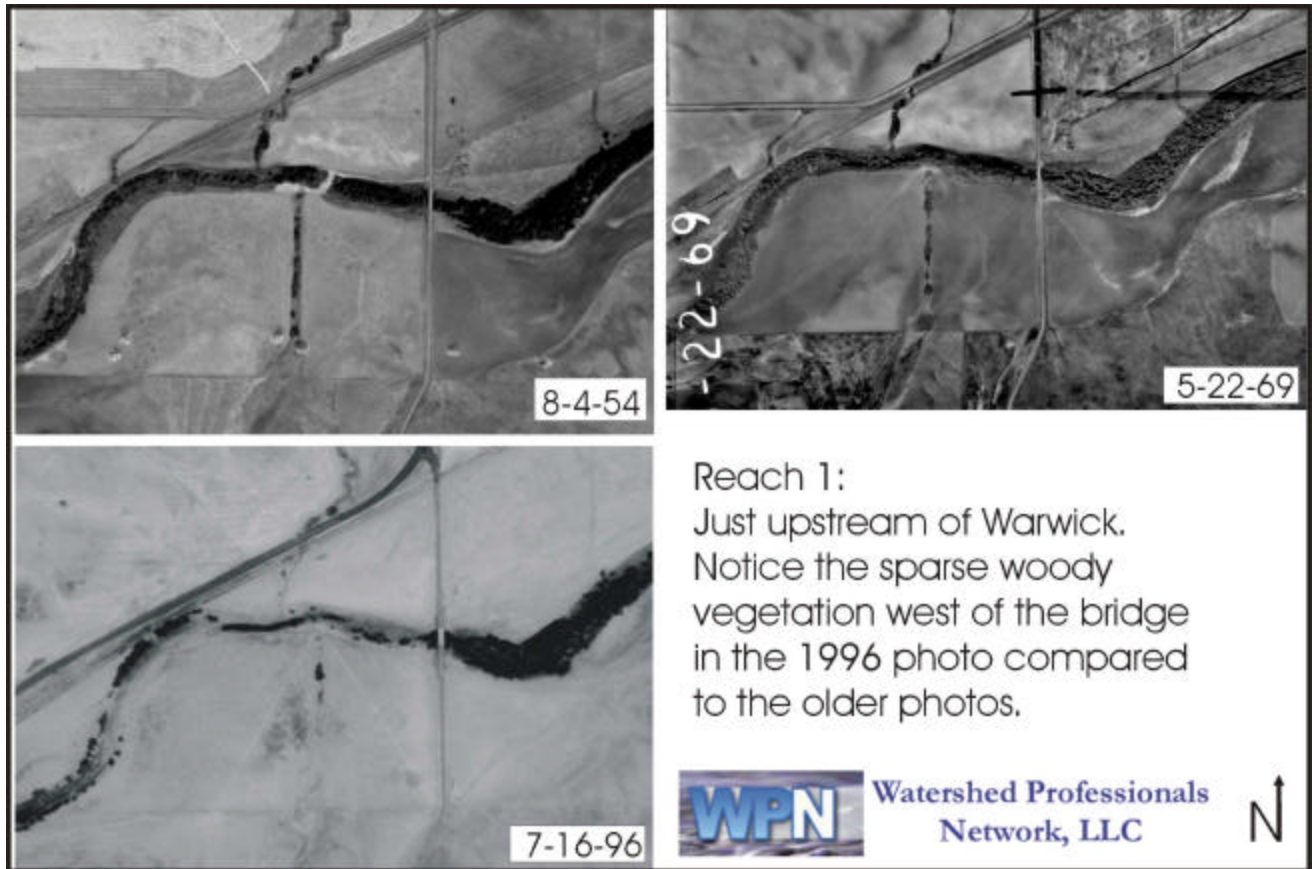
Figure 34. Aerial photographs of reach 1 just upstream of Warwick taken in 1954, 1969, and 1996.

photos remain in 1996, but the brushier vegetation has decreased substantially. This could be the result of intentional clearing or grazing. The photos would indicate that the potential exists to grow taller vegetation along the existing channel configuration, such as willows and alder, adjacent to perennial pools. The cadastral surveys of 1860, however, indicate a paucity of woody vegetation at section lines along this reach (Section 4.4).

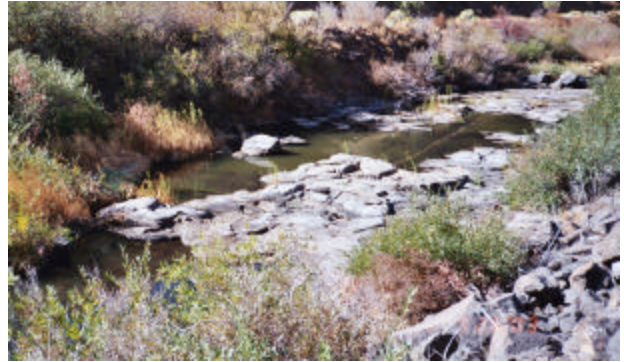
Figure 35. Reach 2, upper canyon.

Just downstream of Warwick, Swale Creek descends into a canyon. The creek is confined to basalt pools (Table 7), with occasional areas of narrow flow trickling between the pools. Vegetation is found only where there is available water (Figure 35). Willow stands are found near seeps and pools. Most of the dry bedrock stretches have no vegetation (Figure 37). Canopy closure is typically low (<20%) in the few shaded locations (Figure 36).
