SWALE CREEK WATER TEMPERATURE STUDY

Klickitat County Planning Unit

Watershed Professionals Network, LLC

September 30, 2004

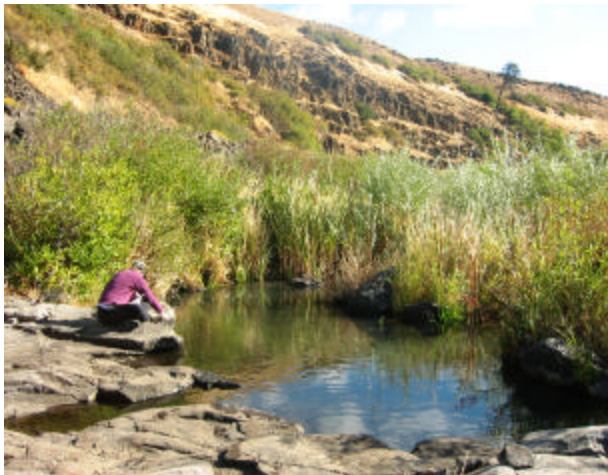
Figure 37. Reach 2, lower end, showing typical shade where vegetation is present.

Just downstream of Warwick, Swale Creek descends into a canyon. The creek is confined to basalt pools (Table 7), with occasional areas of narrow flow trickling between the pools. Vegetation is found only where there is available water (Figure 35). Willow stands are found near seeps and pools. Most of the dry bedrock stretches have no vegetation (Figure 37). Canopy closure is typically low (<20%) in the few shaded locations (Figure 36).

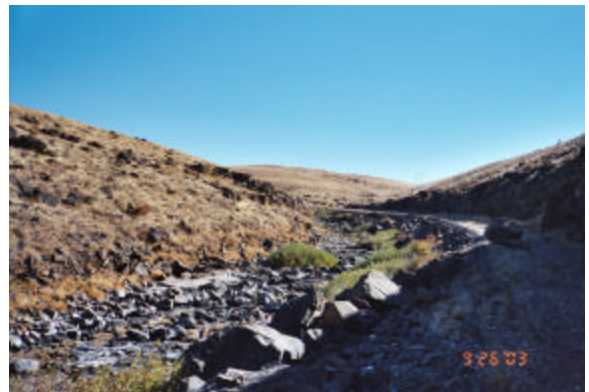
Figure 36. Swale Creek Reach 2 (upper canyon).

In this reach, the potential composition of riparian vegetation under the current channel configuration would not be much different than current vegetation (Figure 36): willow, and riparian grasses. However, there is potential for higher density of vegetation around pools resulting in somewhat shadier conditions.

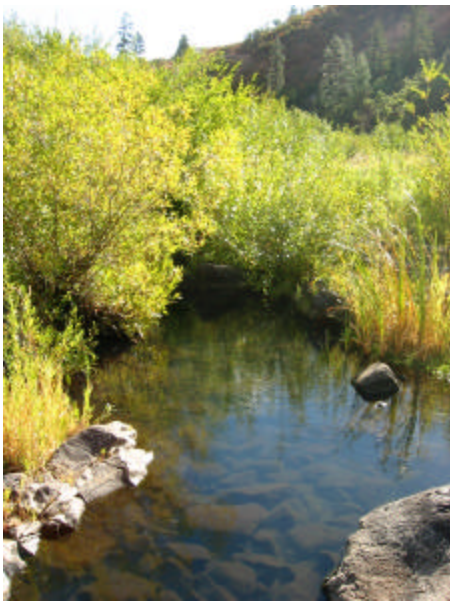
Figure 39. Vegetation around pool in Reach 3.

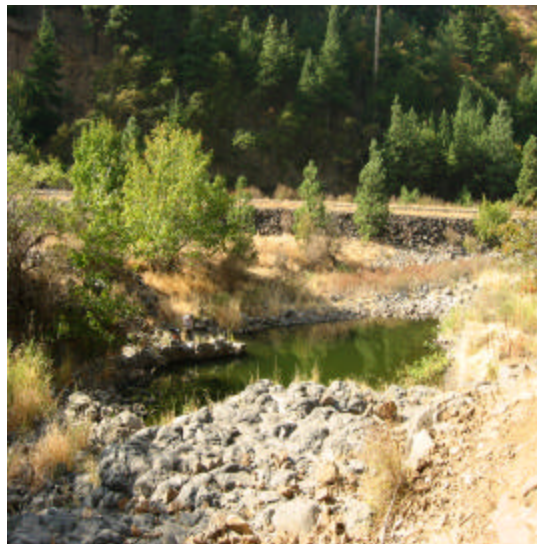
Figure 40. Example of dry cobble with little vegetation in Reach 3.

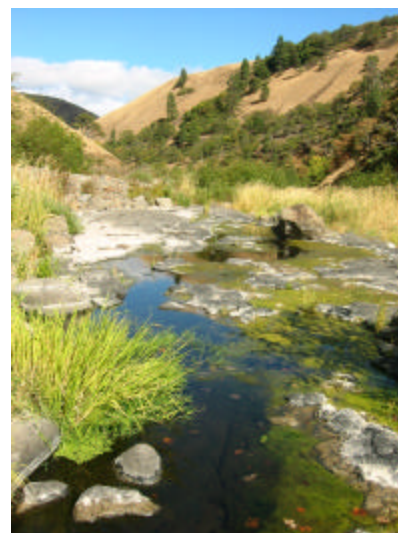
Figure 41. Basalt pool in reach 3.

Swale Creek makes a 90-degree turn to north, and downstream of that turn the vegetation begins to shift. Like reach 2, the creek is confined to basalt pools (Table 8, Figure 41), often with a narrow stream trickling between the pools. There are long stretches with little or no vegetation along stretches of dry bed of cobble (Figure 39). Vegetation is again associated with moisture availability. Vegetation is most found most commonly adjacent to perennial pools but is absent where bedrock outcrops exist. Vegetation, where present, is dominated by alder, willows and reed-canary grass (*Phalaris arundinaceae*) (Figure 40). Big leaf maple (*Acer macrophyllum*) is occasionally found in drainage area and near seeps. This pattern of shaded to non-shaded conditions continues for nearly 4 miles. In the few shaded places, density of vegetation may reach up to 55% cover.

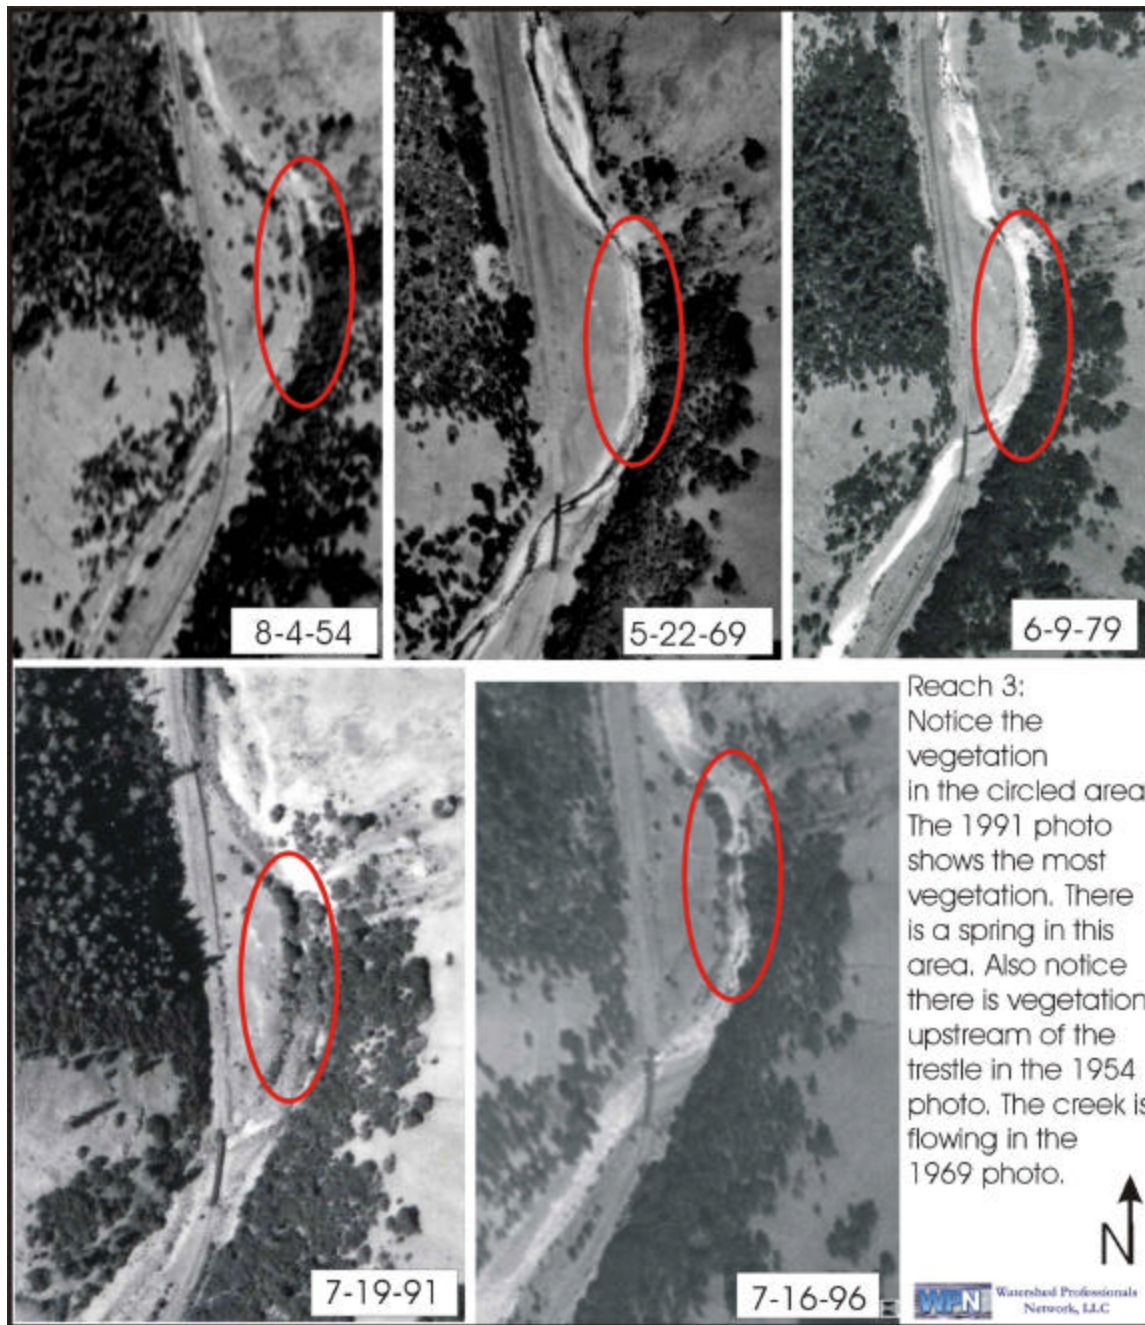
Figure 42. Aerial photos (1954, 1969, 1979, 1991, and 1996) of a stretch of reach 3 demonstrating substantial changes in riparian vegetation over time.

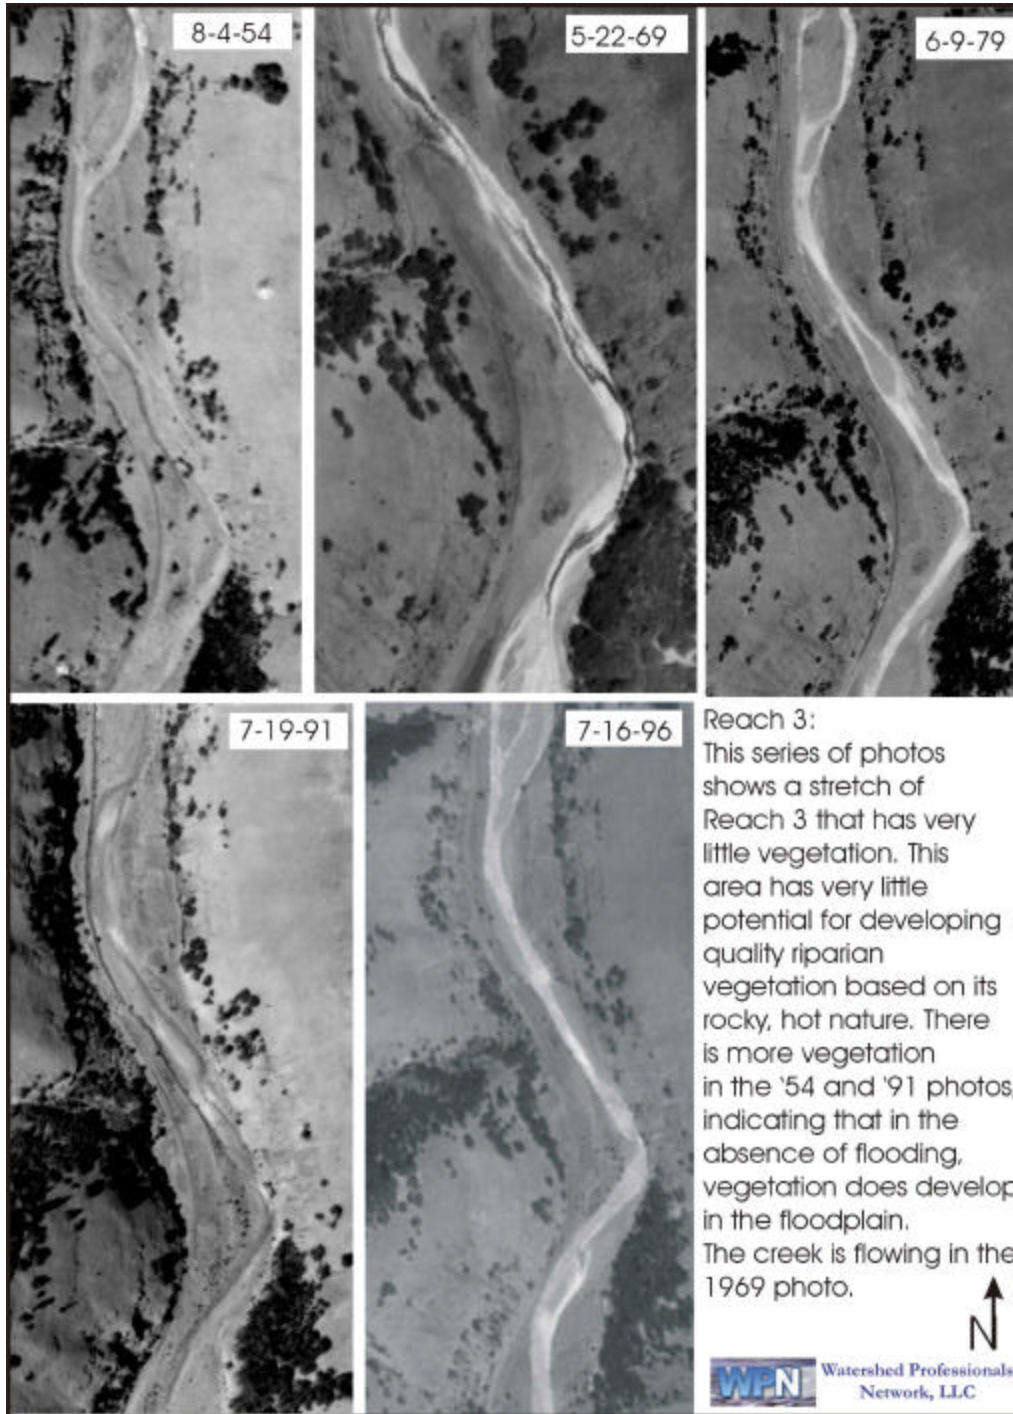
Figure 43. Aerial photos from 1954, 1969, 1979, 1991, and 1996 of an unstable channel within reach 3 where riparian vegetation is consistently low.

Figure 43 provides an example of an area within reach 3 where the riparian vegetation has changed very little since the mid-1950s. In general, this area has very little riparian vegetation. The potential for high quality riparian vegetation to develop in these types of areas is low. The photos also indicate a great deal of shifting of the channel between photos. Between 1954 and 1969, the upper portion of the channel in the photos changed dramatically, and then, between 1969 and 1979, the channel returned to a path close to its 1954 channel. Between years, there is also a considerable amount of shift in side channels and bars. This is obviously an area of the channel that is highly unstable. Channel movements have contributed to the lack of riparian vegetation through time in this area.

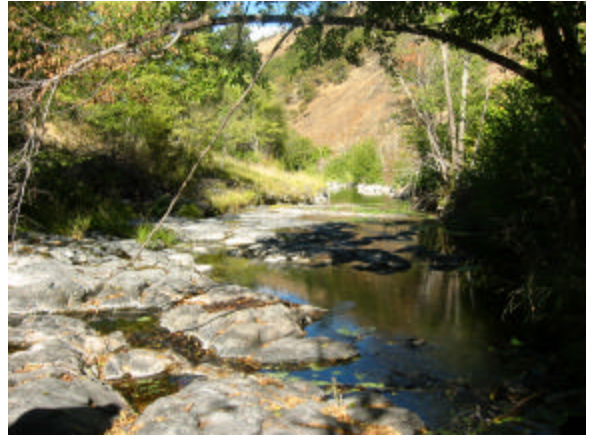
Figure 44. Riparian stands along Reach 4.

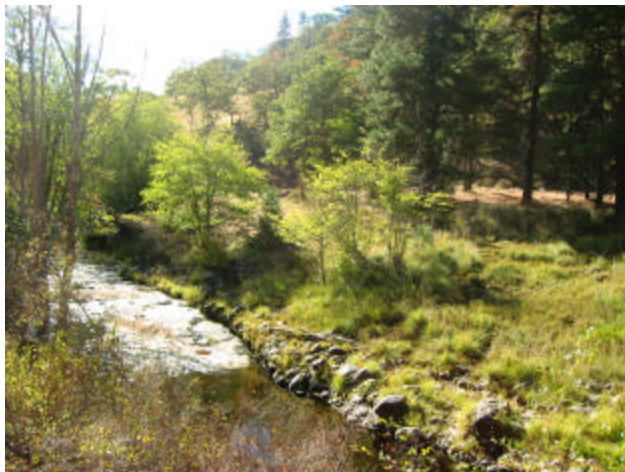
Figure 45. Portion of reach 4 with shading on one side of creek.

In reach 4, Swale Creek makes a wide sweeping turn to the west. It is in this turn that regular stream flow begins to appear, along with alders, willows and reed-canary grass. There are big leaf maple along the creek here, as well as a higher diversity of vegetation including mock orange (*Philadelphus lewisii*), water birch (*Betula occidentalis*), cottonwood (*Populus trichocarpa*) and rose (*Rosa sp.*). Swale Creek continues to flow along its westerly course, maintaining stands of alder along its banks. This area has nearly continuous shading under long stands of alder with a wider floodplain area in places (Figure 44). The creek itself is wide in places, creating non-shaded conditions at the center of the creek. Vegetation can reach densities of 100% cover in many areas (Figure 45). Frequently, only one side of the creek is highly shaded (Figure 46) resulting in the average cover listed in Table 9.

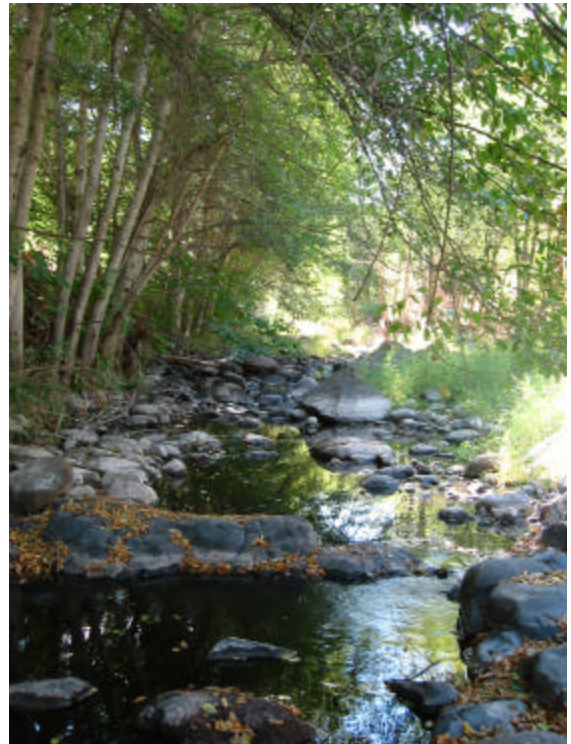
Figure 46. Portion of Reach 4 with nearly 100% shade.

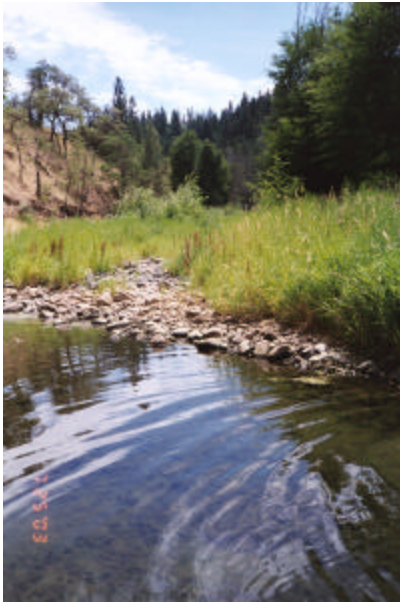
Figure 48. Photo of Reach 5.

As the creek nears Horseshoe Bend Bridge at Wahkiacus, flow disappears again into stretches of dry cobble. Alders and willows still line the banks, but shade is lower (Figure 48). Downstream of Horseshoe Bend Bridge, there is a group of young cottonwoods. Further downstream, the vegetation is dominated by grasses, mainly reed-canary grass. Near its mouth, Swale Creek again disappears into a stretch of dry cobble with no vegetation which continues to the creek's confluence with the Klickitat River (Figure 49, Table 10).

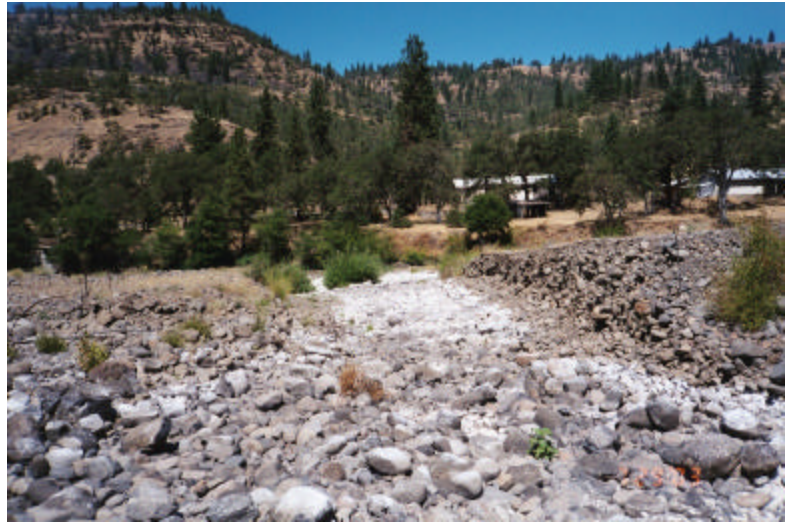
Figure 49. Reach 5 near confluence with Klickitat River.

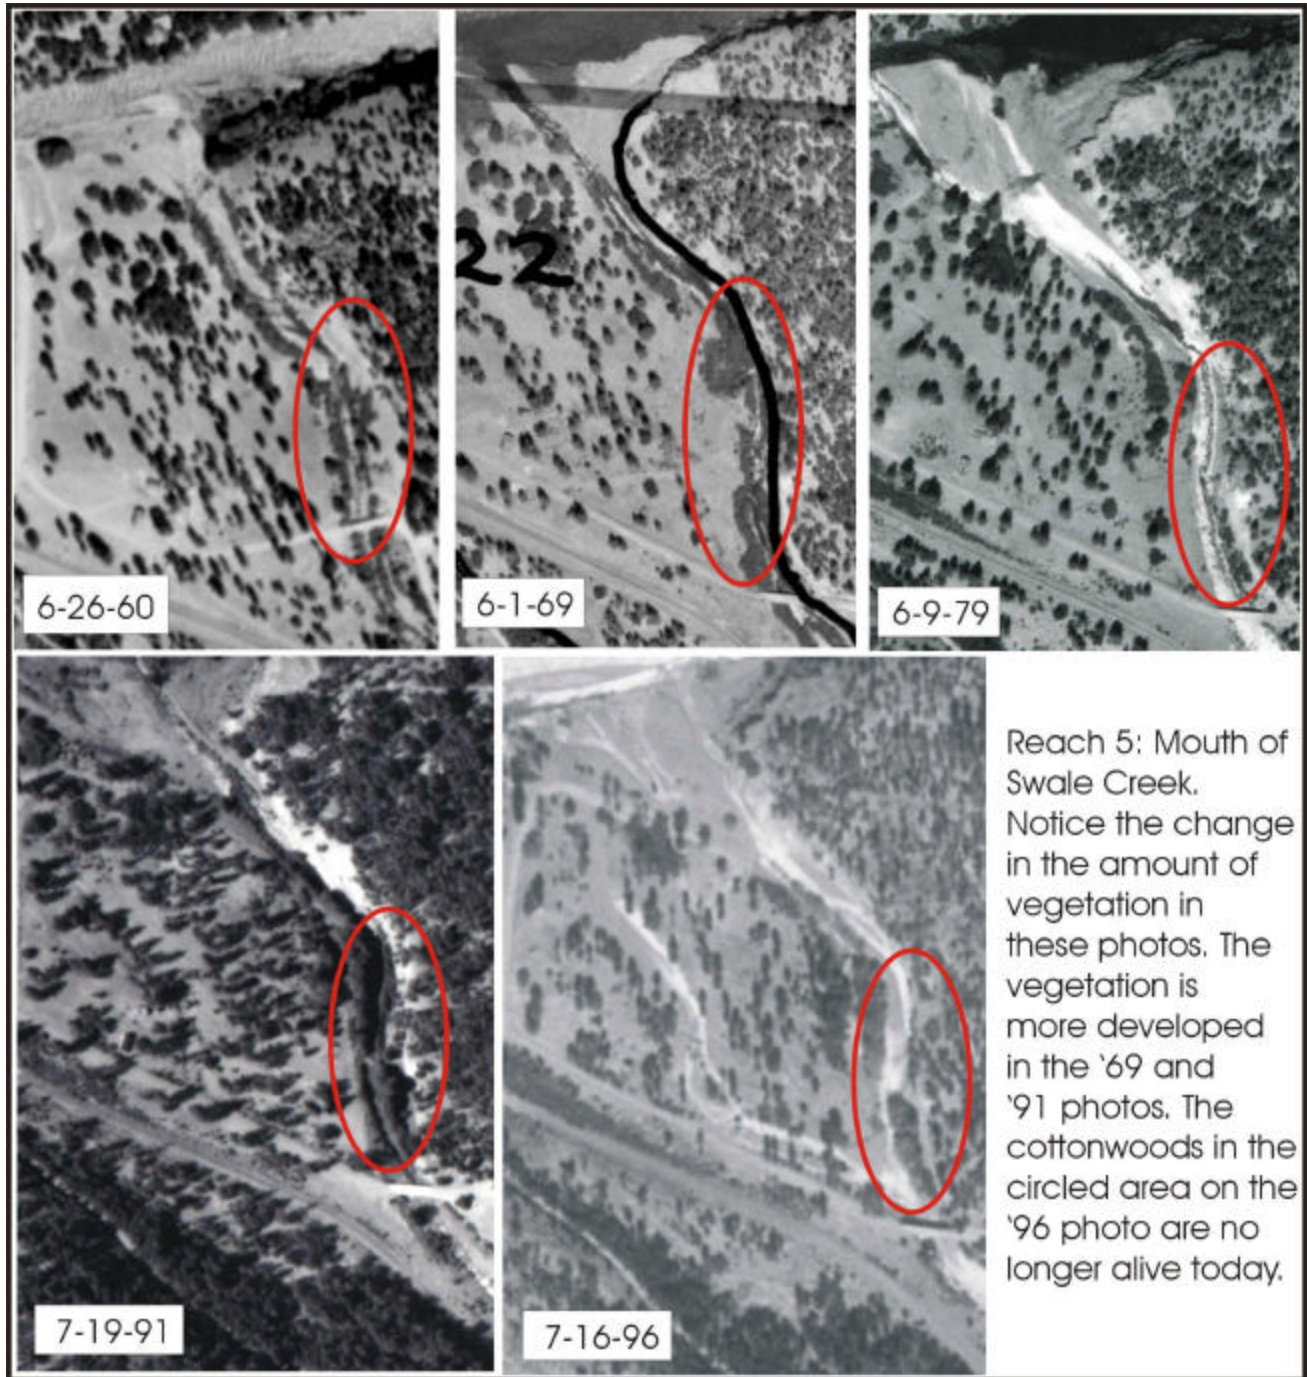
Figure 50. Aerial photos of Reach 5 in 1960, 1969, 1979, 1991, and 1996.

In this reach, riparian vegetation is a mixture of alder, cottonwood, big leaf maple, birch, willow, and riparian grasses. There is a long stretch of bare cobble near the mouth where there is potential for vegetation development with some soil deposition. The aerial photographs from reach 5 show vegetation almost all the way to the confluence in the 1969 photograph. The area near the mouth, however, is a depositional area that will be subject to disturbance by flood events over time. Hence, the riparian vegetation in this area will tend to be dynamic; maturing between flood events and then reduced in density during floods.

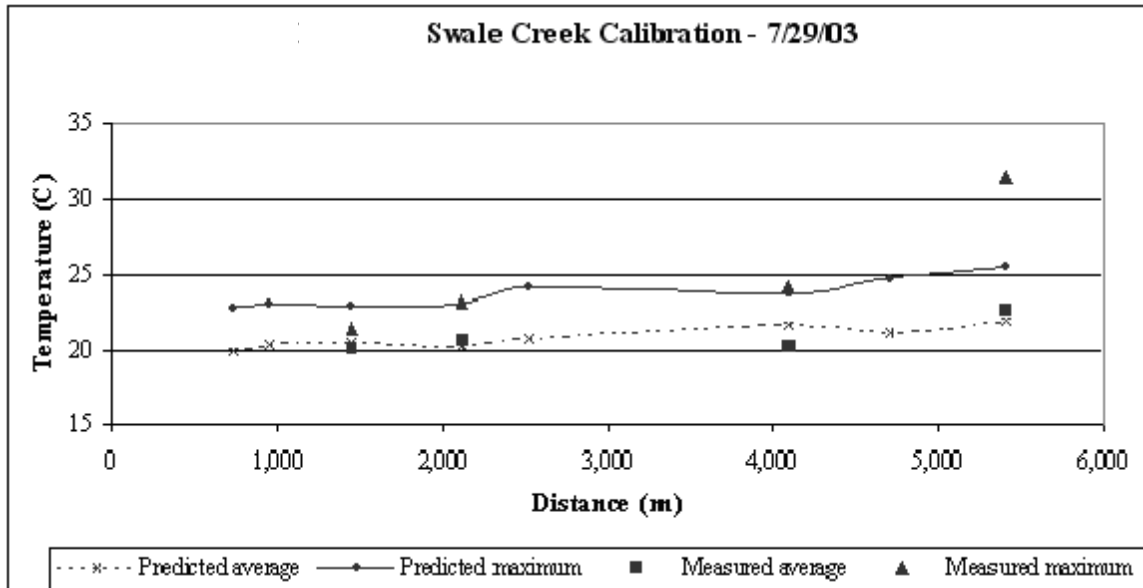
Figure 51. Swale Creek calibration for the data of 7/29/03 showing the actual measured data and the data predicted by the Heat Source model.

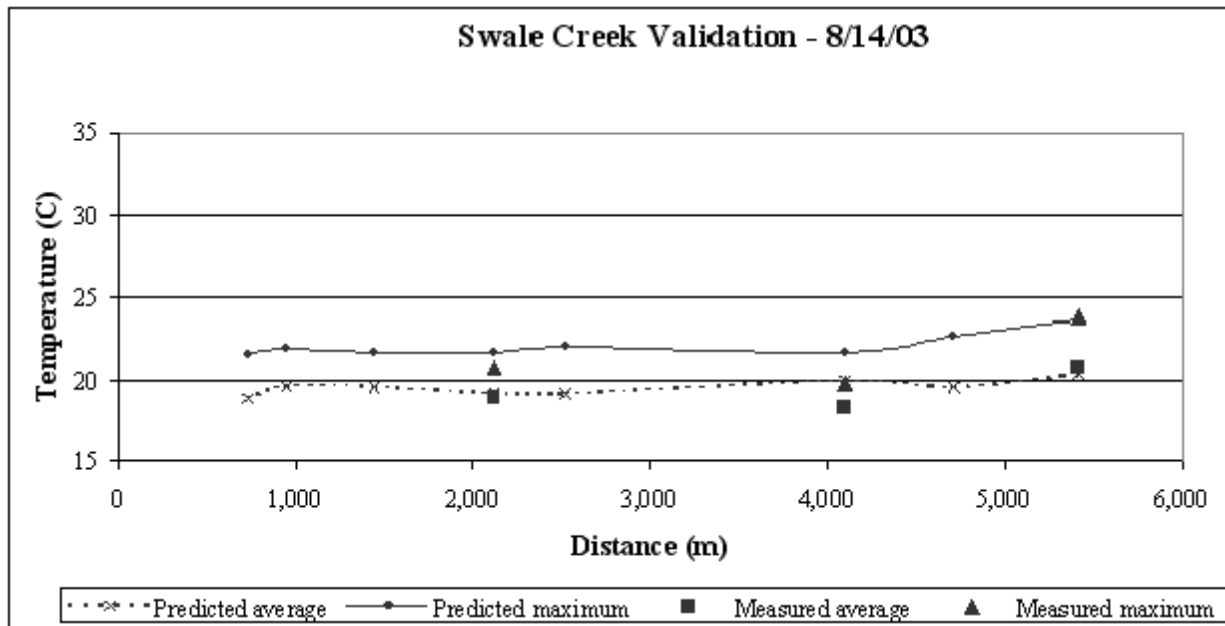
Figure 52. Validation of the calibrated Heat Source model for Swale Creek.

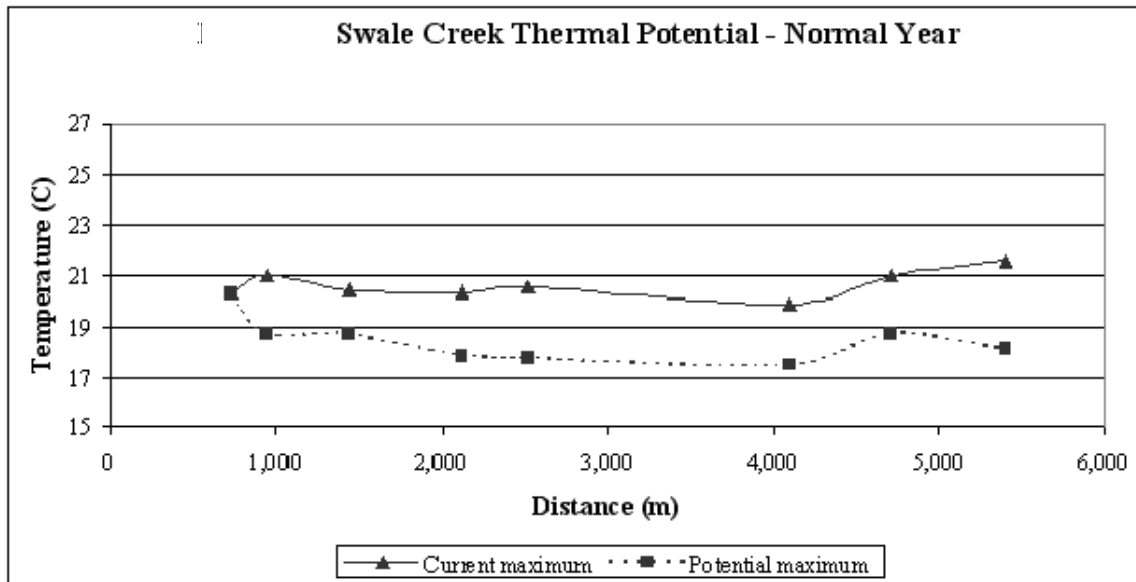
Figure 53. Predicted stream temperature in reach 4 in a normal year under maximum possible shade.

Potential vegetative conditions were input to the model to estimate natural thermal potential for both a normal year and for an unusual year. In both cases, natural thermal potential was evaluated for the date of July 29; the results of these comparisons are illustrated in Figures 53 and 54.

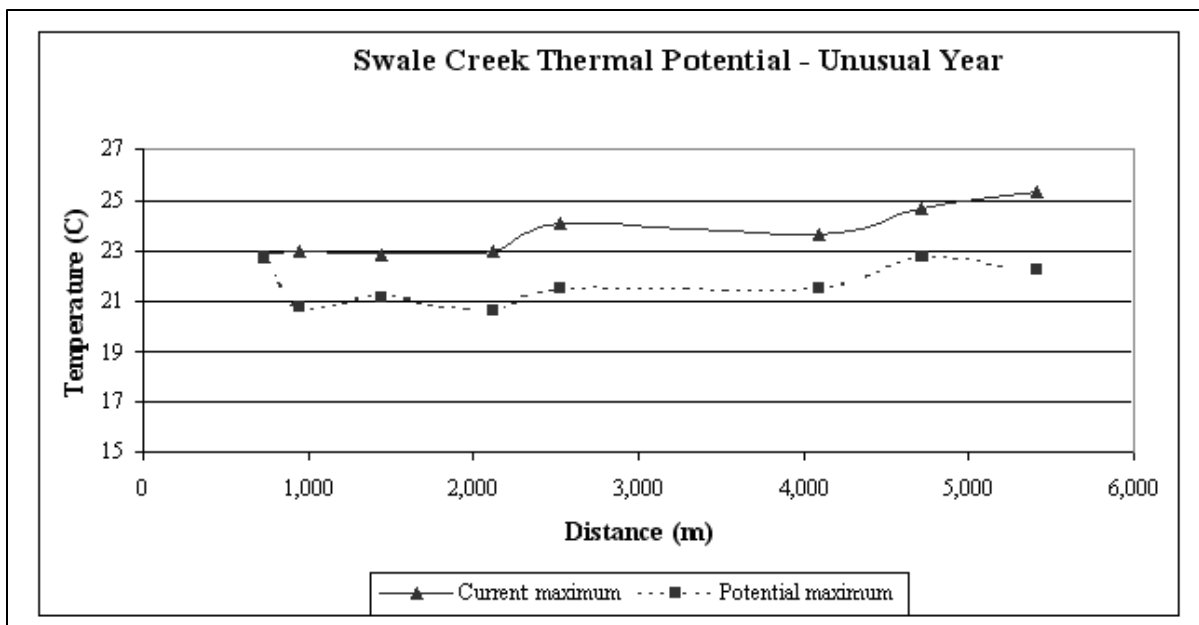
Figure 54. Predicted stream temperature in reach 4 in an unusual year under maximum possible shade.

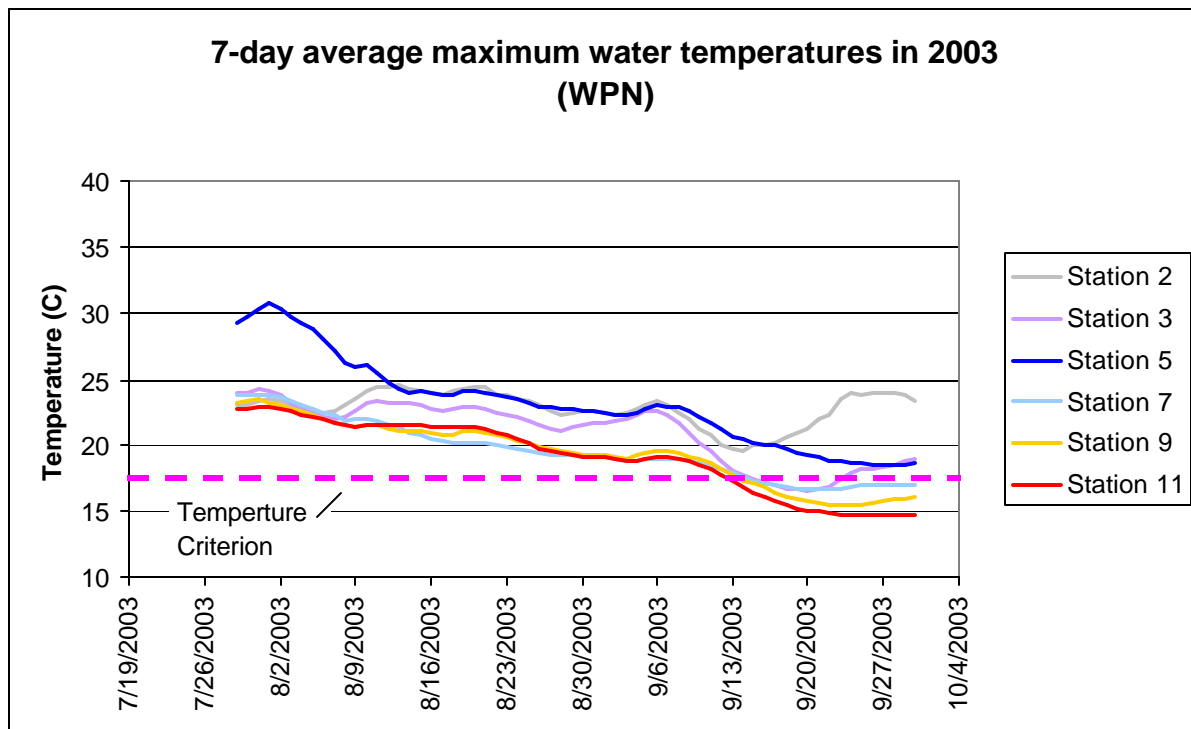
Figure 55 . Maximum daily temperatures at all monitoring sites in 2003. The Stations represented by warmer colors (5, 7, and 9) are within reach 4, the reach that has higher vegetation and continuous water. The rest of the sampling sites were collected in disconnected pools.

The temperature criterion of 17.5 °C was clearly exceeded at all stations monitored in 2003 (Figure 55). From this stand point, 2003 was not unusual. The criterion has been exceeded in all years of monitoring from 1995 to present (Figures 18 and 19). Inter-annual variability was not as high as expected. The differences between years were smaller than the differences within years (Figures 18 and 19).
