Chapter 5. Fish Habitat Assessment

Figure 5-1
SALMONID DISTRIBUTION
WRIA31 Watershed Planning
Benton, Klickitat and Yakima Counties, WA

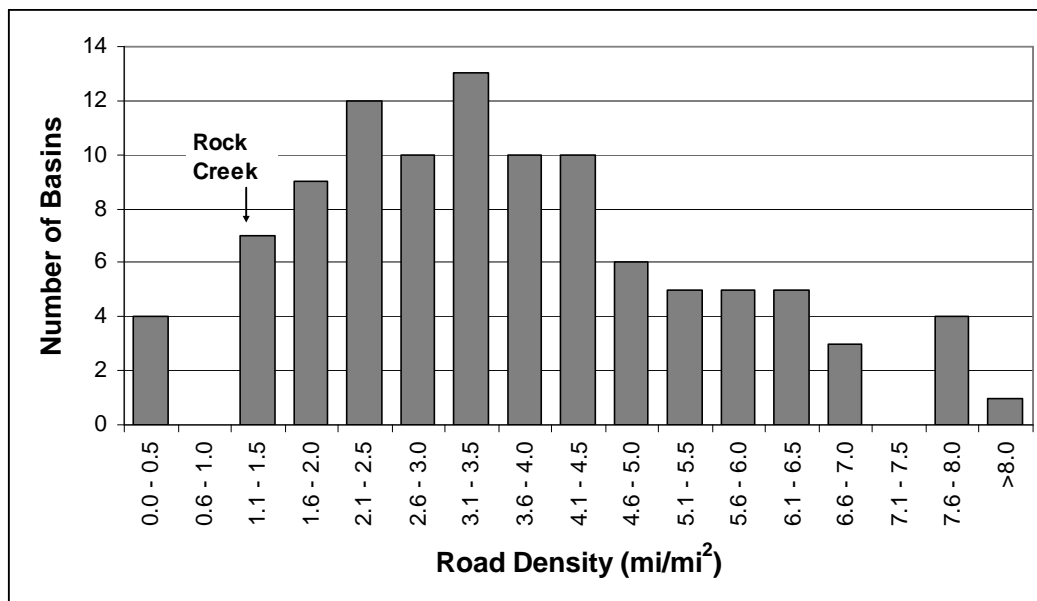
Figure 5-4. Road Density in Basins on the Eastside of Washington State. Data compiled from watershed analyses completed under the Washington Department of Natural Resources' Watershed Analysis Methodology. The road density in Rock Creek basin is 1.5 miles per square mile.

Coe (2004) found that connectivity to the stream network is influenced by precipitation. The mean annual precipitation in Rock Creek is 16.2 inches (Chapter 2). At this precipitation, the data provided by Coe would indicate that, on average, less than 10

percent of the road system would be expected to be connected to the stream system. This level of connectivity is lower than that present in any study of road effects on hydrology.

The magnitude of effect of roads has been highly variable in studies conducted across the western United States. Effects have ranged from no effect to an increase in peak flows of up to 12 percent. The larger effects were found in smaller basins where both stream density and road density were high. Peak flows were found to increase significantly when road density exceeded 12 miles of road per square mile (Harr et al., 1975), which is substantially higher than the density found in Rock Creek. In general, the relative affect of roads decreases as the magnitude of the storm event increases. Hence, roads are more likely to affect average flows than the major peak events (Coe 2004). Given the magnitude of effects found in other studies, the low road density in the Rock Creek subbasin, and the configuration of the road system, significant effects on hydrology due to roads is unlikely in this subbasin.

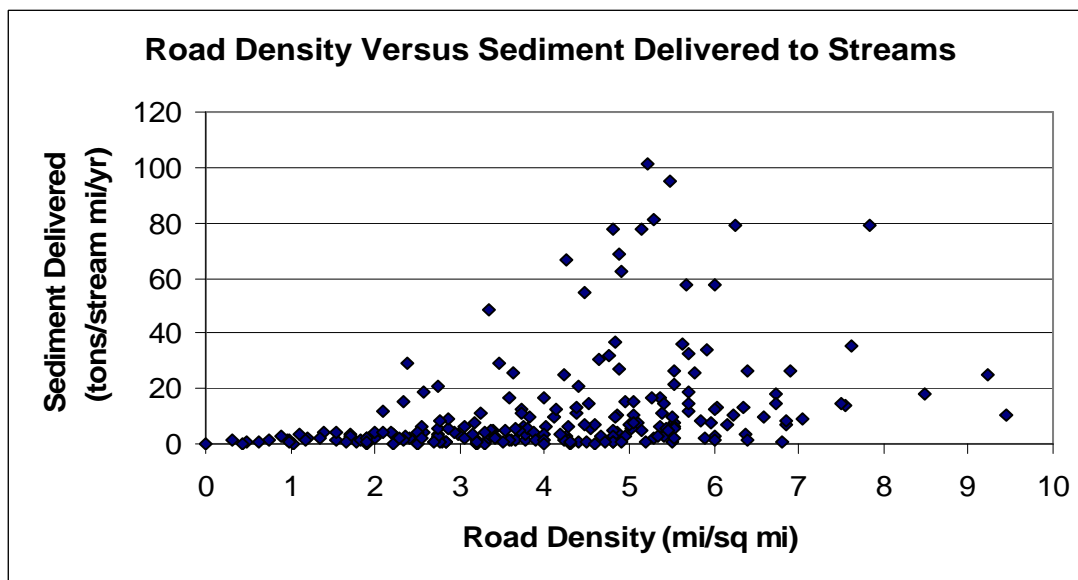
Figure 5-5. Sediment Delivered to Streams as a Function of Road Density. Based on sediment loads estimated using the WDNR watershed analysis methodology (Glass 1999).

Sediment Inputs. Sediment delivered to streams from road systems is a function of the connectivity of the road system to the stream network, the surfacing of the roads, the configuration of the roads, road gradient, and traffic levels (Bilby et al. 1989; Megahan 1974; Megahan and Ketcheson 1996; Reid and Dunne 1984; Sullivan and Duncan 1980; Swift 1984; Vincent 1985). Road density is indirectly related to sediment inputs in that the potential to have significant affects increases with the number of roads present in a basin (Figure 5-5; Glass 1999). As can be seen in Figure 5-5, the quantity of sediment input from high density road systems can range widely. No cases of high sediment loads arising from low density road systems have been documented. At the road density found

in Rock Creek (1.5 mile per square mile), significant basin-scale inputs are unlikely. However, some roads may be locally affecting habitat through erosion of the road bed.

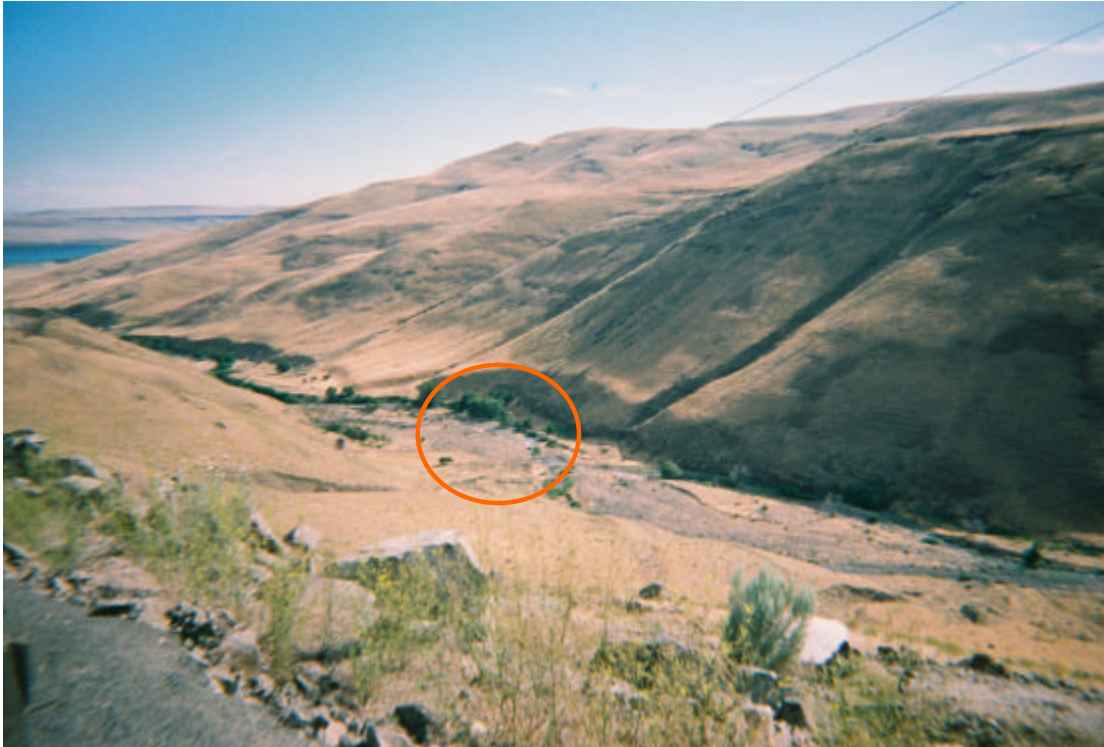
Figure 5-6. Lower Wood Gulch Creek. Note the cluster of trees in the circled area. These grow alongside one of the few pools present in late June 2004.

In late June 2004, the channel was dry with the exception of a few pools. Three pools were observed in the lower 5 miles of the creek. Riparian vegetation is sparse and is most developed in the areas near pools (Figure 5-6). The lowest reach running through Sundale passes near a horse pasture. A hole dug in the ground indicated that water was available roughly 18 inches below the surface, suggesting some subsurface flow of water.
