ROCK CREEK WATER QUALITY REPORT

Water Resource Inventory Area 31

Prepared for: WRIA 31 Planning Unit

Project No. 030009-003-01 • June 22, 2005 Final

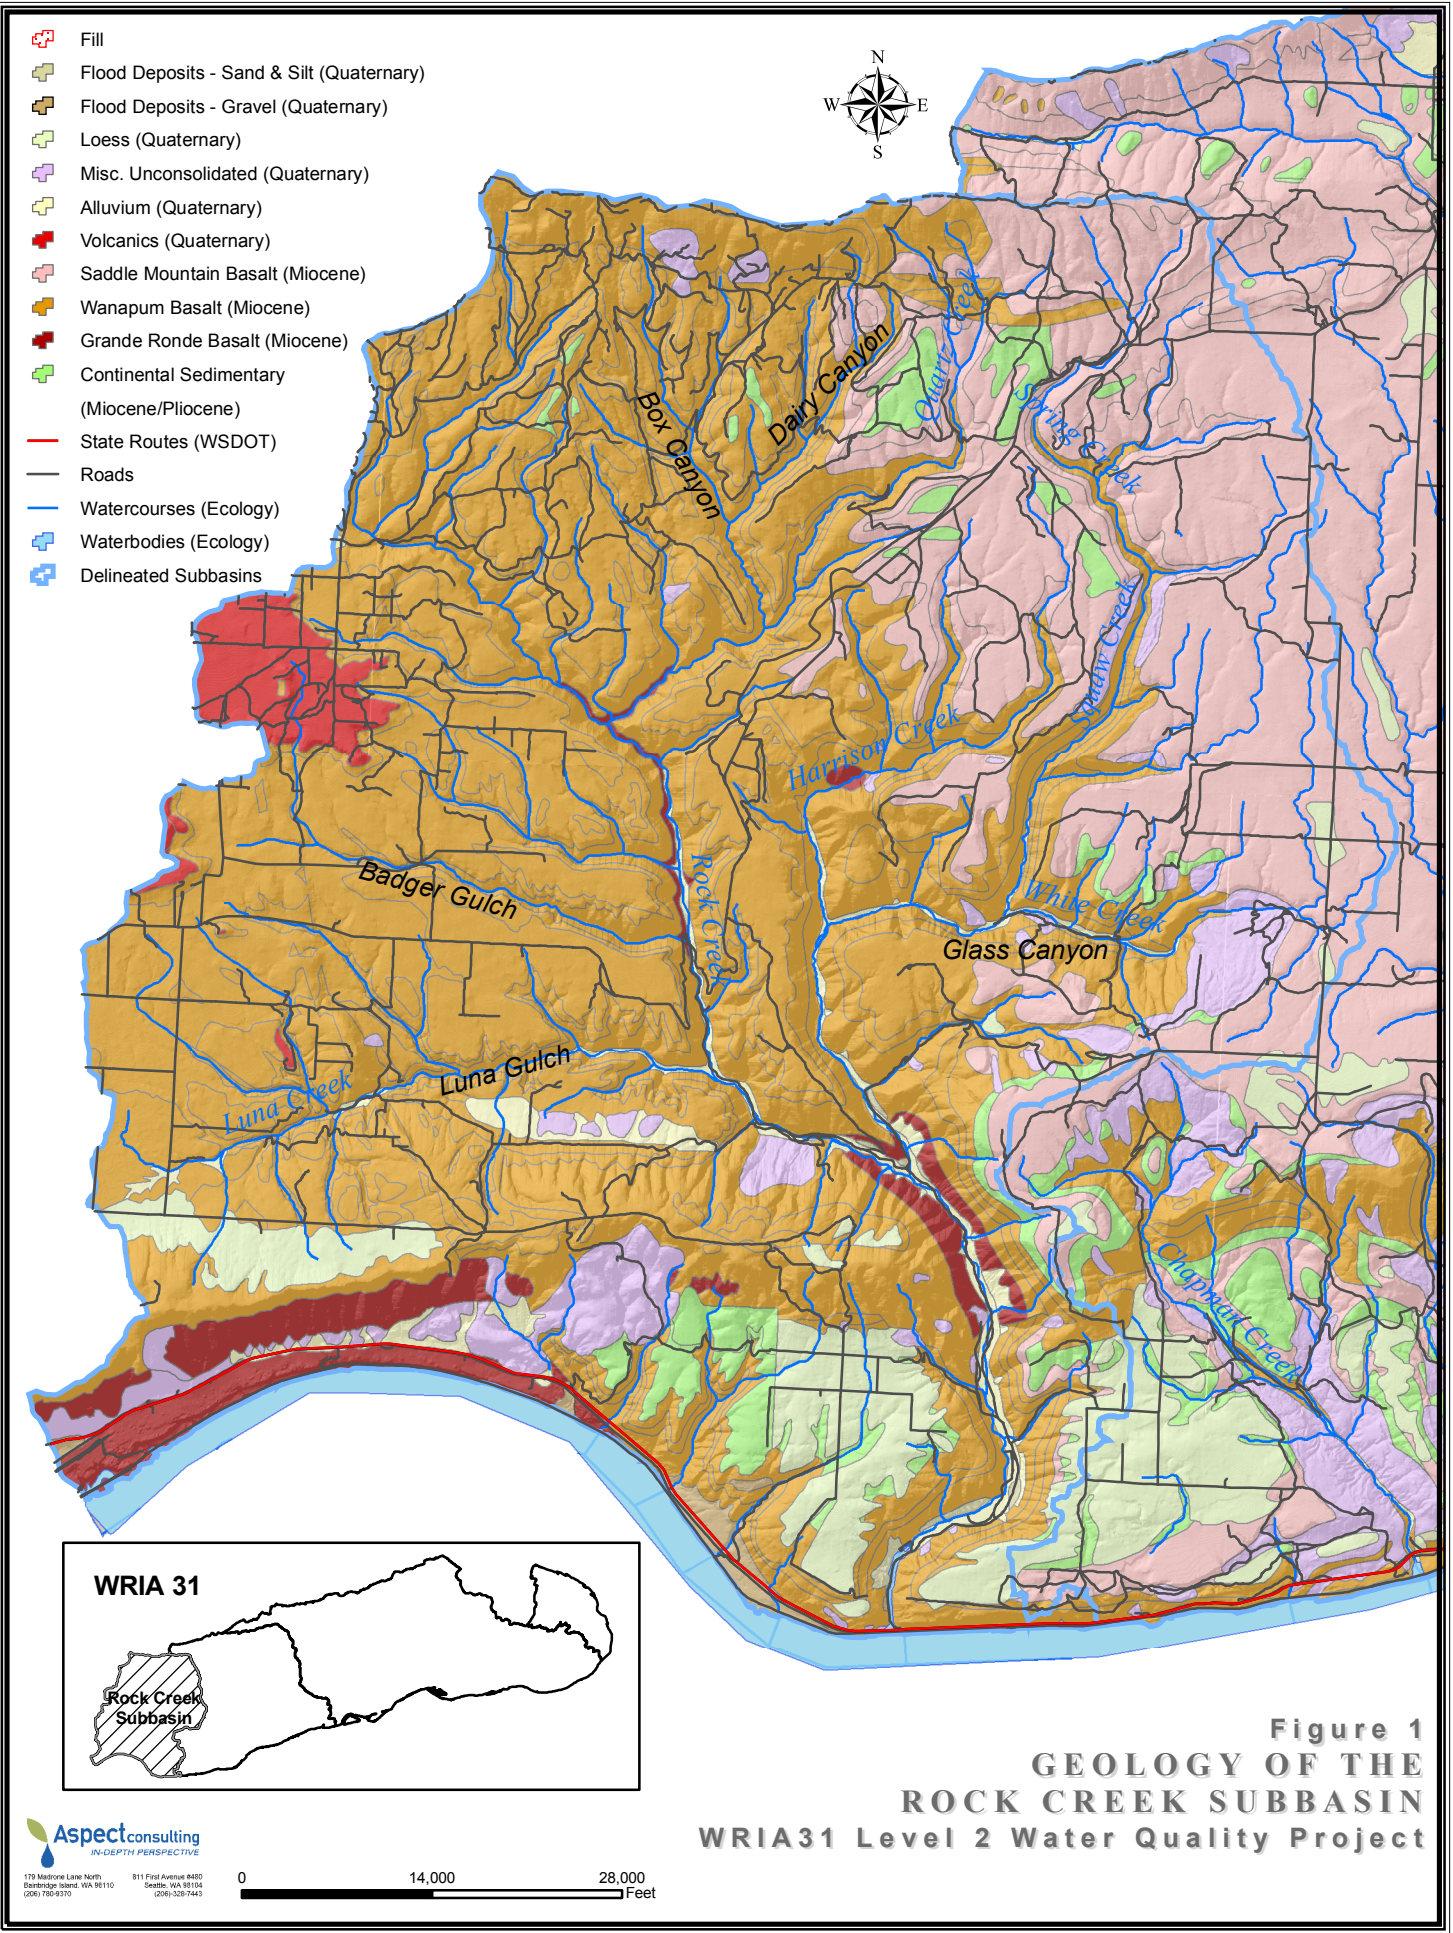
Figure 1
GEOLOGY OF THE
ROCK CREEK SUBBASIN
WRIA31 Level 2 Water Quality Project

Age	Formation	Sedimentary Interbed	Aquifer
Holocene and Pleistocene	Loess, alluvial, lacustrine, and glacial flood deposits		Alluvial Aquifer
Miocene	Saddle Mountains Basalt	Rattlesnake Ridge	Saddle Mountains Aquifer
		Selah	
	Wanapum Basalt	Mabton	
			Wanapum Aquifer
	Grande Ronde Basalt	Vantage	
			Grande Ronde

This supplemental water quality project addresses water quality in one of the four WRIA 31 subbasins – the Rock Creek subbasin (Figure 1). Background information pertinent to the Rock Creek subbasin is summarized below (from the WRIA 31 Level 1 Assessment; Aspect Consulting and WPN 2004).

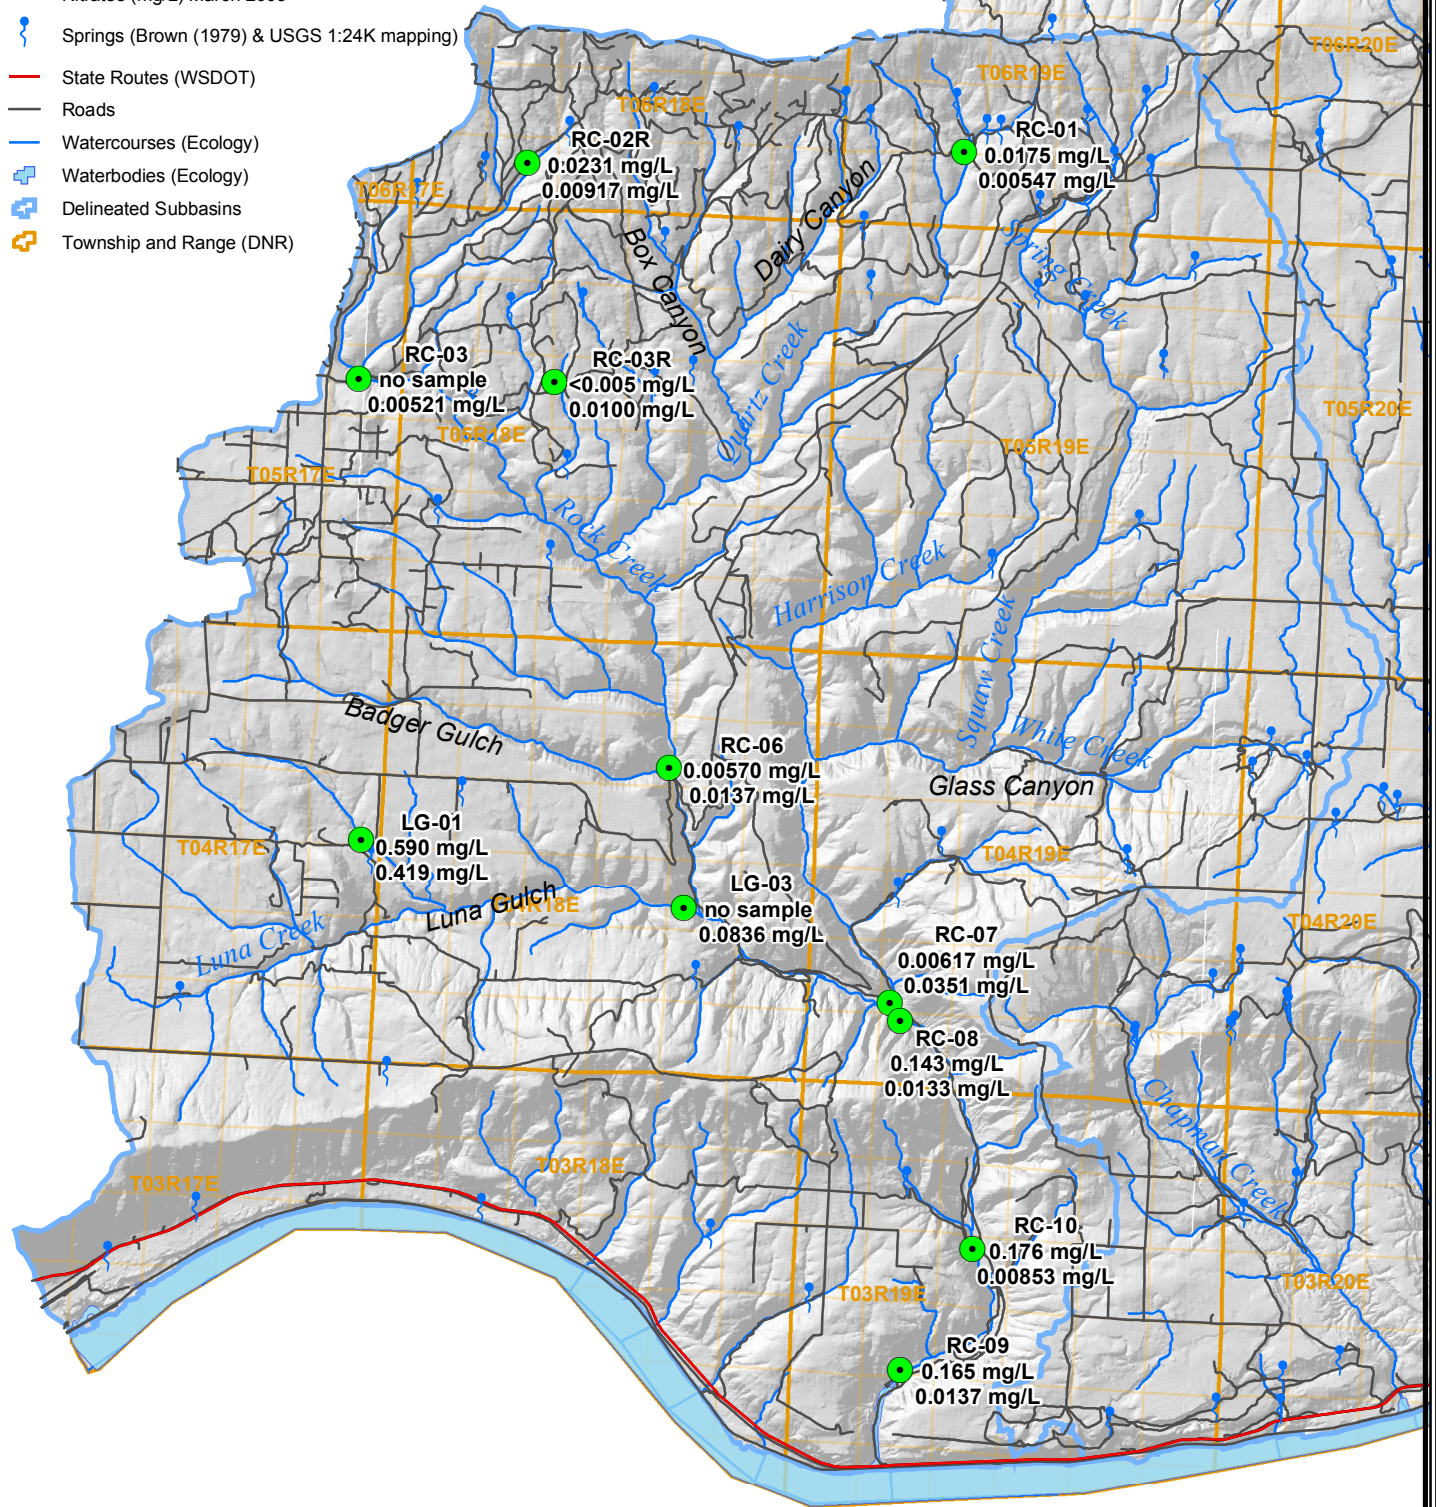
Figure 5
DISTRIBUTION OF NITRATE
CONCENTRATIONS IN ROCK CREEK SUBBASIN
WRIA31 Level 2 Water Quality Project

- Identifier
- Nitrates (mg/L) November 2004
- Nitrates (mg/L) March 2005
- Springs (Brown (1979) & USGS 1:24K mapping)
- State Routes (WSDOT)
- Roads
- Watercourses (Ecology)
- Waterbodies (Ecology)
- Delineated Subbasins
- Township and Range (DNR)

The highest nitrate level was found in monitoring station LG-01, on the north fork of Luna Gulch, during both the November 2004 and March 2005 sampling events. During the November event, the Rock Creek samples downstream of the confluence with Luna Gulch also have slightly elevated nitrate (0.14 to 0.18 mg/L) compared to the upstream samples (0.023 mg/L or less), presumably due to the influence of Luna Gulch. The concentrations downstream of Luna Gulch were lower in March 2005, presumably as a

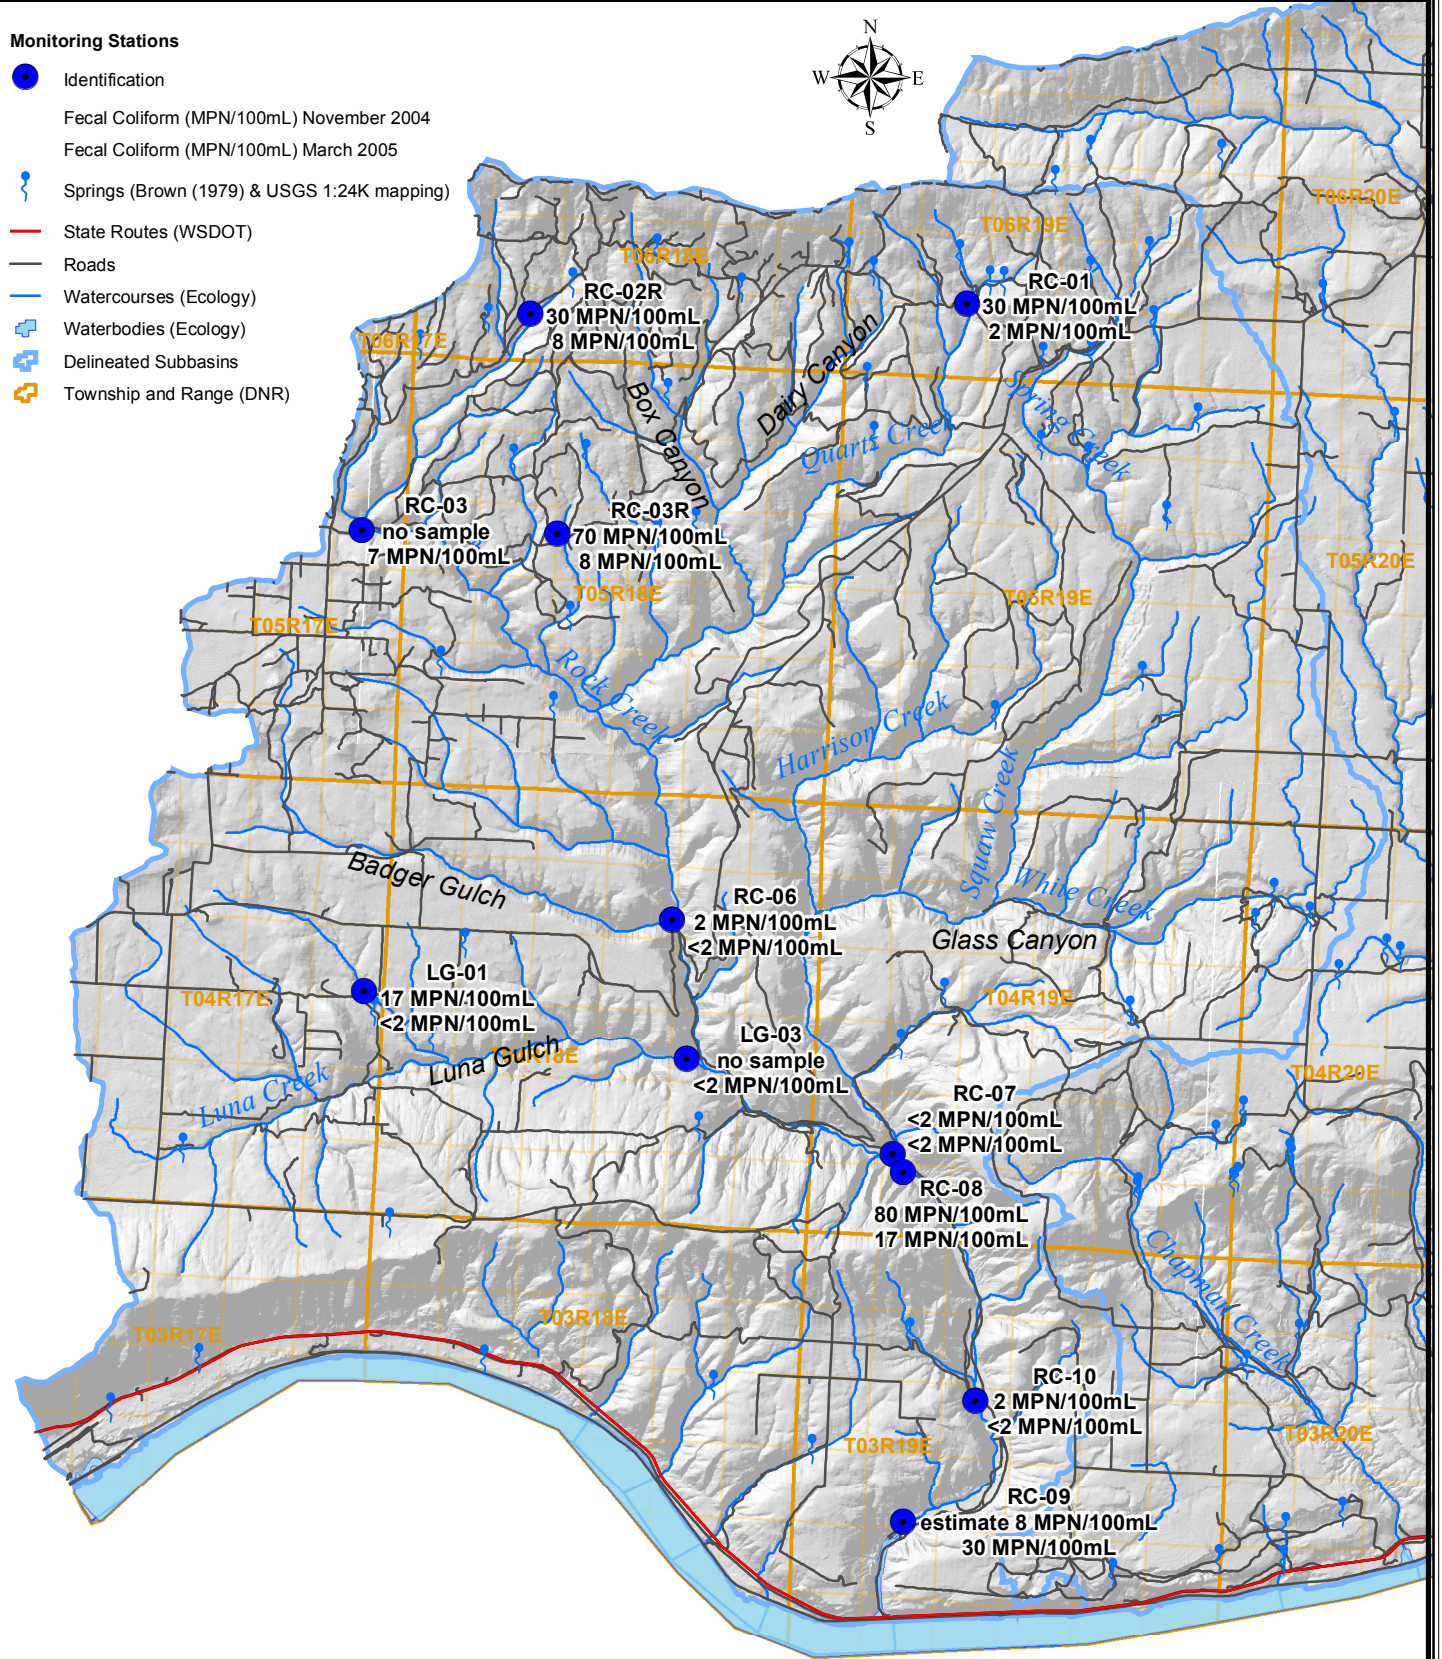
Figure 6
DISTRIBUTION OF FECAL COLIFORM
CONCENTRATIONS IN ROCK CREEK SUBBASIN
WRIA31 Level 2 Water Quality Project

- Identification
- Fecal Coliform (MPN/100mL) November 2004
- Fecal Coliform (MPN/100mL) March 2005
- ~ Springs (Brown (1979) & USGS 1:24K mapping)
- State Routes (WSDOT)
- Roads
- Watercourses (Ecology)
- + Waterbodies (Ecology)
- + Delineated Subbasins
- + Township and Range (DNR)

The highest concentration of fecal coliform detected during the fall 2004 sampling of Rock Creek was 80 colonies/100 mL at RC-08. Cattle feces were noted near this sampling location at the time of the fall sampling. During the spring 2005 event, the highest value detected was 30 colonies/100 mL at RC-09. Recent cattle activity was observed upstream of this location during this sampling event. Fecal coliform values for each sampling station during the two sampling events are plotted on Figure 6.

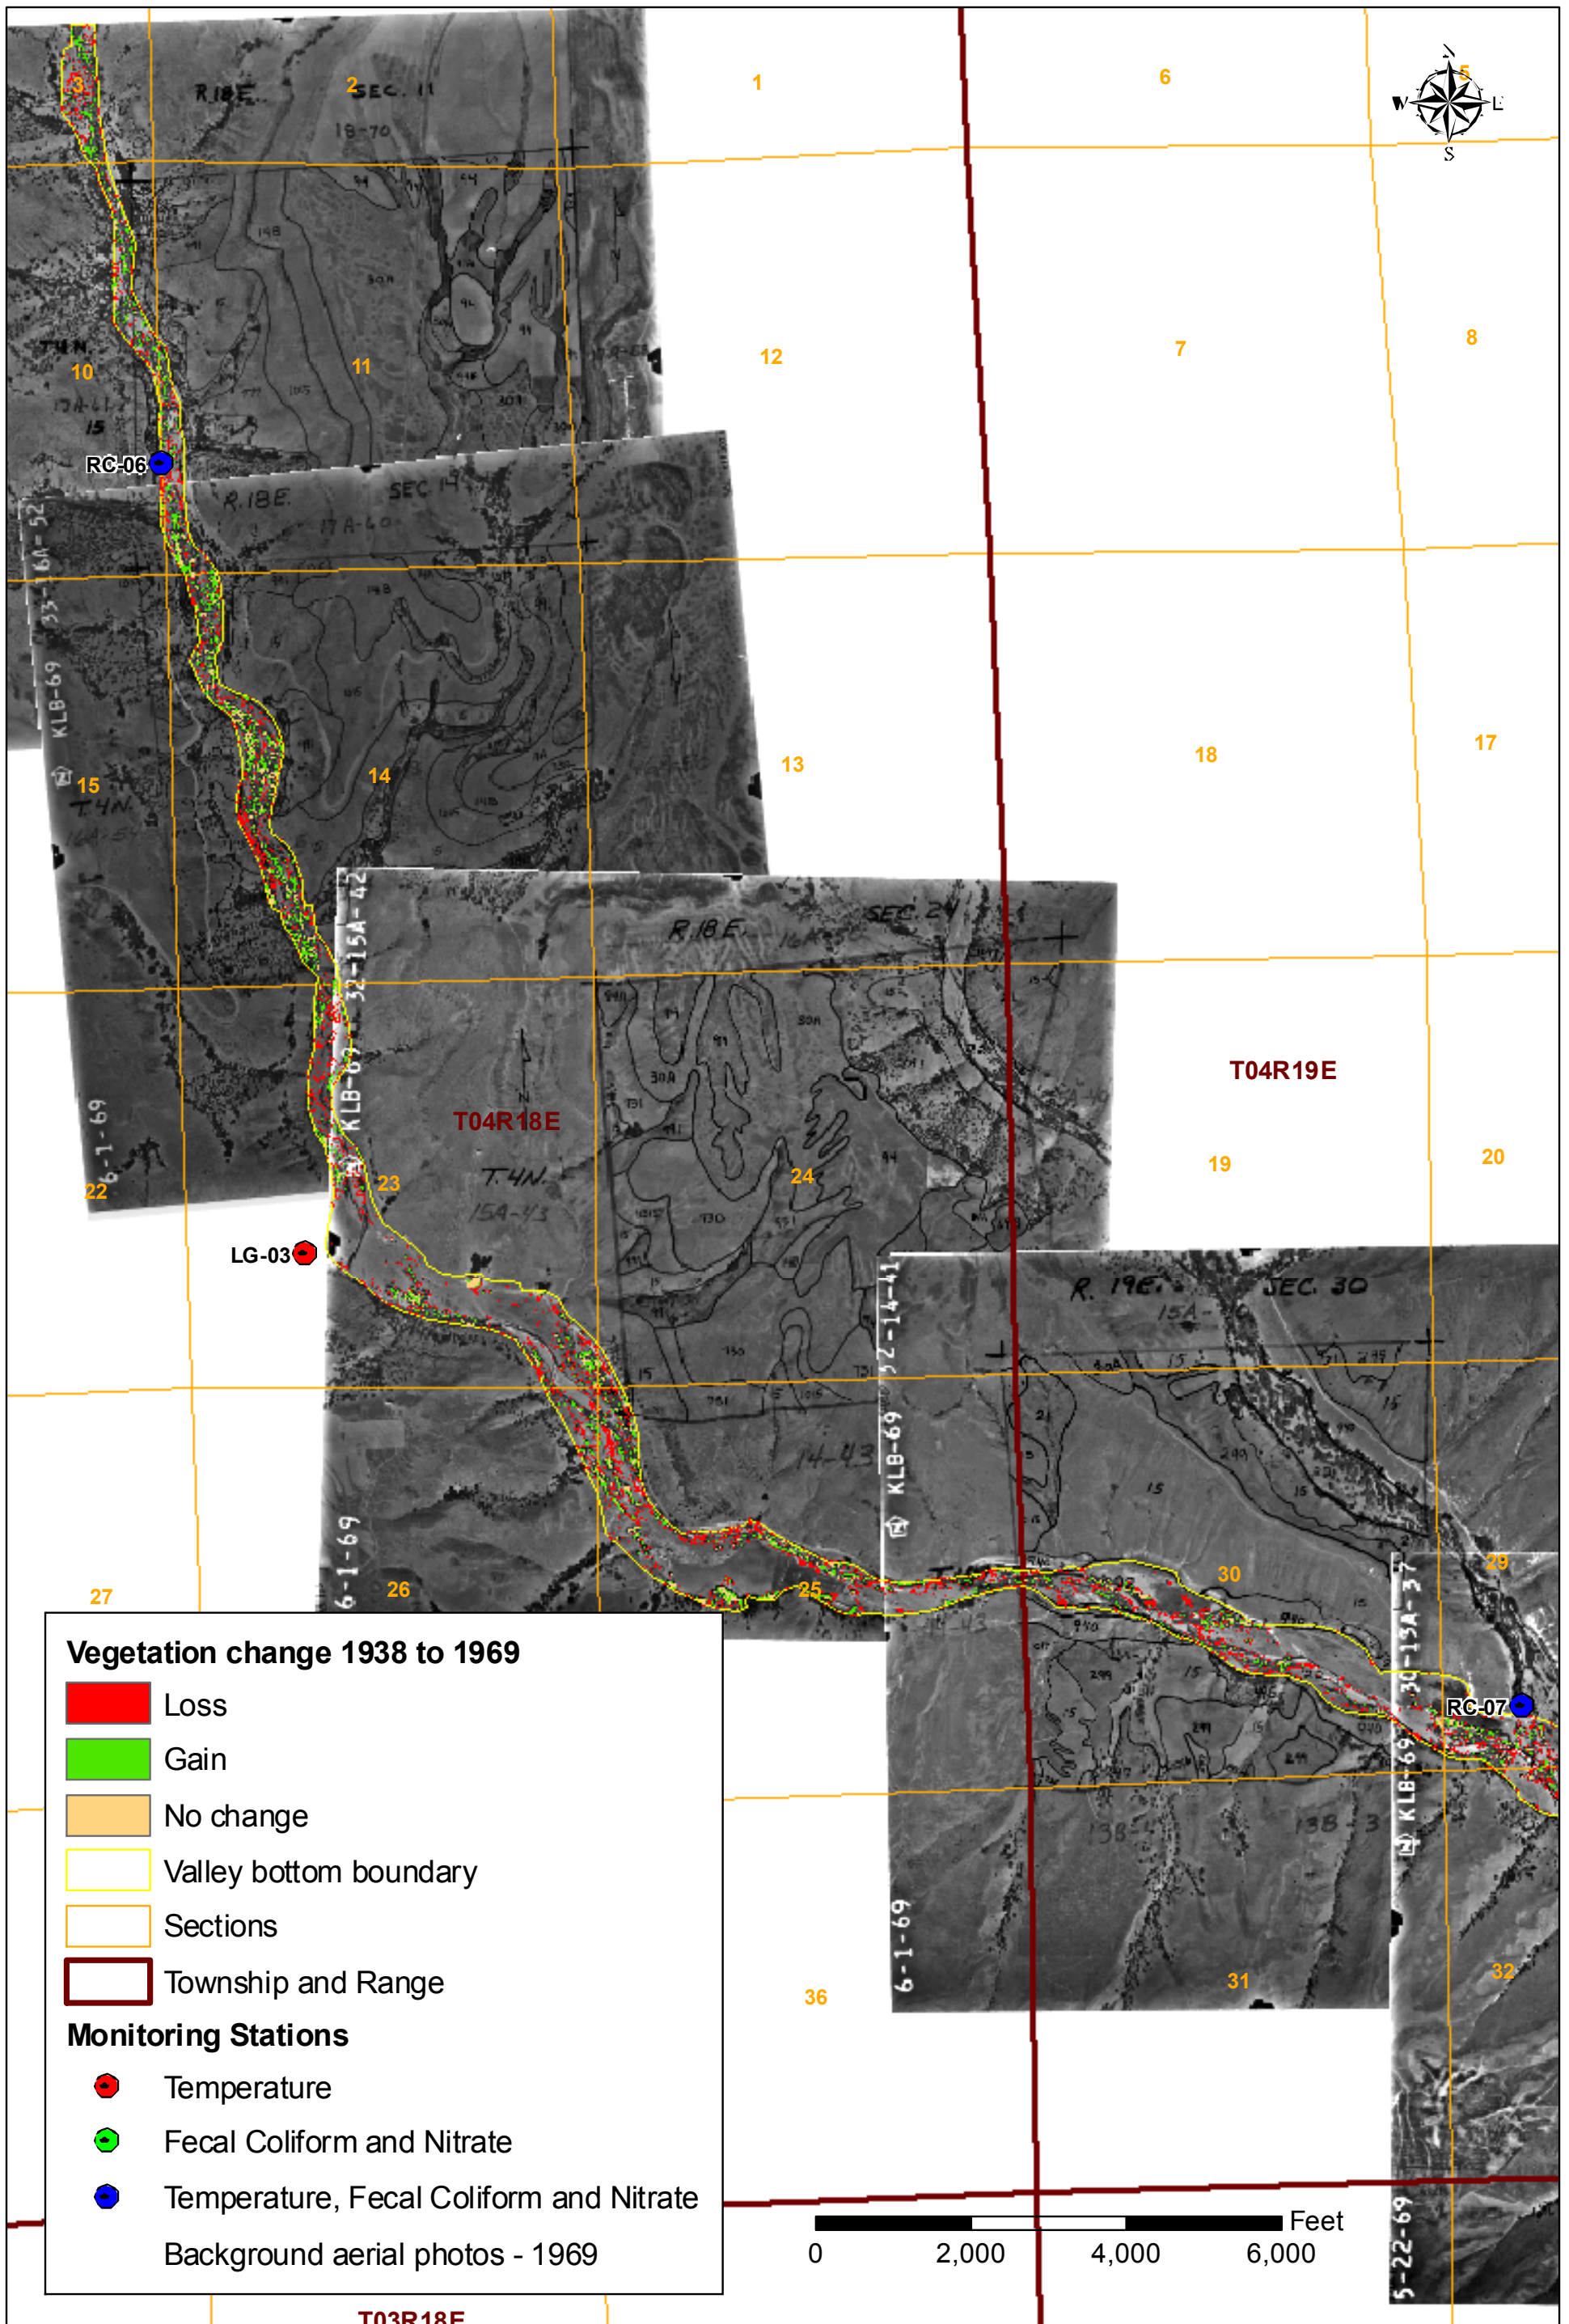
FIGURE NO.
9

Vegetation change 1938 to 1969

One possible explanation for the increased total acreage of vegetation in the valley bottom from 1938-2002 is the use of fire suppression in the watershed. Fire suppression likely began to be implemented in the watershed around the turn of the century. This implies that if it is the cause of riparian vegetation increases from 1969 to 2002, a similar increase in vegetation might be observed from 1938 to 1969. However, it is possible that the 1964 flood removed much of this new vegetation. This may be observed in a few sections of the stream where a net loss in vegetation occurred between 1938-1969 (e.g., T04N R18E Section 25, and R04N R19E Sections 30, 29, 32).

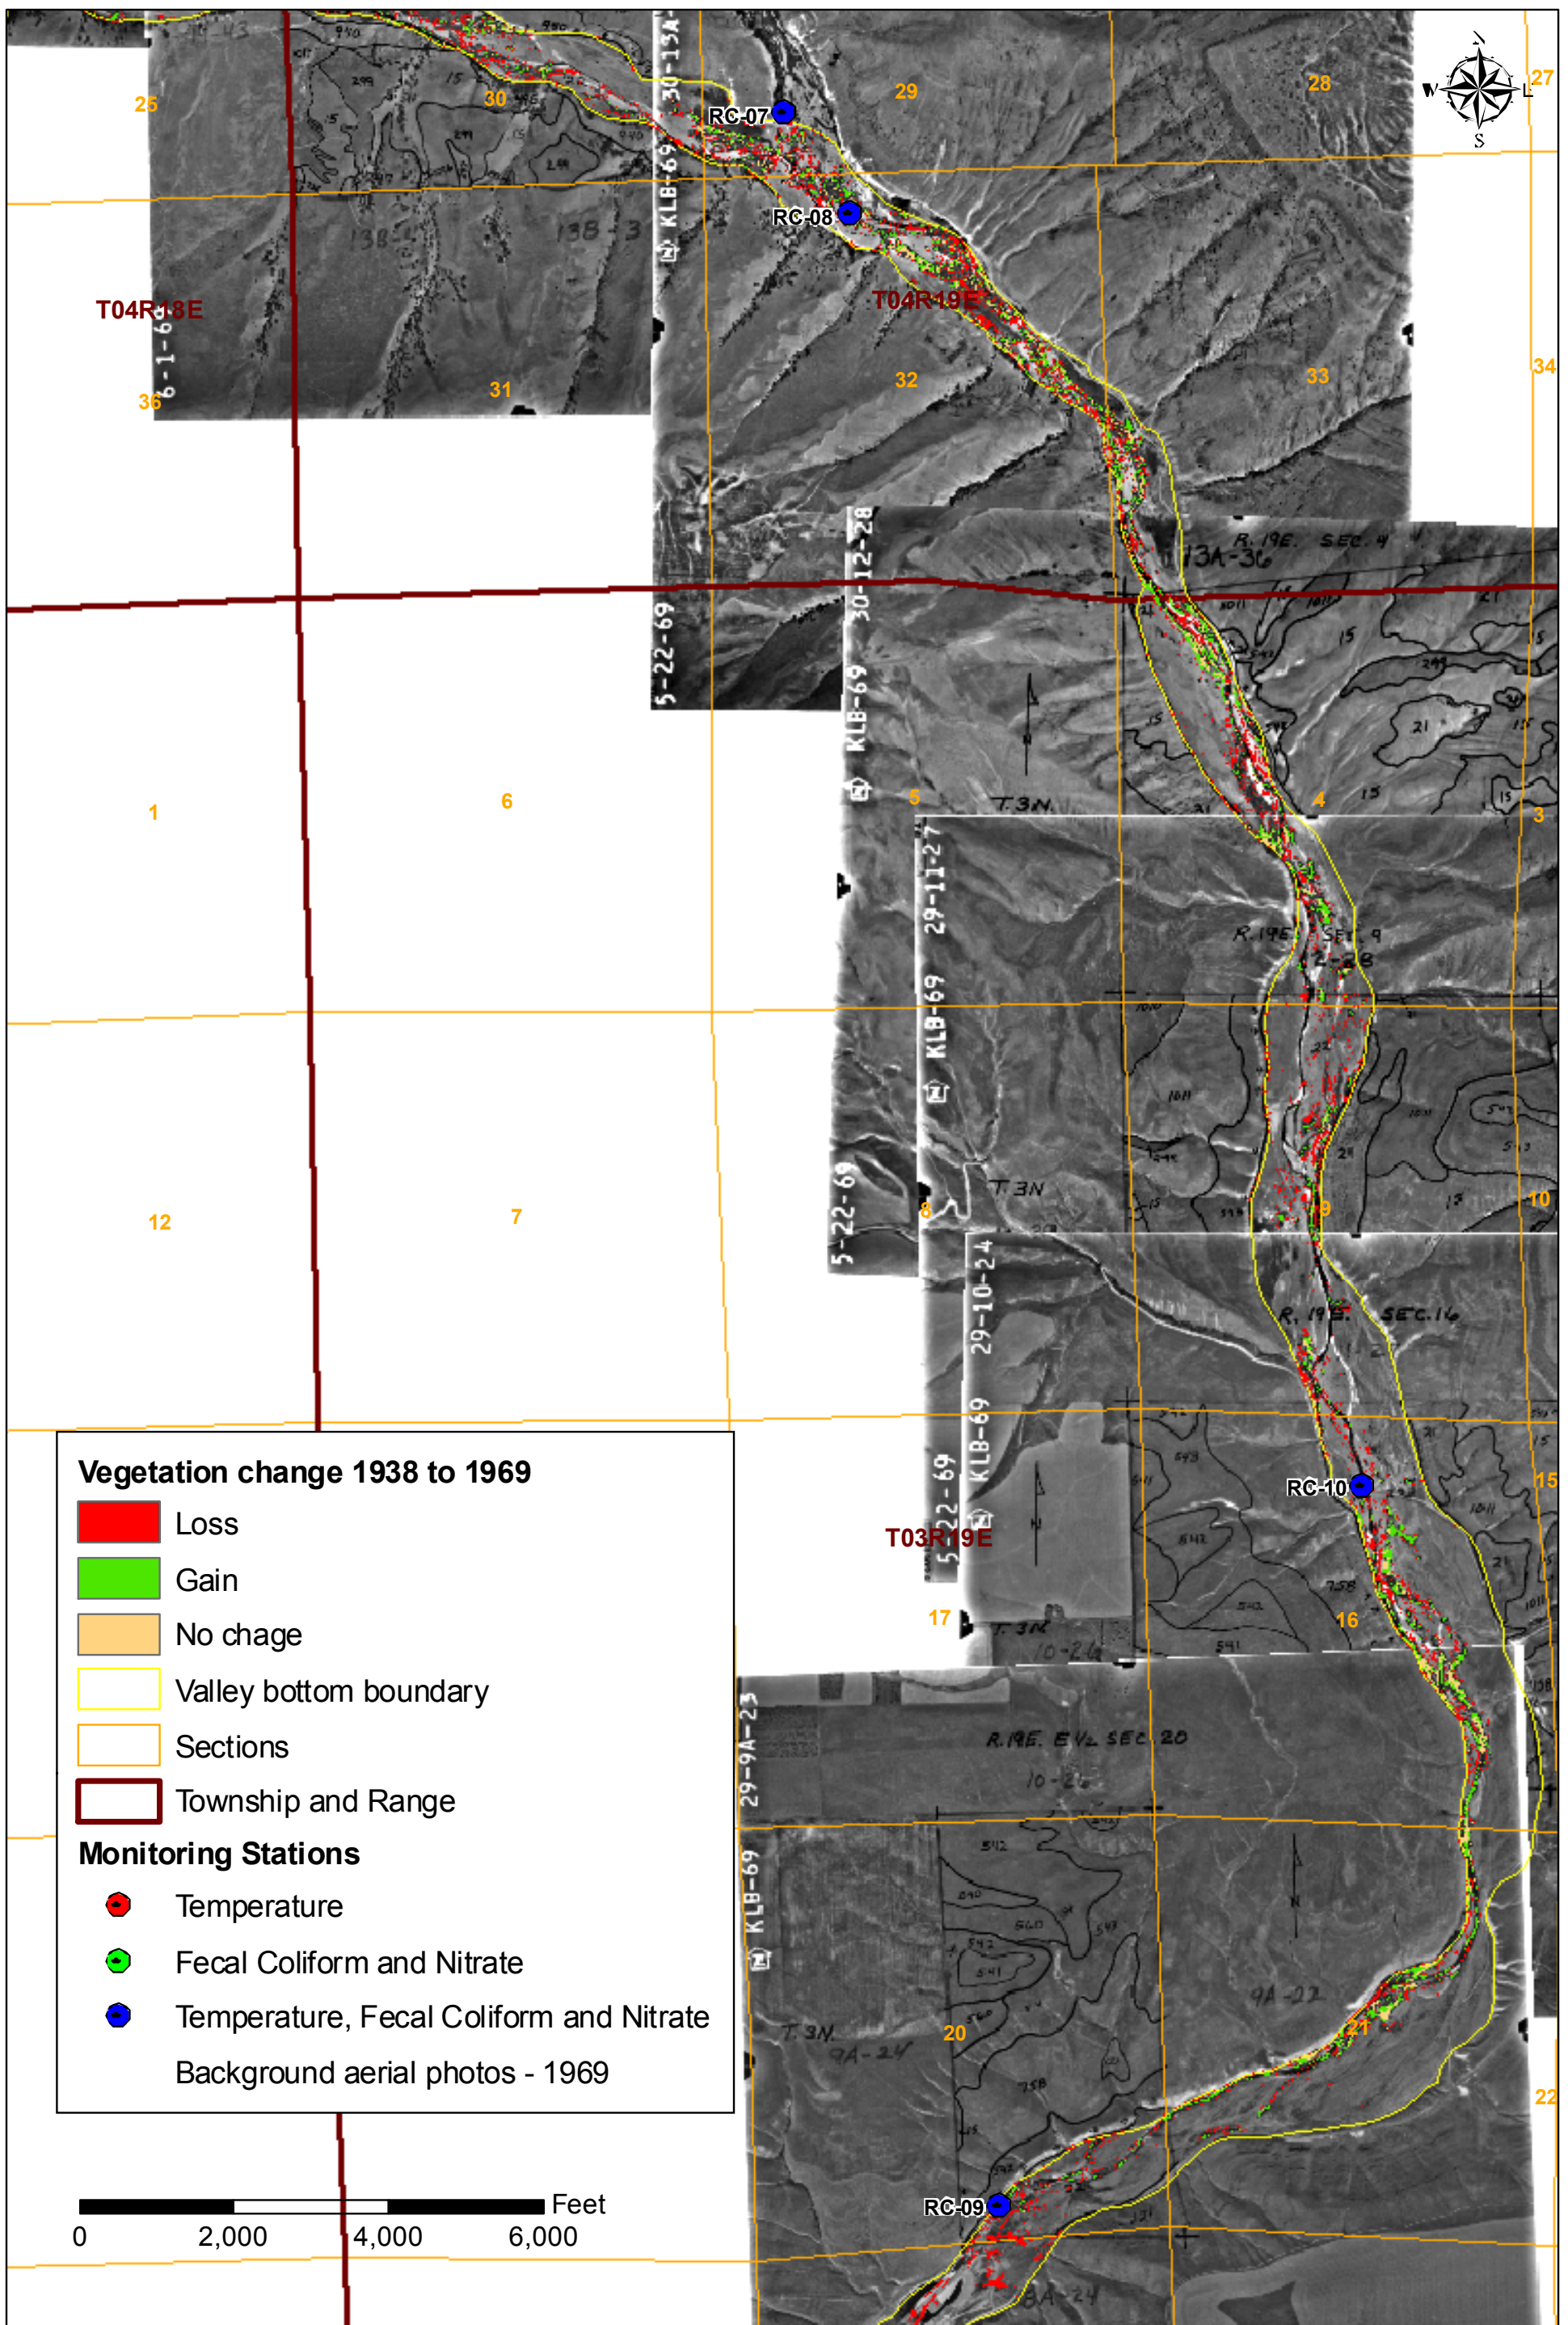
FIGURE NO.
10

Vegetation change 1938 to 1969

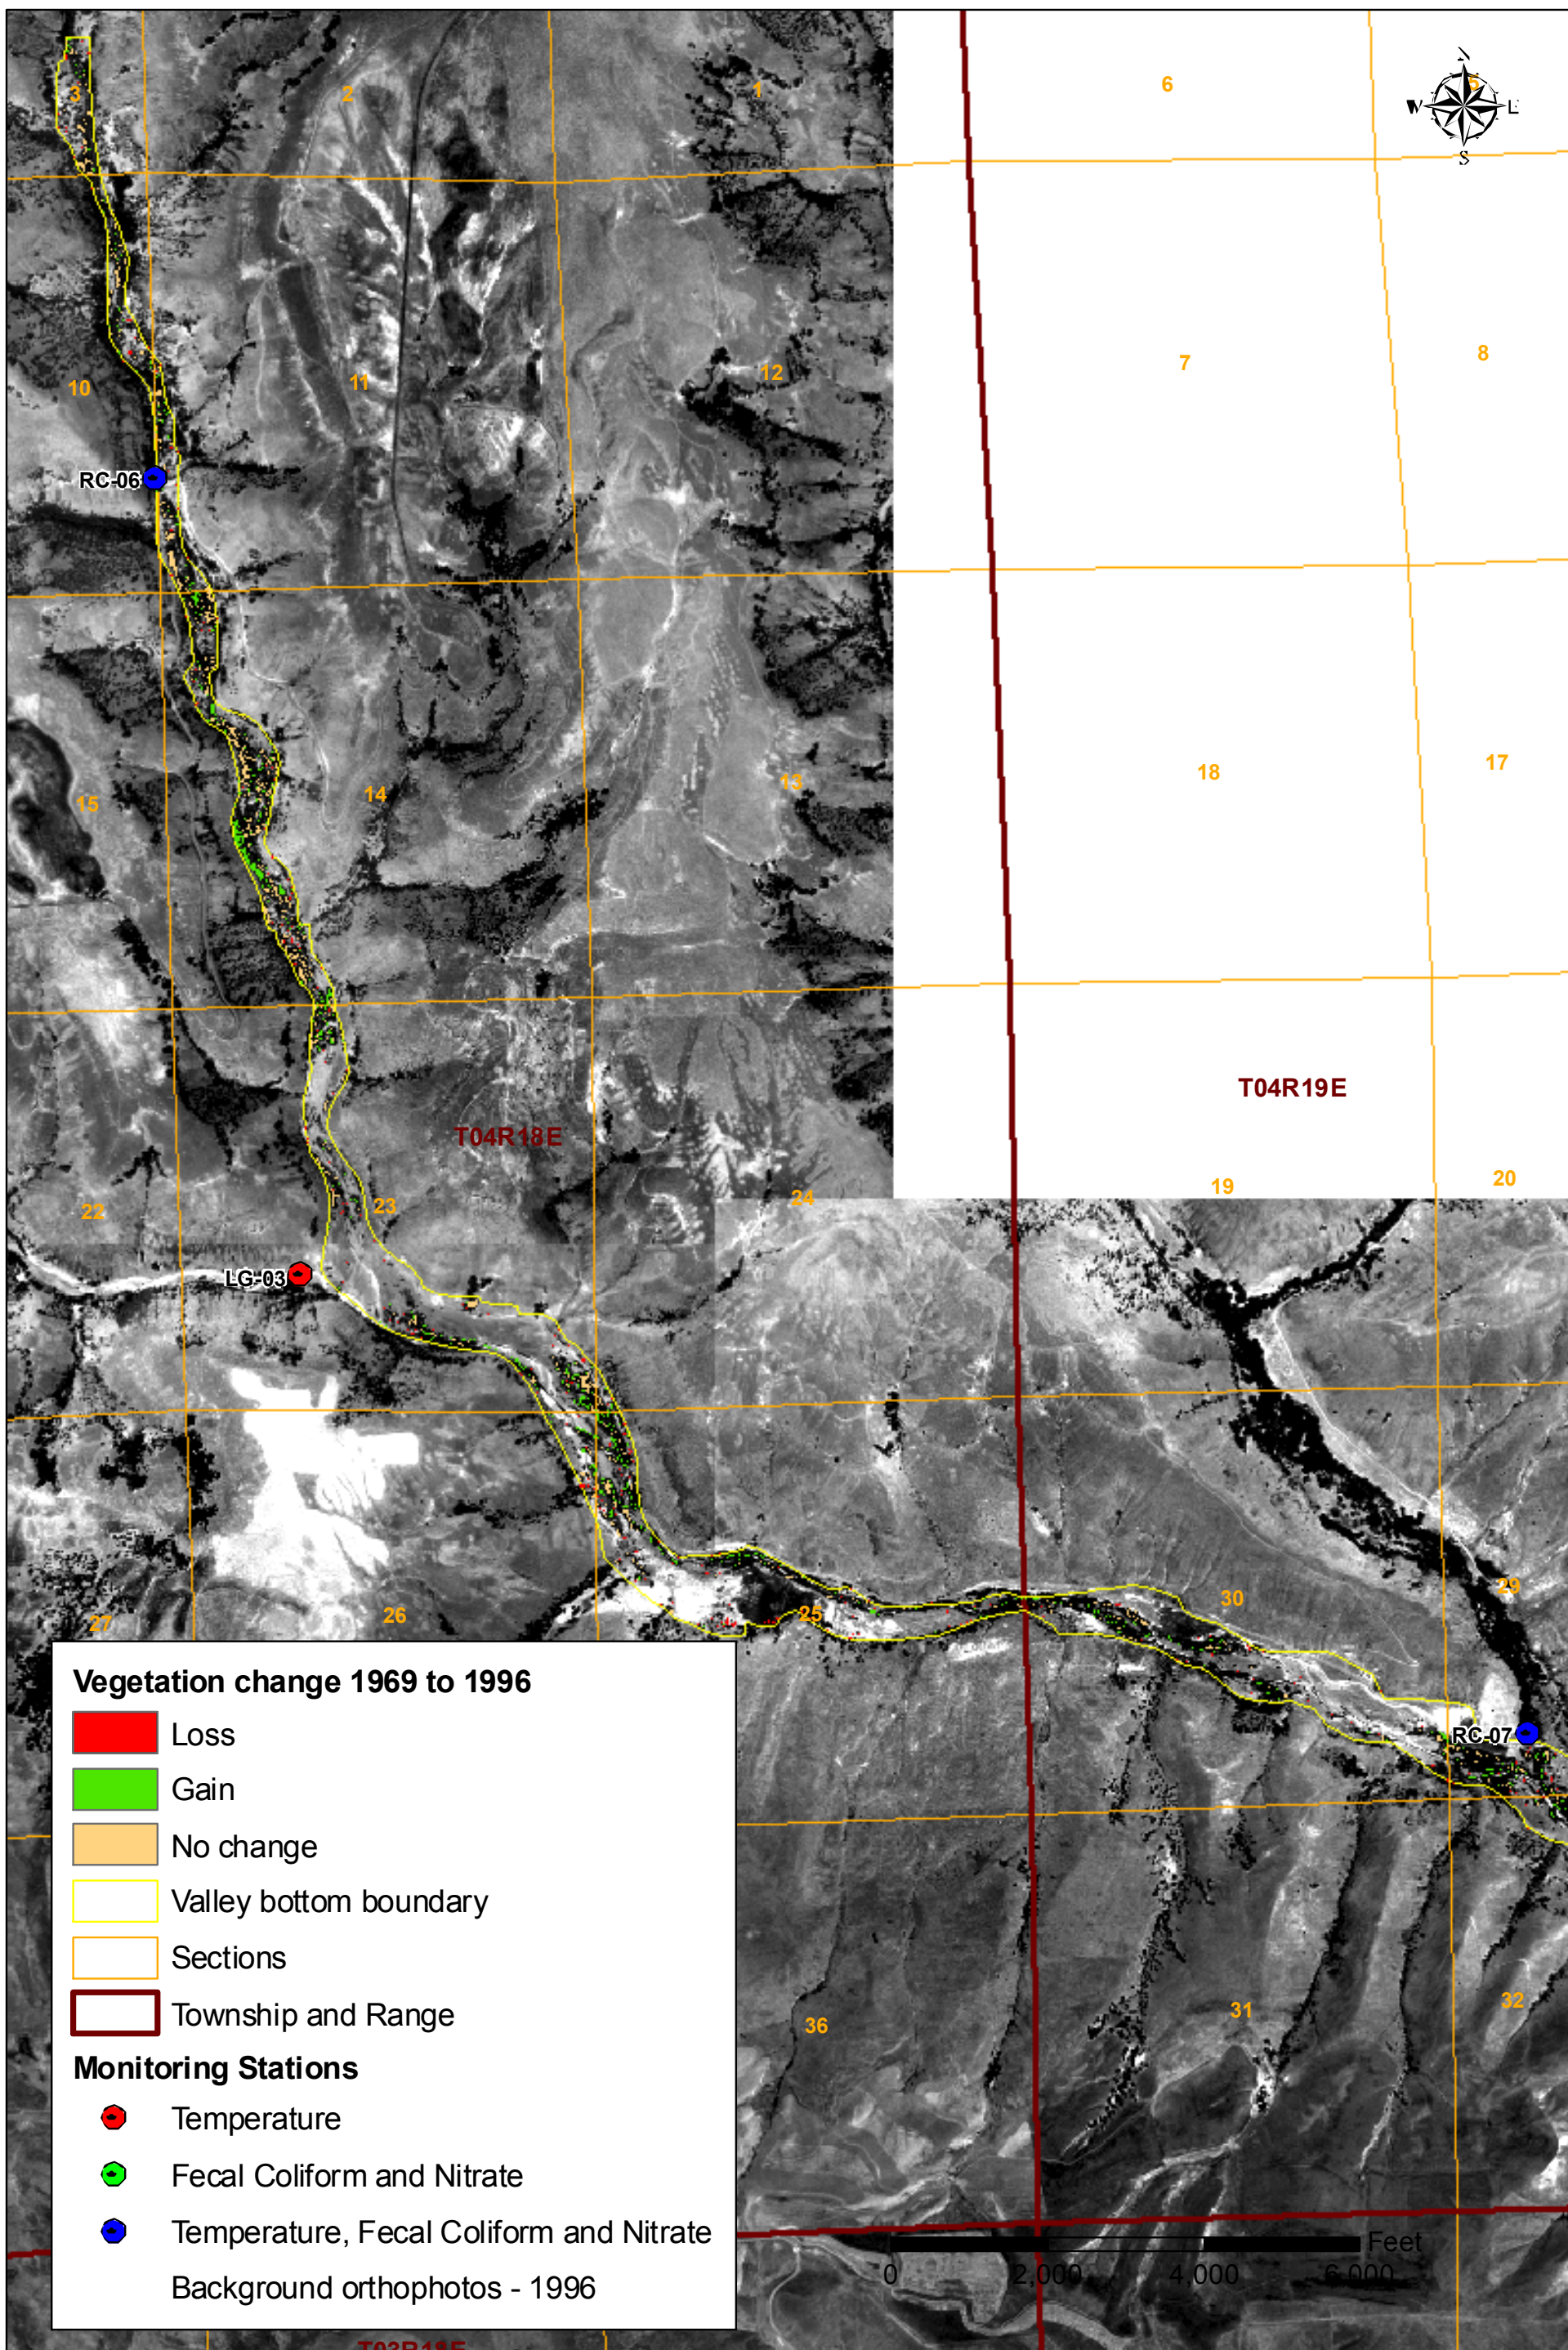
Vegetation change 1969 to 1996

<small>DATE</small> January 2005	<small>PROJECT NO.</small> 030009
<small>DESIGNED BY:</small> GJC	<small>FIGURE NO.</small> 11
<small>DRAWN BY:</small> GJC	
<small>REVISED BY:</small> ACM

The 1969 photos were taken roughly 4 ½ years after a major flood in December of 1964. The 1996 photos were taken approximately 6 months after a major flood (January 1996). Assuming that the 1938 photos can be used to establish a baseline condition of riparian vegetation along the mainstem (albeit not a predevelopment condition), this analysis suggests that the 1964 flood did not remove enough vegetation to create a net reduction in vegetated acres across the valley bottom as a whole. Likewise, the data suggest that riparian vegetation along the mainstem has increased significantly from 1969 to 1996 despite a major flood just before the 1996 photos were taken. According to this rationale, the major floods observed in 1964 and 1996 did little to remove vegetation from the valley bottom as a whole. This is, however, contradictory to locals' observations of the stream channel before and after major floods. It is likely that vegetation immediately adjacent the stream channel has been removed during floods, with little change occurring at greater distance from the channel. The stream channel does move across the valley bottom with regularity, likely switching channels during flood flows, as discussed below.
