ROCK CREEK WATER QUALITY REPORT

Water Resource Inventory Area 31

Prepared for: WRIA 31 Planning Unit

Project No. 030009-003-01 • June 22, 2005 Final

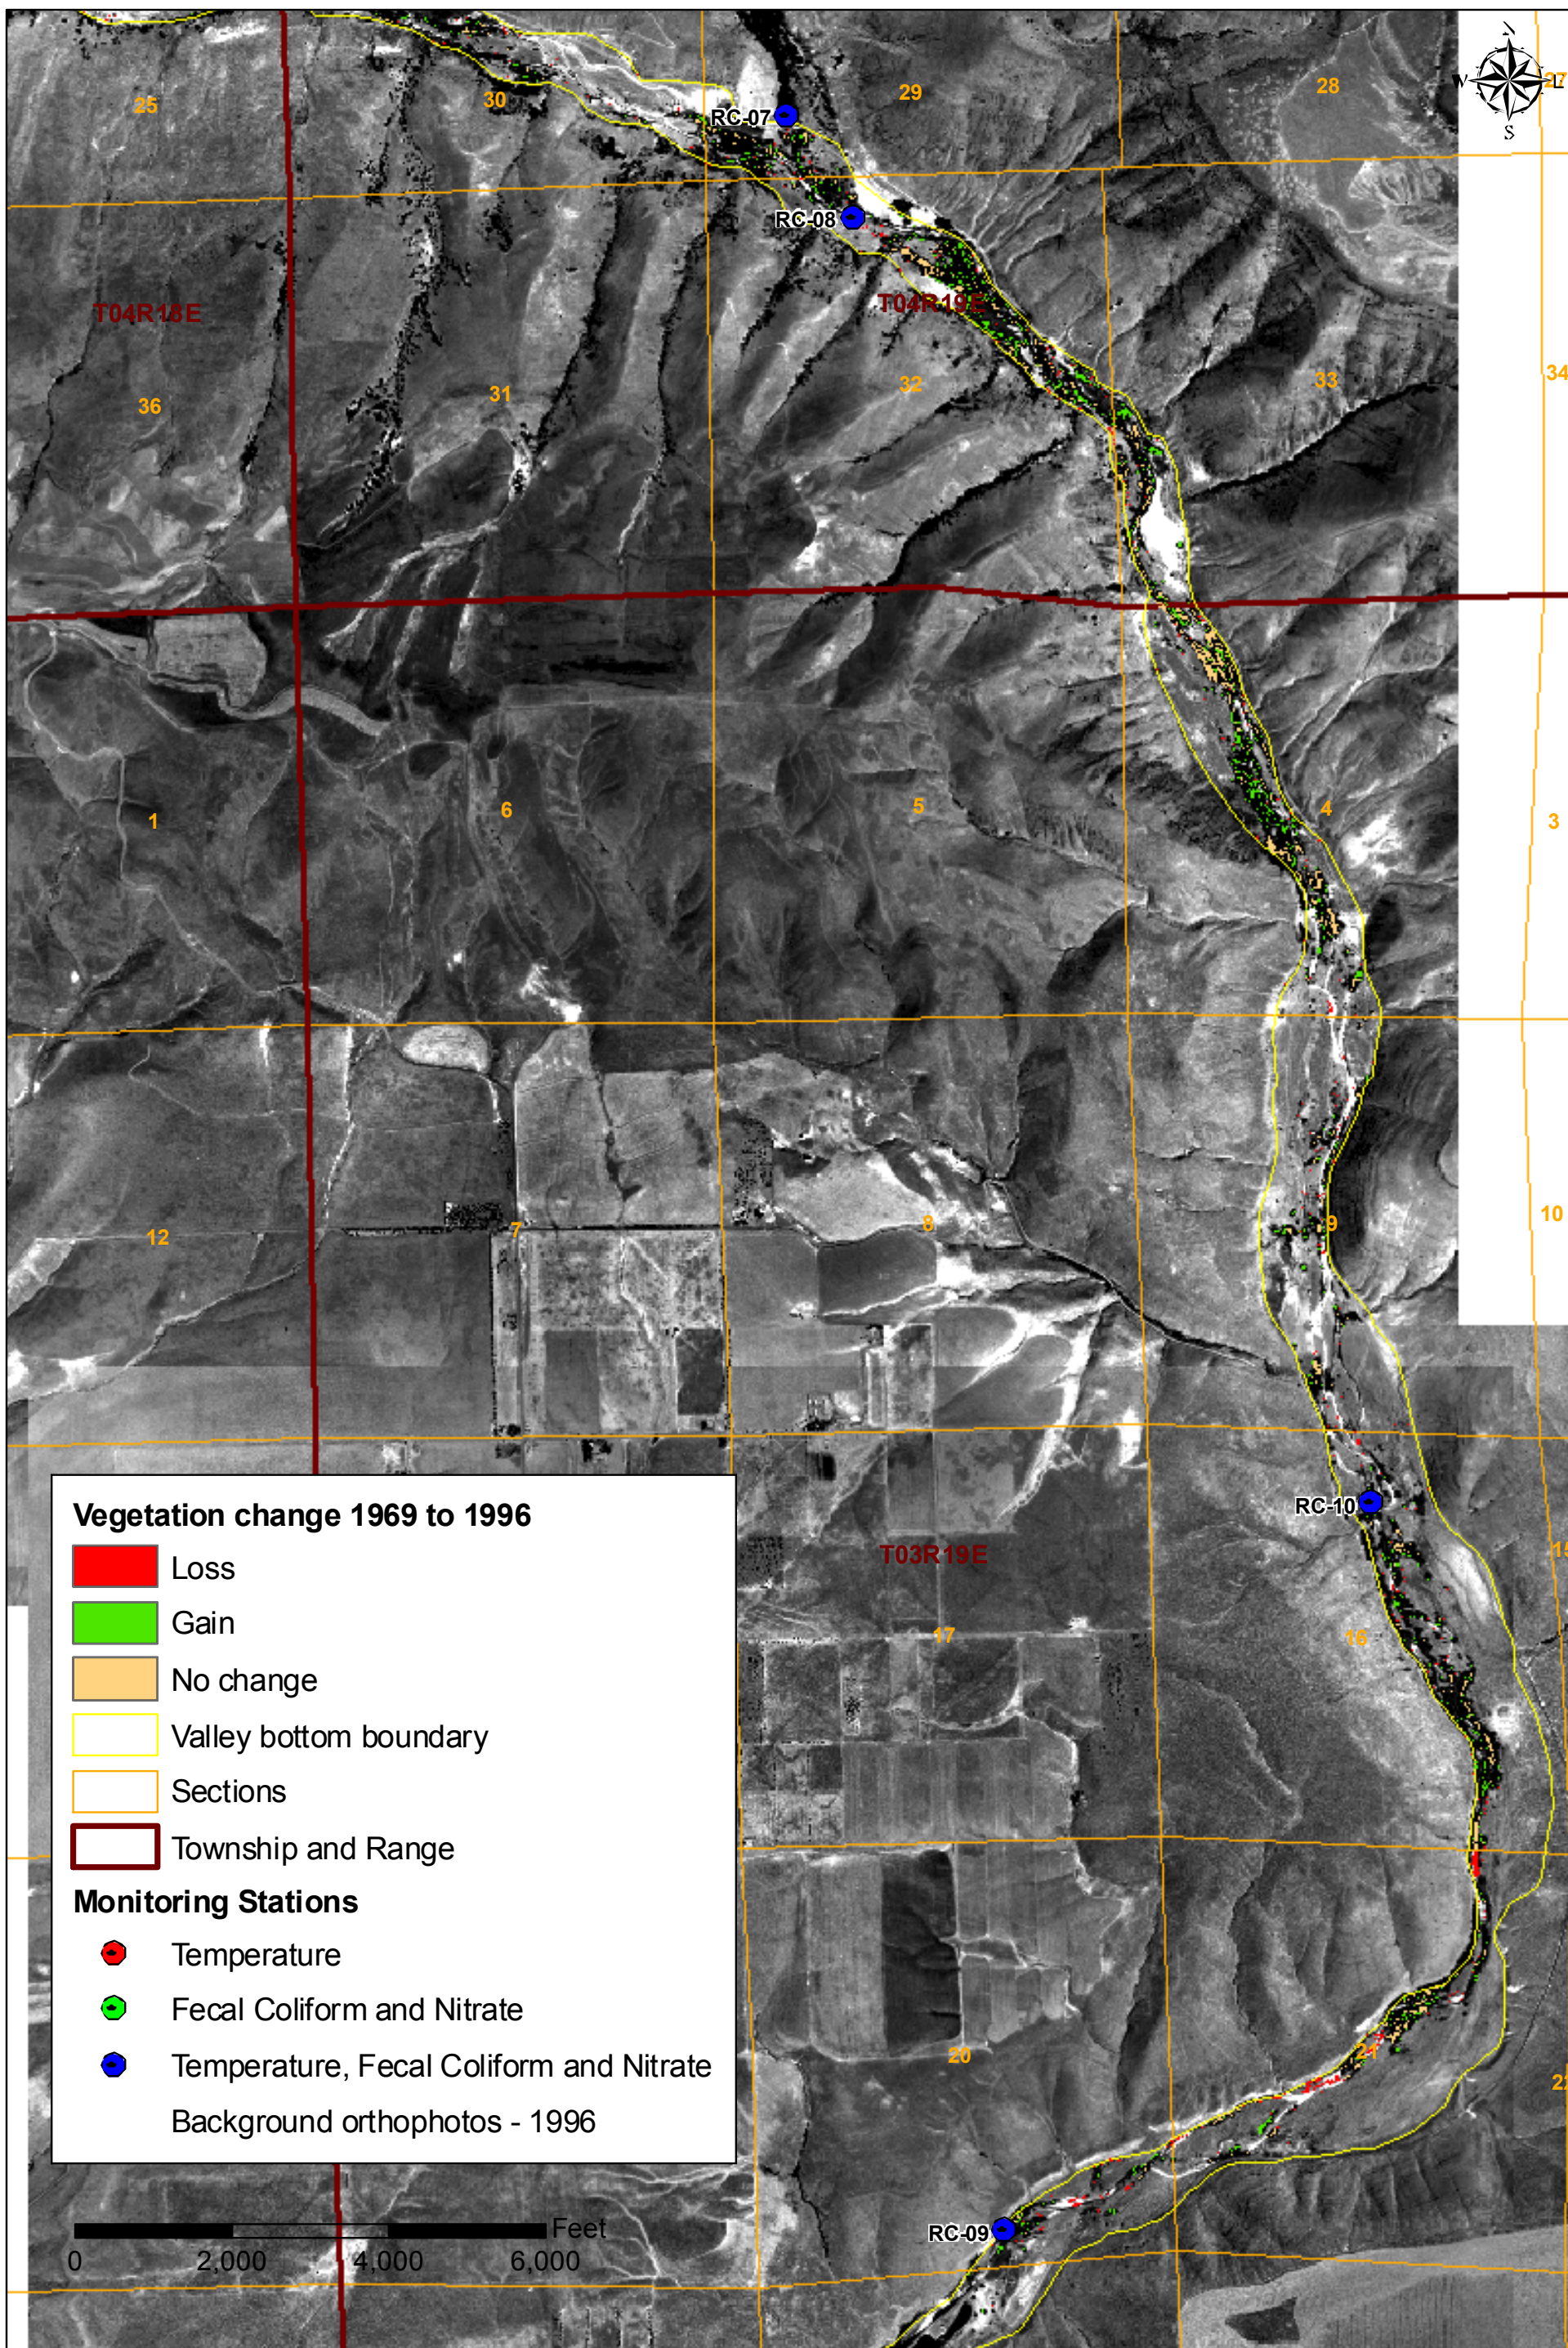
<small>DATE</small> January 2005	<small>PROJECT NO.</small> 030009
<small>DESIGNED BY:</small> GJC	<small>FIGURE NO.</small> 11
<small>DRAWN BY:</small> GJC	
<small>REVISED BY:</small> ACM

Vegetation change 1969 to 1996

- Loss
- Gain
- No change
- Valley bottom boundary
- Sections
- Township and Range

The aerial photograph analysis of historical riparian vegetation indicates that the areal extent of vegetation across the Rock Creek valley bottom has been increasing and becoming more stable since 1938. This is likely a result of active fire suppression conducted over the past century. However, there are localized riparian areas that have very little vegetative cover, and where the stream channel is shallow, rocky, and braided. Ehinger (1996) recommended that establishing a single, deeper channel where shallow braided channels currently exist in the lower stream reaches could help lower water temperatures and facilitate riparian vegetation growth that would reduce temperatures even more. The findings of this study do not support this approach to revegetation, because the Rock Creek channel changes course regularly in its lower reaches which limits the establishment of vegetation. Because of this highly dynamic character, it does not appear that it would be practical or even possible to confine the shallow, braided areas of Rock Creek in its lower reaches into a single channel. In areas of the Rock Creek subbasin where the stream channel is more defined and stable (e.g., upstream of RC-06), riparian plantings might be able to be established to increase stream shade. However, prior to undertaking such plantings, it should be confirmed that there is adequate late-season water in such areas to ensure that a benefit to fish would be achieved. This could warrant additional discussion and assessment as part of Phase 3 watershed planning.

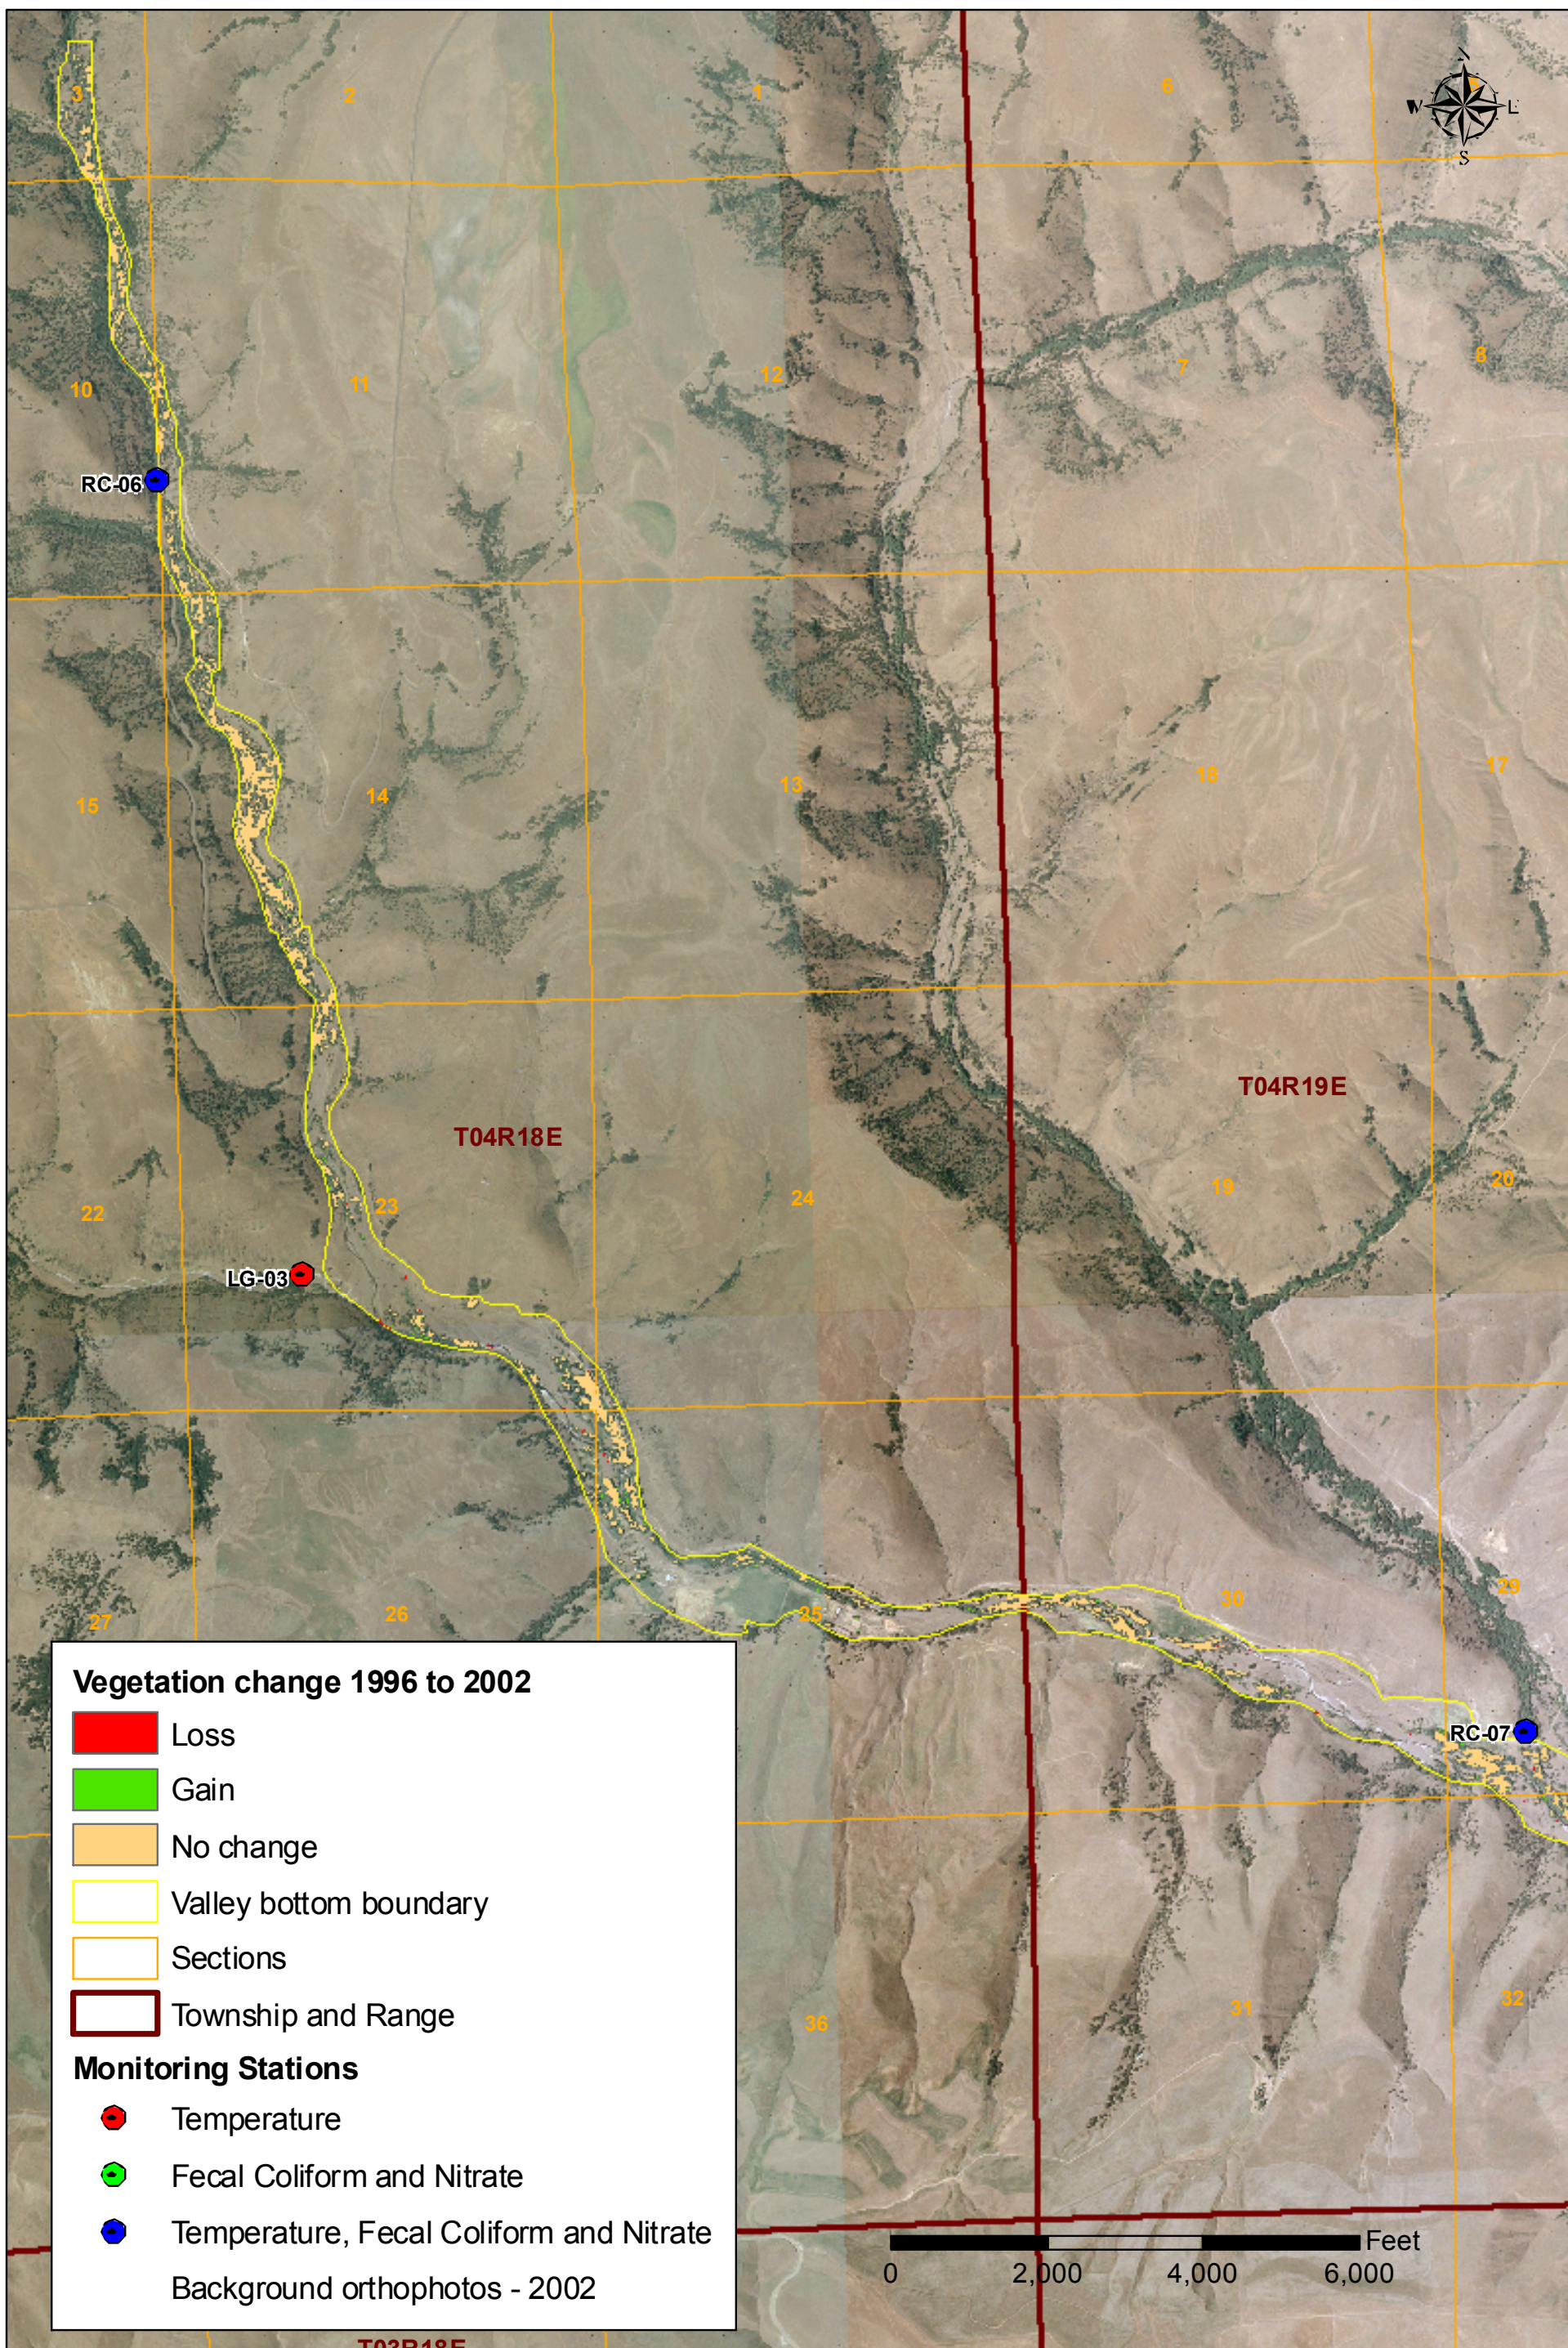
Vegetation change 1996 to 2002

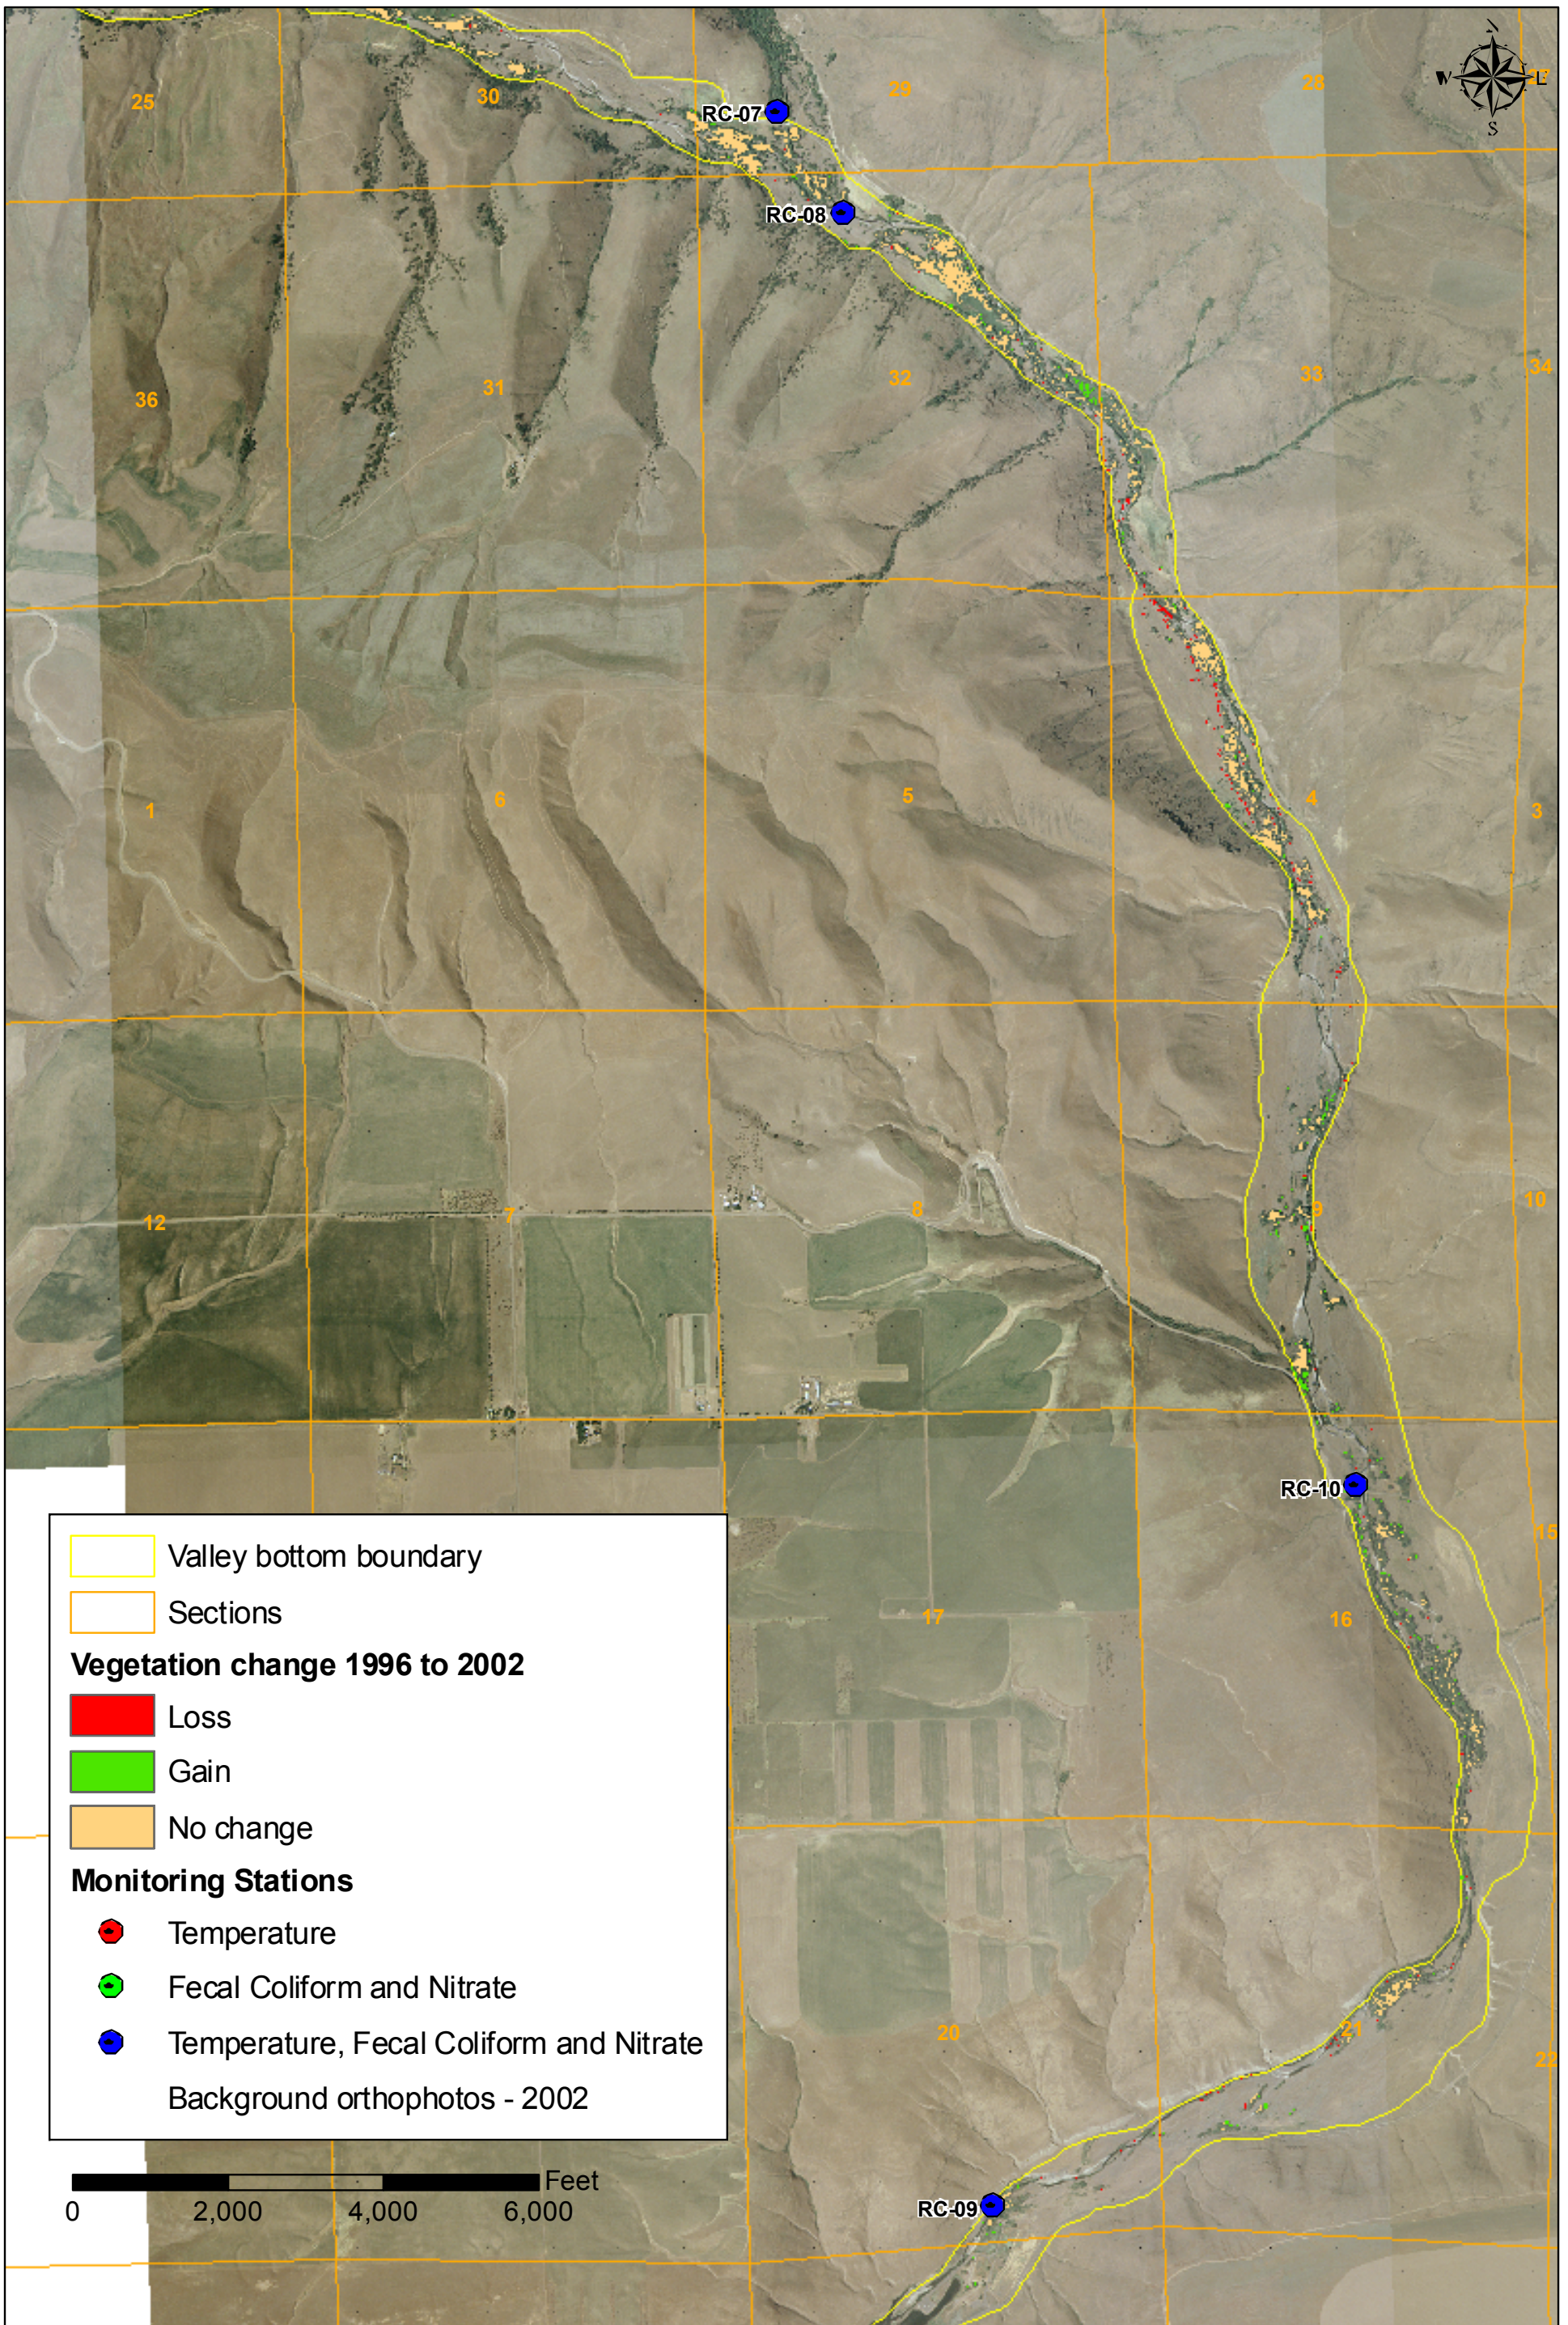
Valley bottom boundary
 Sections
Vegetation change 1996 to 2002
 Loss
 Gain
 No change
Monitoring Stations
 Temperature
 Fecal Coliform and Nitrate
 Temperature, Fecal Coliform and Nitrate
 Background orthophotos - 2002

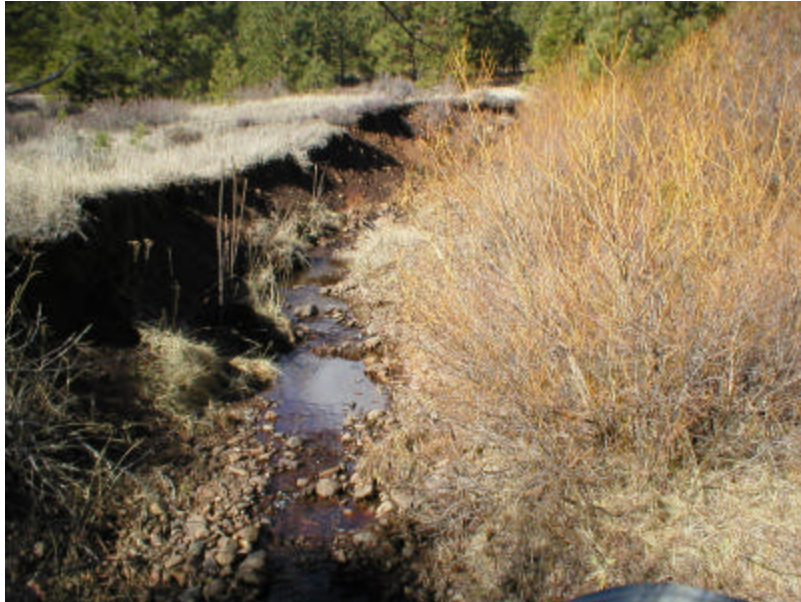
Photo 1. Quartz Creek flowing near Station RC-01, 03/02/05

The EKCD water temperature station RC-01 was maintained during the summers of 1995 and 1996. The station was located near the headwaters of the Rock Creek watershed on the Quartz Creek tributary (Figure 4). During the period of record, streamflow at the station would typically reduce to stagnant pools, but did not completely dry up. Summer water temperatures (as represented by the 7-DADMax) exceeded the draft default state water temperature standard 41% of the time during the period of record. EKCD staff noted “little fishes” in the stream on June 27, 1995, but no more specific information was recorded. A site visit to RC-01 on November 17, 2004, found minimal (<0.1 cfs) flow in the stream, and the water temperature was 49° F. A site visit on March 2, 2005 found slightly higher streamflow (~0.5 cfs) and lower water temperature (42° F). Again, the winter of 2004-2005 was exceptionally dry, and greater flows would be expected at RC-01 in March during most years. The stream channel is deep and vegetated with Ponderosa pine and brush covered banks (Photo 1 in Appendix A).

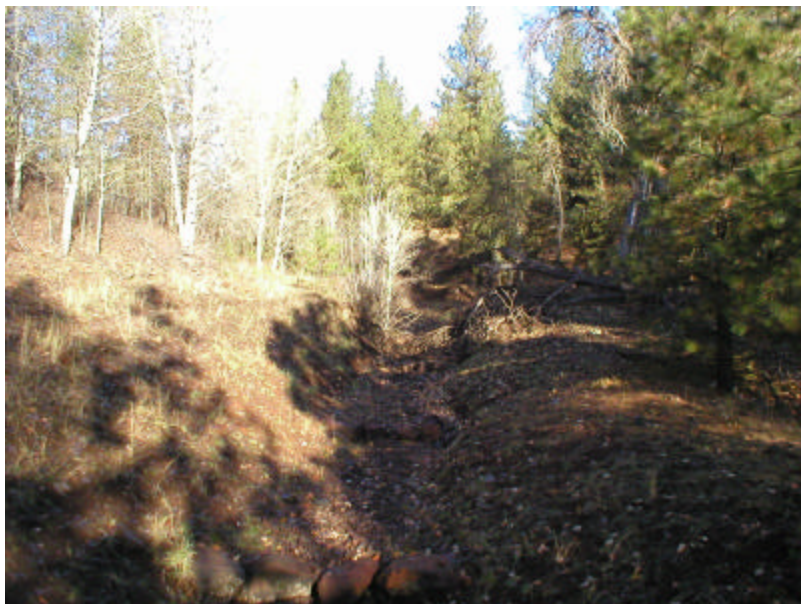
Photo 2. Rock Creek stream channel near Station RC-02, 11/18/04

The EKCD water temperature station RC-02 on Rock Creek was maintained during the summers of 1995 and 1996. The station was located near the headwaters of the Rock Creek watershed (Figure 4). During the period of record, streamflow at the station would typically reduce to stagnant pools, and went dry in 1996. Summer water temperatures (7-DADMax) exceeded the draft state water temperature standard 28% of the time during the period of record. EKCD staff noted a “small trout in pool” in the stream on August 30, 1995. During the site visit to RC-02 on November 18, 2004, the stream was dry. Consequently, a water quality sample was collected from adjacent location RC-02R that had some flow (see Section 3.3). The stream banks at RC-02 were vegetated with scattered Ponderosa pine and Aspen (Photo 2 in Appendix A).

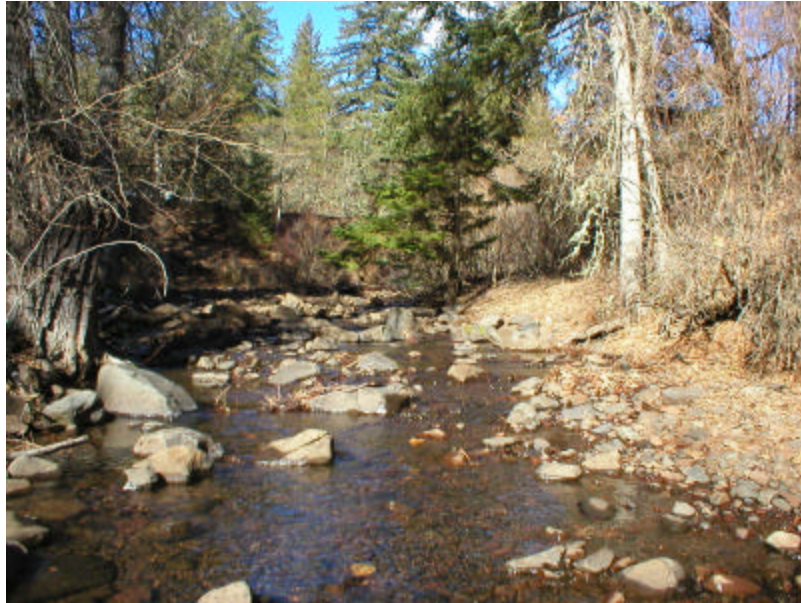
Photo 3. Rock Creek stream channel near Station RC-03, 03/02/05

on March 2, 2005, found the stream flowing approximately 3-5 cfs. The stream banks were heavily vegetated with deciduous and conifer trees and brush (Photo 3 in Appendix A).

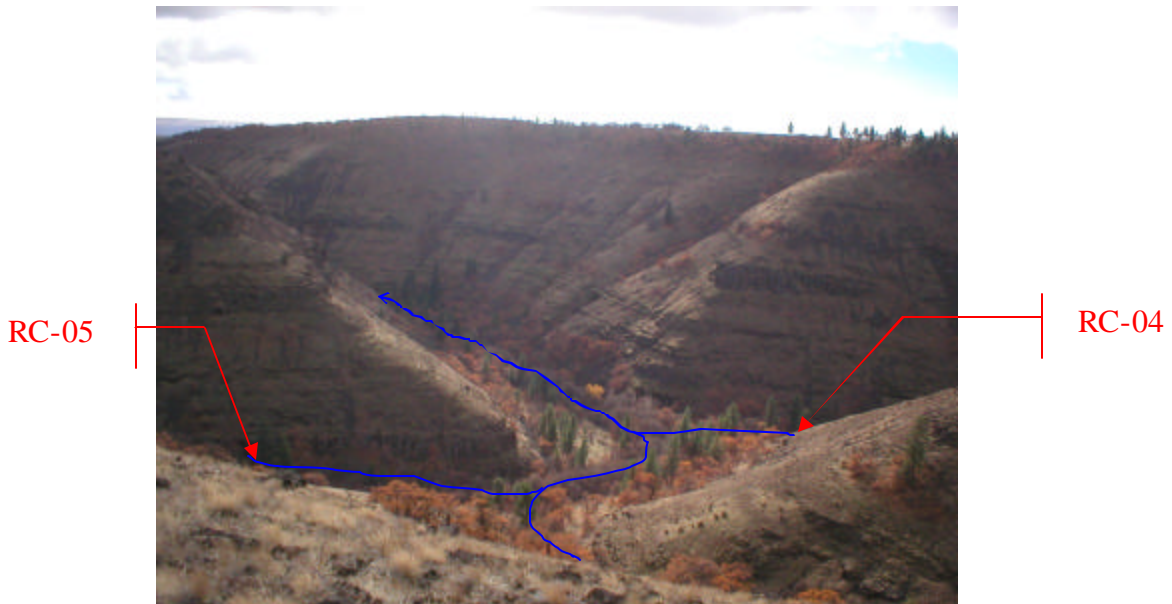
Photo 4. Rock Creek stream channel near Stations RC-04 and RC-05, 11/18/04

The EKCD water temperature station RC-04 on Rock Creek was maintained during the summers of 1995 through 1997. The station was located on Rock Creek just upstream of the confluence with Quartz Creek (Figure 4). During the period of record, streamflow at the station would occasionally reduce to stagnant pools. Summer water temperatures (7-DADMax) exceeded the draft state water temperature standard only 3% of the time during the period of record. EKCD staff typically observed “small fish” in the stream during the summer of 1995. The stream channel is heavily vegetated with Oak and Ponderosa Pine in a deep canyon (Photo 4 in Appendix A).

The EKCD water temperature station RC-05 on Quartz Creek was maintained during the summers of 1995 through 1996. The station was located on Quartz Creek near the confluence with Rock Creek (Figure 4). During the period of record, streamflow at the station would occasionally reduce to stagnant pools. Summer water temperatures (7-DADMax) exceeded the draft state water temperature standard 30% of the time during the period of record. EKCD staff typically observed “1-5 inch fish” in the stream during the summer of 1995. The stream channel is heavily vegetated with Oak and Ponderosa Pine in a deep canyon (Photo 4 in Appendix A).

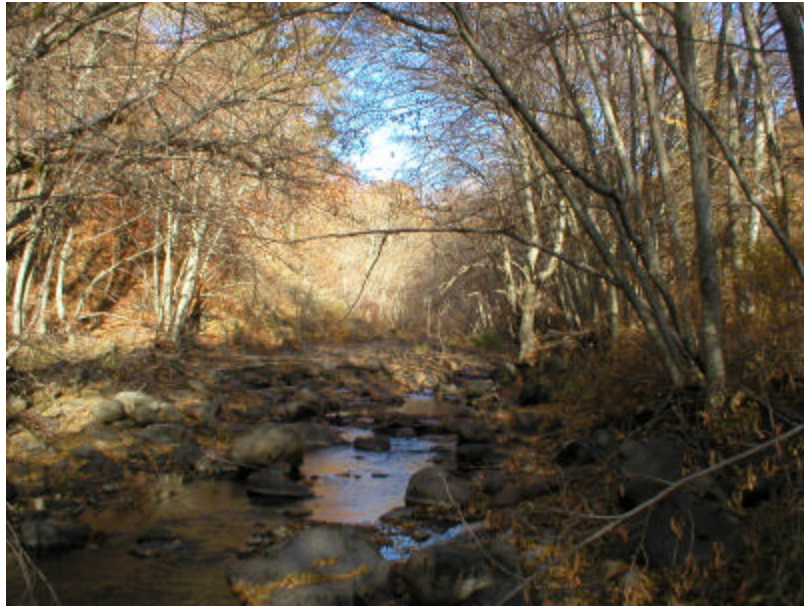
Photo 5. Rock Creek stream channel near Station RC-06, 11/17/04

The EKCD water temperature station RC-06 on Rock Creek has been maintained during the summer from 1995 to present. The station is located on the mainstem of Rock Creek upstream of the Bickleton Highway (Figure 4). During the period of record, streamflow at the station was typically always flowing but did go dry in 1995 and 2002. Summer water temperatures (7-DADMax) exceeded the draft state water temperature standard 46% of the time during the period of record. EKCD staff typically observed “8 inch trout” in the stream on during the summer. A site visit to RC-06 on November 17, 2004, found the stream flowing approximately 2-3 cfs and the water temperature was 43° F. A site visit on March 1, 2005 found higher streamflow (~ 7-10 cfs) and the same water temperature (43° F). The stream channel near the station was heavily shaded by mature Alder trees on both banks (Photo 5 in Appendix A).

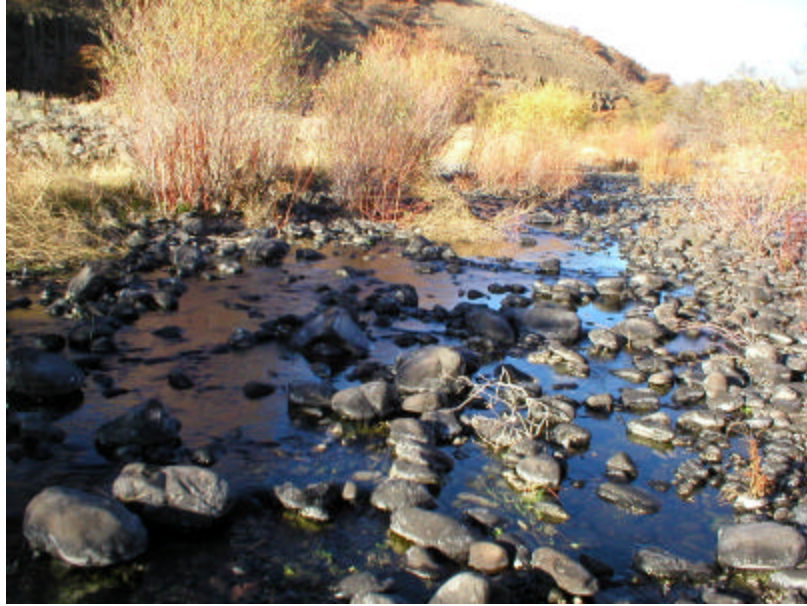
Photo 7. Rock Creek stream channel near Station RC-08, 11/17/04

The EKCD water temperature station RC-08 on Rock Creek has been maintained during the summers from 1995 to present. The station is located on the mainstem of Rock Creek just downstream of the confluence with Squaw Creek (Figure 4). During the period of record, streamflow at the station was typically reduced to stagnant pools and often (every year since 2000) goes dry. Summer water temperatures (7-DADMax) exceeded the draft state water temperature standard 85% of the time during the period of record. EKCD staff typically observed fish up to an “8 inch trout” in the stream during the summer. A site visit to RC-08 on November 17, 2004, found the stream flowing approximately 0.5-1 cfs, and the water temperature was 50° F. A site visit on March 1, 2005 found higher streamflow (~5-6 cfs) and lower water temperature (45° F). The stream channel near the station was rocky and very slightly shaded by Willow clumps on the right banks (Photo 7 in Appendix A).

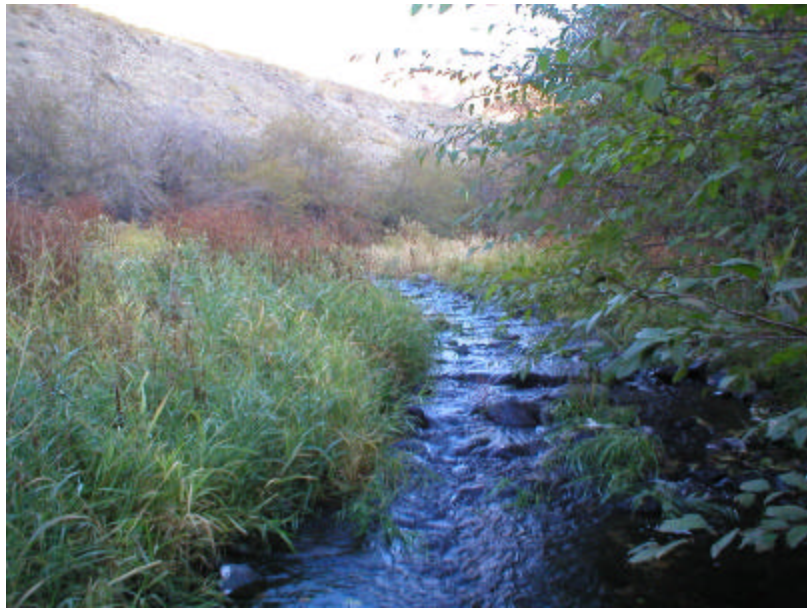
Photo 8. Rock Creek stream channel near Station RC-09, 11/17/04

The EKCD water temperature station RC-09 on Rock Creek has been maintained during the summers from 1995 to present, excluding 1997 and 2000. The station is located on the mainstem of Rock Creek just upstream of the Columbia River backwater pool (Figure 4). During the period of record, streamflow at the station was typically reduced to stagnant pools but only went dry in 1995. Summer water temperatures (7-DADMax) exceeded the draft state water temperature standard 84% of the time during the period of record. EKCD staff observed small fish in the stream during the summer of 1998. A site visit to RC-08 on November 17, 2004, found the stream flowing approximately 3 cfs, and the water temperature was 49° F. A site visit on March 1, 2005 found much higher streamflow (~15-20 cfs) and lower water temperature (44° F). The stream channel near the station is lightly shaded by tall grass and scattered mature Alder trees on both banks (Photo 8 in Appendix A).

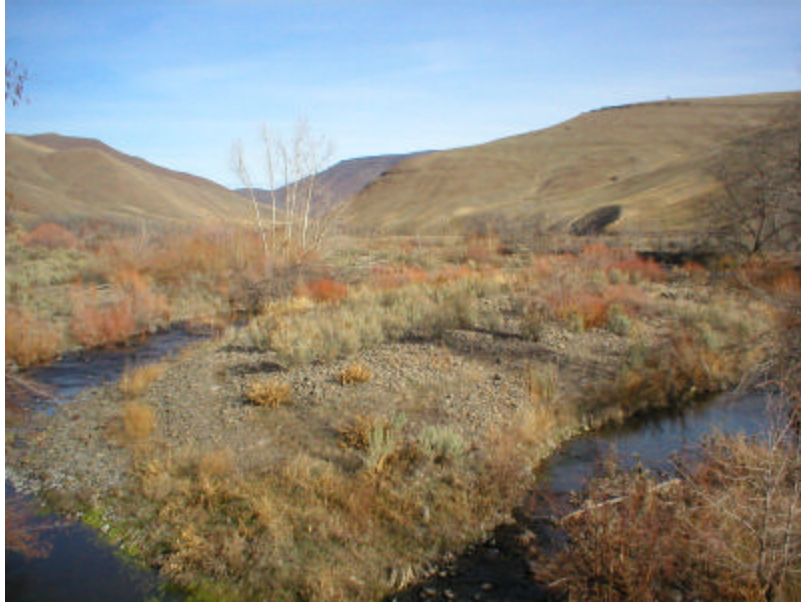
Photo 9. Rock Creek stream channel near Station RC-10, 3/1/05

The EKCD water temperature station RC-10 on Rock Creek was maintained during the summers from 1995 to 2000. The station is located on the mainstem of Rock Creek upstream of the Highway 8 Bridge (Figure 4). During the period of record, streamflow at the station was typically reduced to stagnant pools and went dry from 1998-2000. Summer water temperatures (7-DADMax) exceeded the draft state water temperature standard 98% of the time during the period of record. EKCD staff observed small fish in the stream during the summer of 1998. A site visit to RC-08 on November 17, 2004, found the stream flowing approximately 0.5-1 cfs, and the water temperature was 57 ° F. A site visit on March 2, 2005, found higher streamflow (~5-6 cfs) and much lower water temperature (45° F). The stream channel near the station is very slightly shaded by Willow clumps and scattered mature Alder trees on the right bank. (Photo 9 in Appendix A).

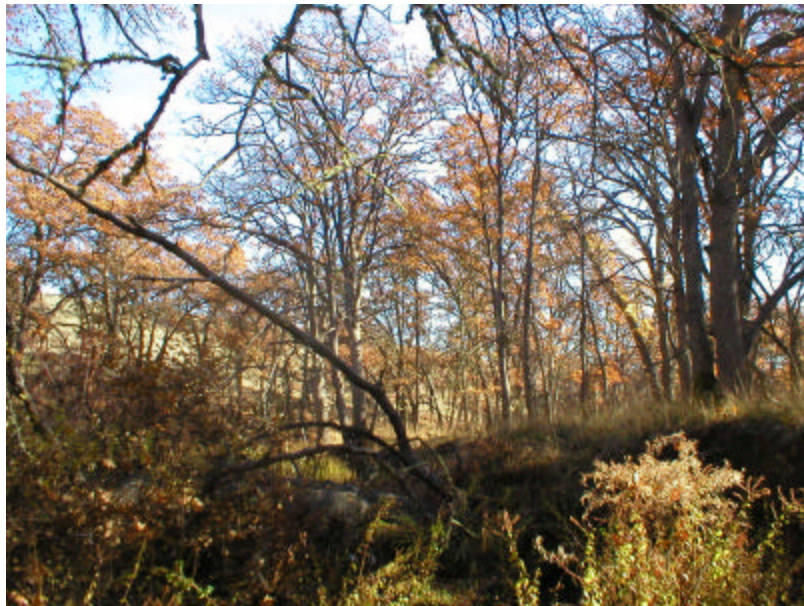
Photo 10. Luna Gulch stream channel near Station LG-01, 11/17/04

The EKCD water temperature station LG-01 on Luna Gulch was maintained during the summers from 1997 to 2002. The station is located on the north fork of Luna Creek downstream of the Oak Flat Road crossing (Figure 4). During the period of record, streamflow at the station was typically reduced to stagnant pools. Summer water temperatures (7-DADMax) exceeded the draft state water temperature standard 36% of the time during the period of record. A site visit to LG-01 on November 17, 2004, found the stream flowing less than 0.1 cfs, and the water temperature was 43° F. A site visit on March 2, 2005, found approximately the same streamflow and higher water temperature (47° F). The stream channel near the station is heavily shaded by Oak trees on both banks (Photo 10 in Appendix A).

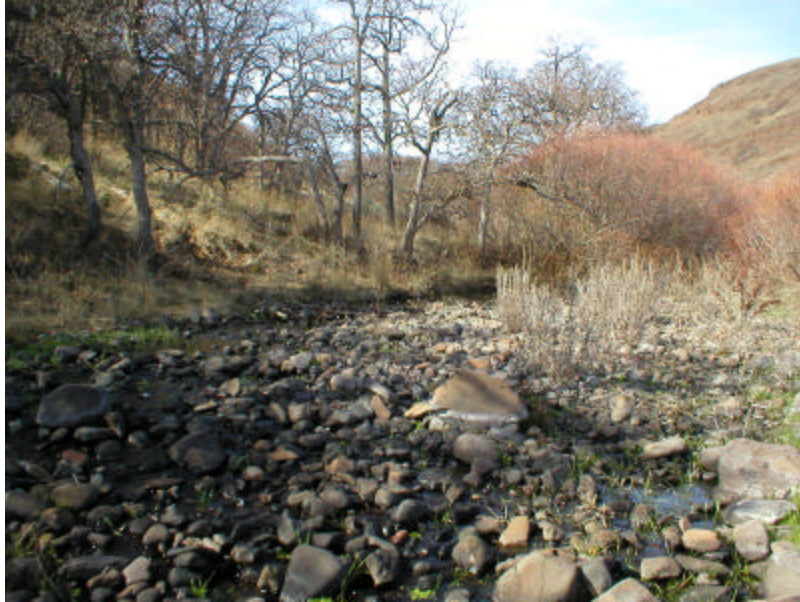
Photo 11. Luna Gulch stream channel near Station LG-02, 3/1/05

The EKCD water temperature station LG-02 on Luna Gulch was maintained during the summers of 1997 and 1998. The station is located on Luna Gulch just upstream of its confluence with Rock Creek (Figure 4). During the period of record, streamflow at the station was typically reduced to stagnant or very slow pools. Summer water temperatures (7-DADMax) exceeded the draft state water temperature standard 69% of the time during the period of record. A site visit on March 1, 2005 found the stream flowing approximately 1 cfs and a water temperature of 45° F. The stream channel was slightly shaded with mature oak and willow clumps scattered on both banks (Photo 11 in Appendix A).

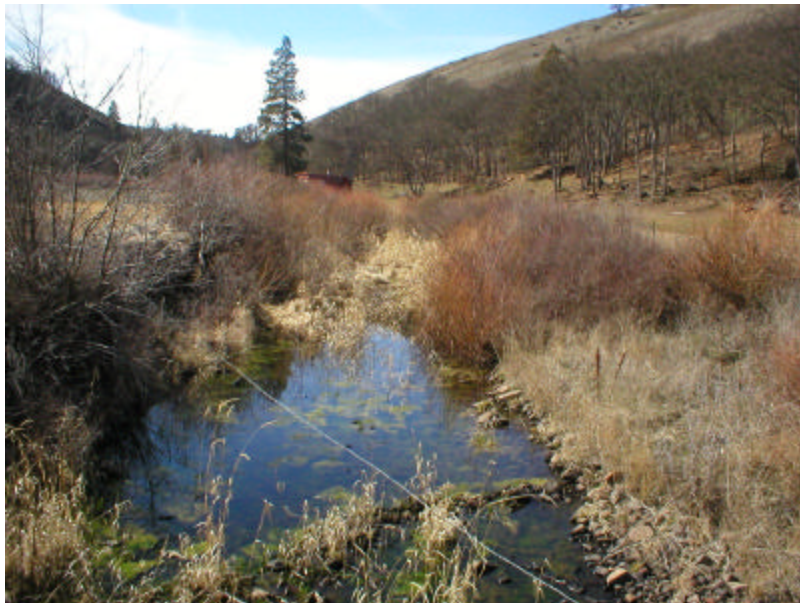
Photo 12. Luna Gulch stream channel near Station LG-03, 3/1/05

The EKCD water temperature station LG-03 on Luna Gulch was maintained during the summers from 1997 to 2000. The station is located on the south fork of Luna Gulch approximately 1 mile upstream of the Oak Flat Road Bridge (Figure 4). During the period of record, streamflow at the station was typically reduced to alternating stagnant or very slow pools and dry periods. Summer water temperatures (7-DADMax) exceeded the draft state water temperature standard 74% of the time during the period of record. A site visit on March 1, 2005, found the stream flowing approximately 2 cfs. The stream channel was slightly shaded with mature Ponderosa pine, oak, willow clumps and grasses scattered on both banks (Photo 12 in Appendix A).
